Lambeth Palace – Great Hall

Architectural Paint Investigation

Introduction

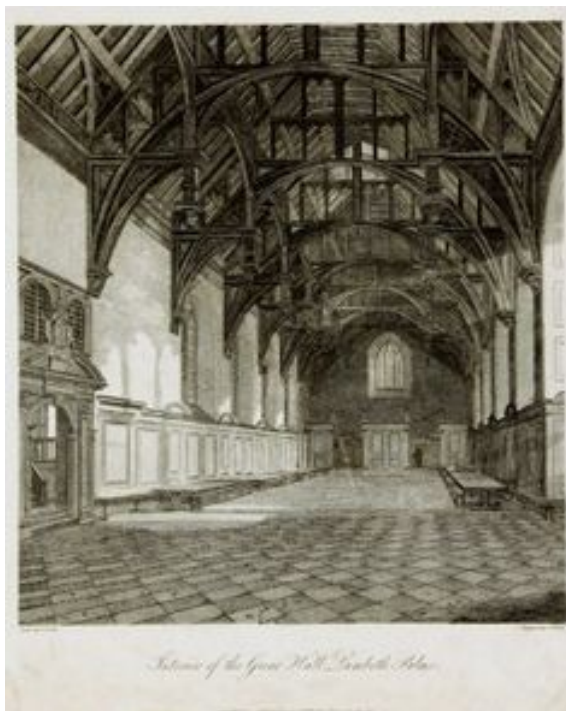
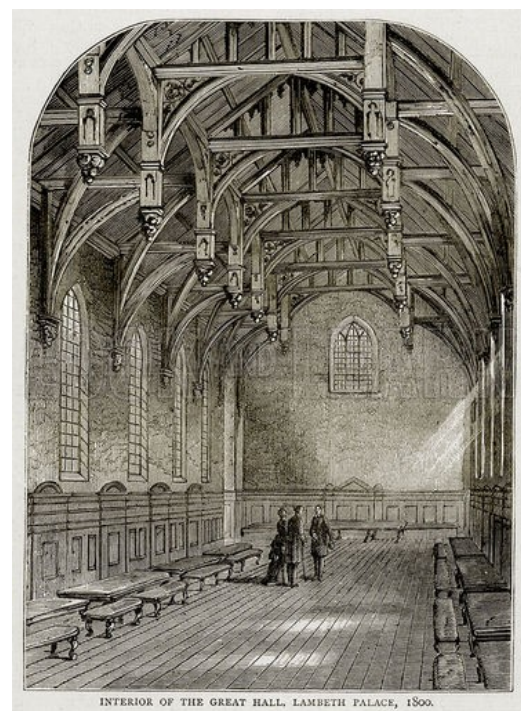
Figure 2 the Great Hall - Early 19th Century

The hall was altered during the 18th century. By the beginning of the 19th century the western end of the hall had been altered and the Screen and first floor rooms had been removed.

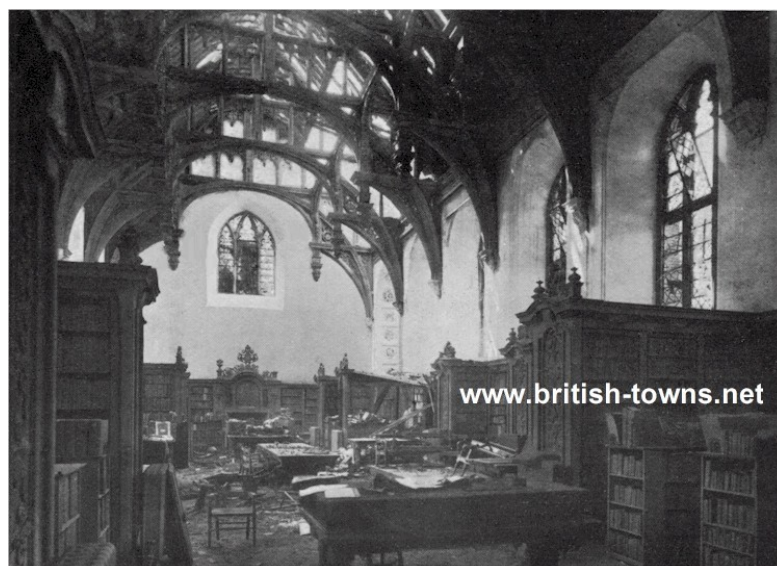
Figure 4 the Great Hall - WWII Bomb Damage

The Great Hall was altered during the 19th century when it was configured for use as a library with the addition of projecting book shelves on the north and south walls. This alteration was directed by the architect Edward Blore. Blore's alterations were discussed in *The Gentleman's Magazine* (Volume 156-157, 1834, pp. 152-154). The hall is described as being, 'wainscotted to a considerable height'. The hall was heated by under floor pipes and two fireplaces installed at the east and west ends. The entrance to the courtyard in S/W corner was converted into a bay window. The roof suffered bomb damage during WWII and the building was altered during the 1950s.

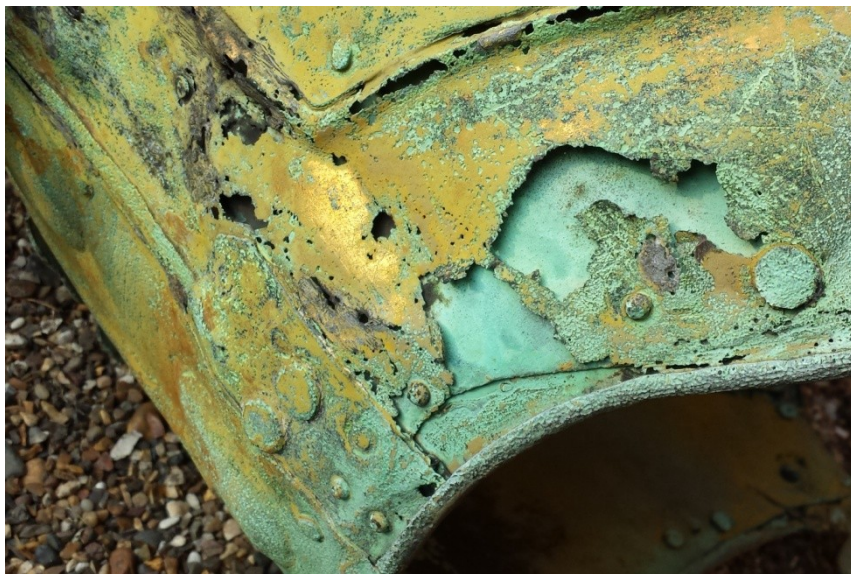
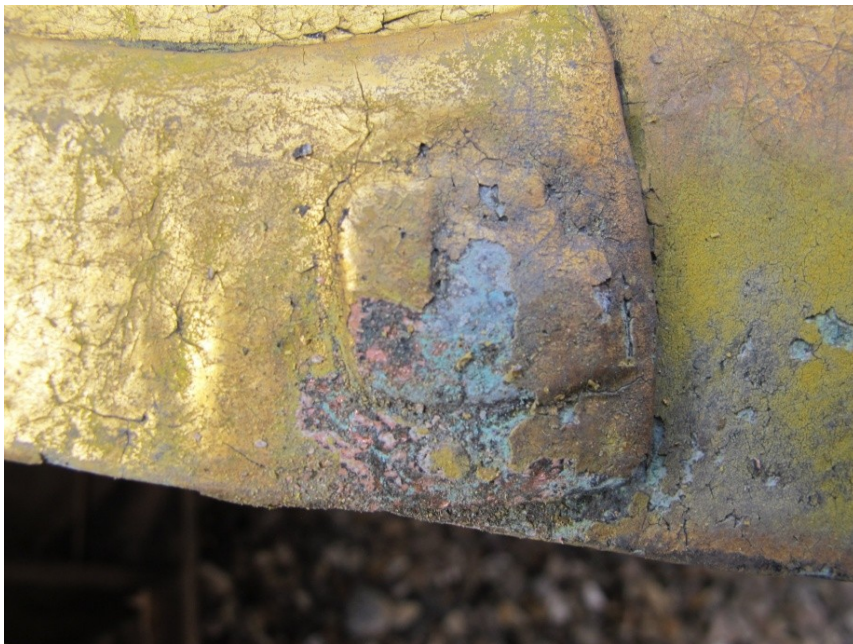
Figure 5 the Weathervane - Detail of Surface

- There is evidence of various repairs and patching of the copper.
- The upper crown is badly corroded in places. There are holes in the copper.
- The current decorative scheme (all elements fully gilded) is damaged in places.
- A layer of corroded copper is visible in numerous areas. This layer is particularly noticeable on the on the top crown.
- Several layers of gilding are visible. The existing scheme has been applied over a yellow coloured ground. The penultimate gilding has been applied over a pink coloured undercoat.
- There are traces of a brown layer beneath these two gilding decoration.

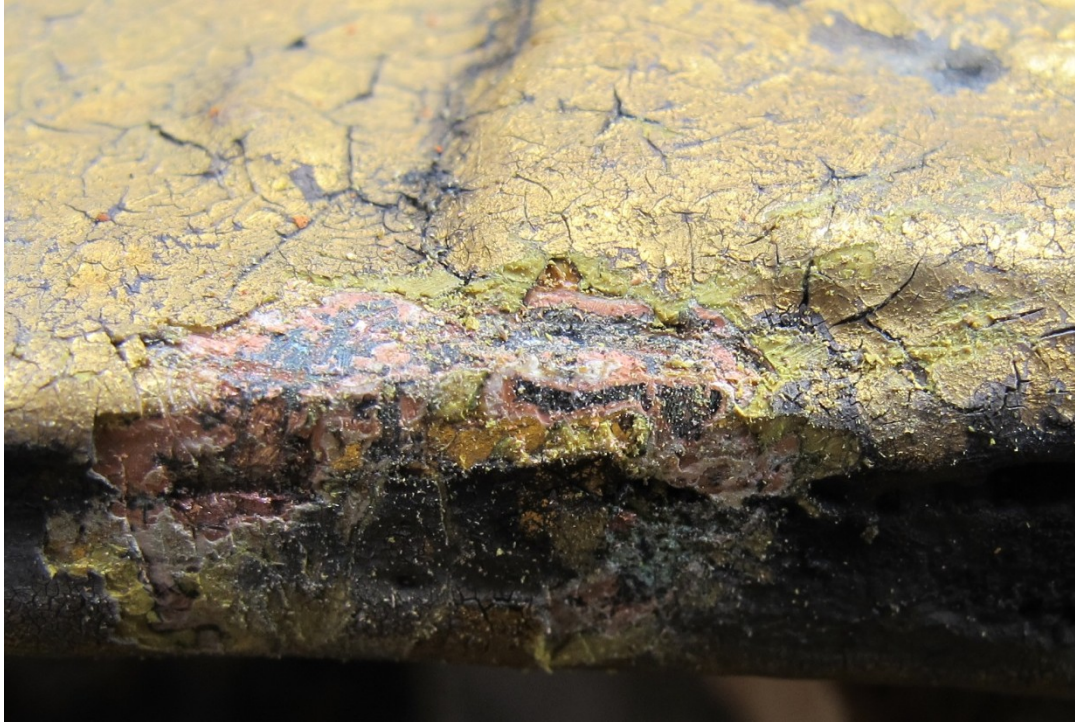
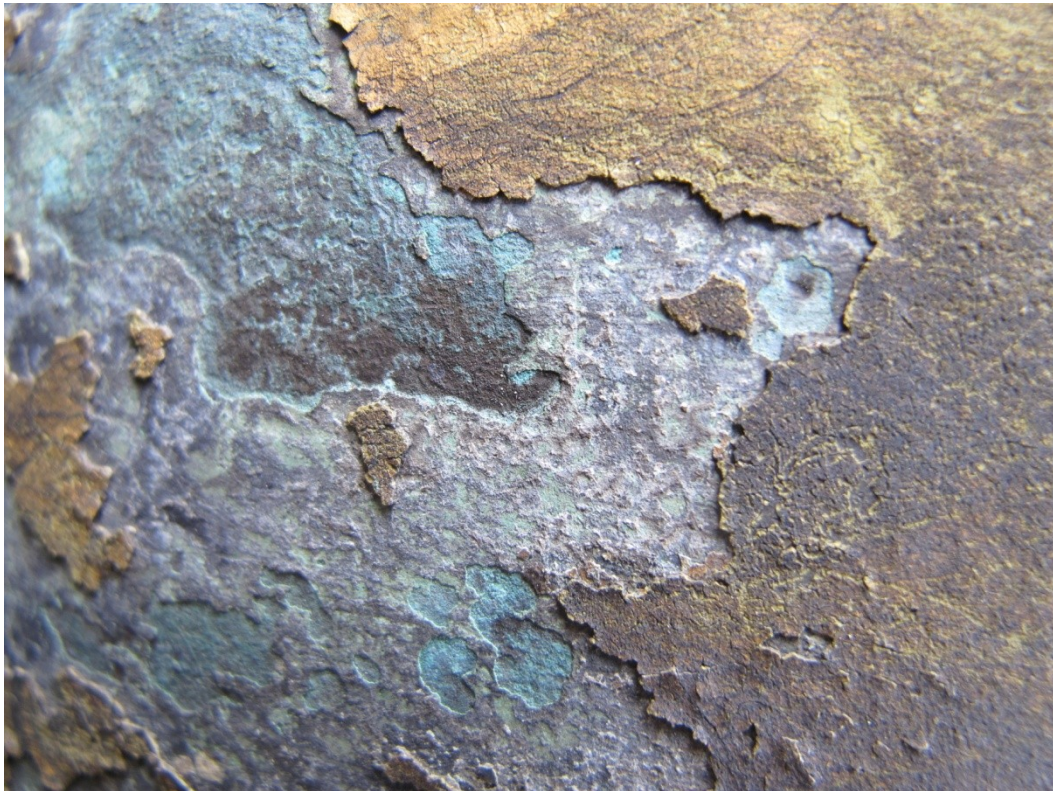
Examination of the samples revealed that the weather vane had been extensively **stripped of its early decorative finishes (possibly post c.1850)** prior to the application of a **gilded decoration applied over a zinc based pink undercoat** (tinted with red lead).

There are traces of an early brown primer on the surface of the copper. It is noted that the extensive copper corrosion (verdigris – copper acetate) has built up **above** this brown layer.

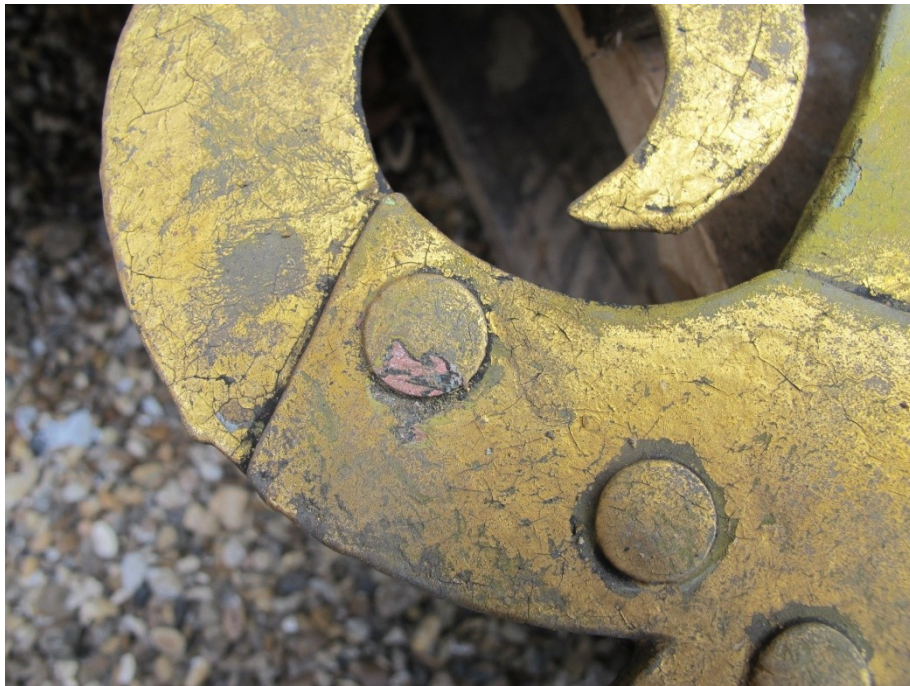
Figure 11 Sample 13 Location - bottom fleur de lys

Sample 13 – Early decorations in Dark Green and Grey on Brown Red (Sample 7 similar)

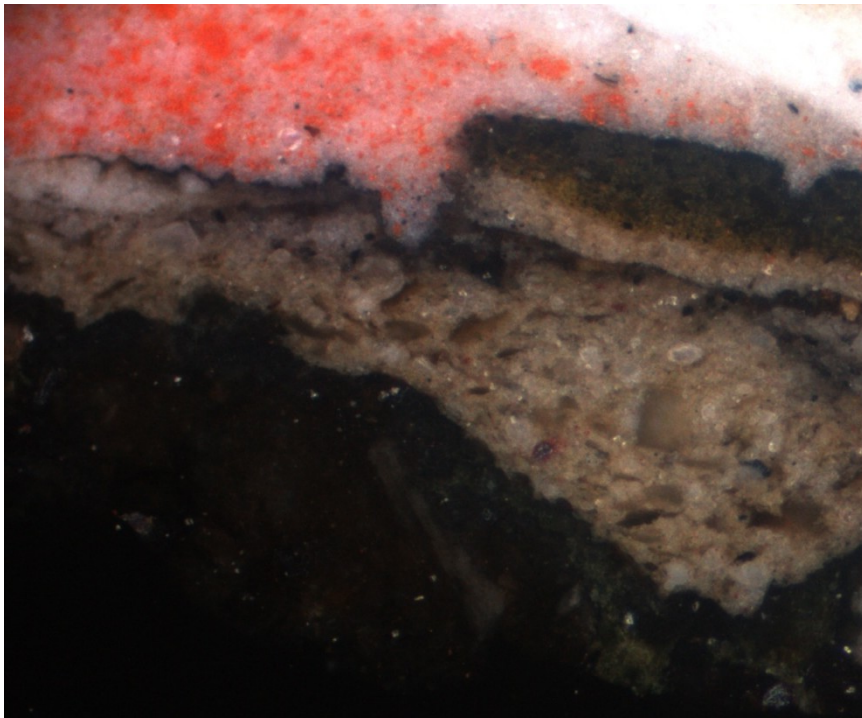
Sample 13 – Details of pink primer (with zinc)

Zinc white was a pigment commonly used by housepainters from the mid 19th century, but fell out use in the early 20th century. When viewed under ultra-violet light zinc white exhibits a bright sparkly appearance. This means that it is a useful marker material for the dating of paint.

Pink primer of gilding

Traces of early finishes

Green in grey

Grey

Dark Green

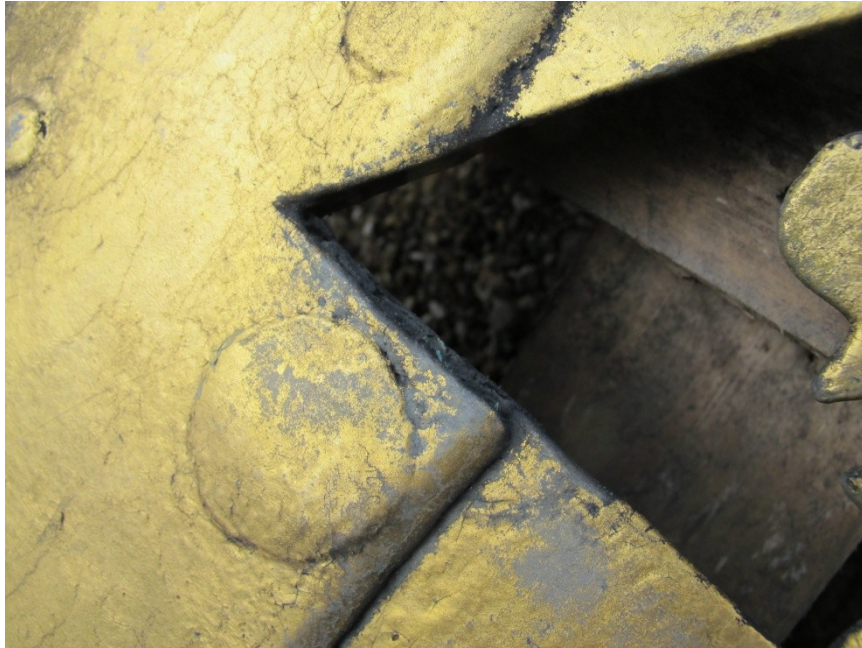
Sample 9 – Sample location – Corner of ‘Y’ Gap

Figure 13 Sample 9 Location - Edge of Corner of Arms cut

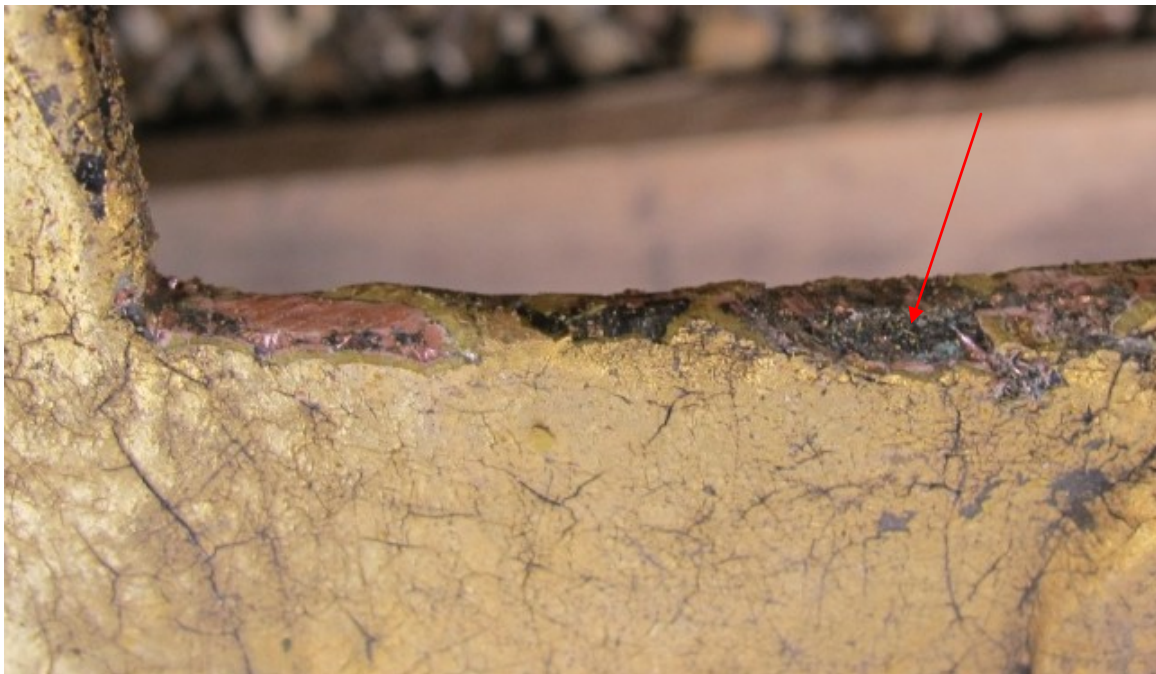
Figure 16 Sample 15 - Traces of early decorative schemes visible beneath pink primer

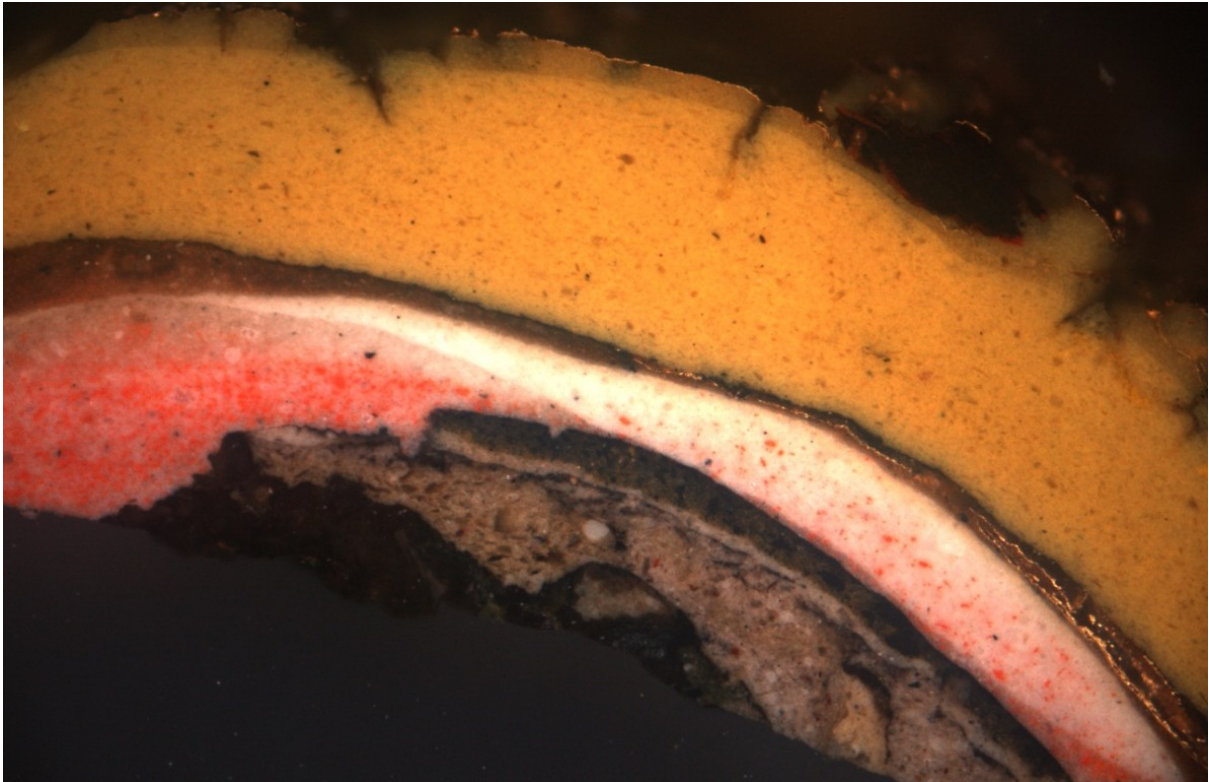
Figure 17 Sample 15 - Traces of early decoration beneath later gilding

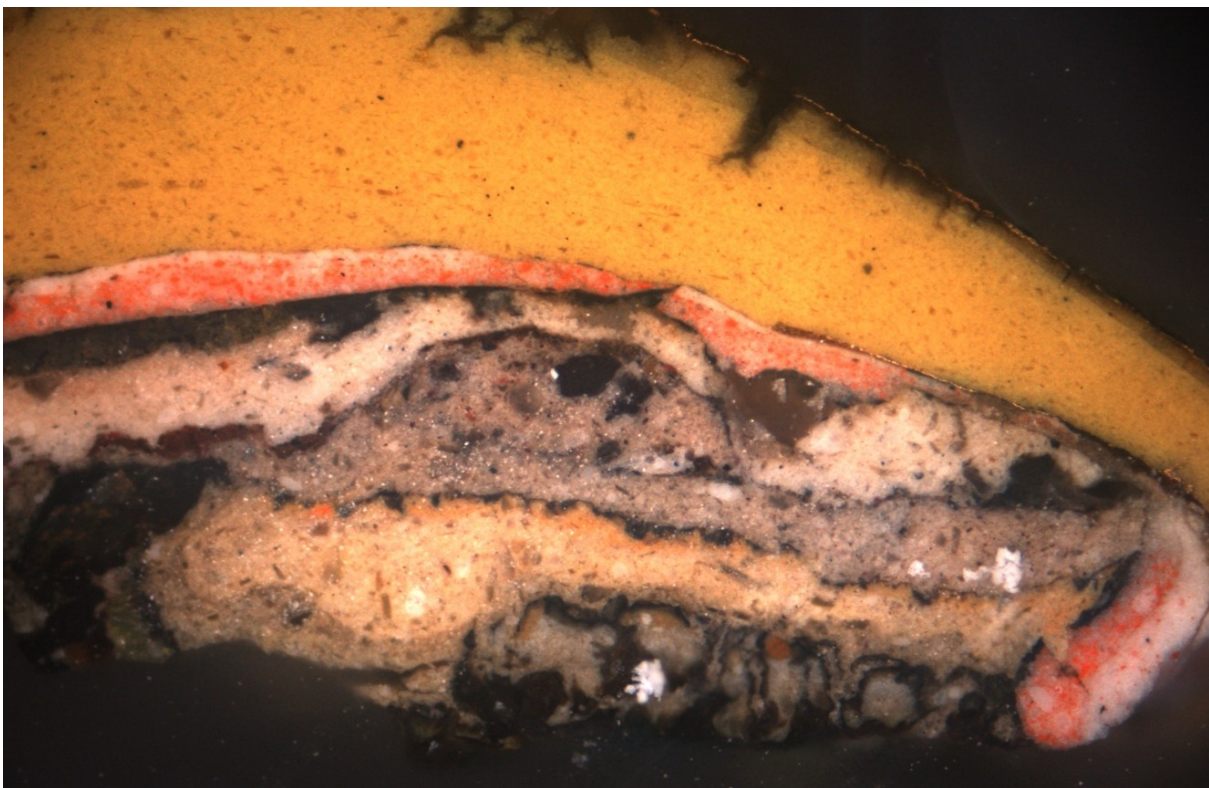
Figure 18 Sample 15 Cross-section - Traces of early decorative finishes beneath later gilding

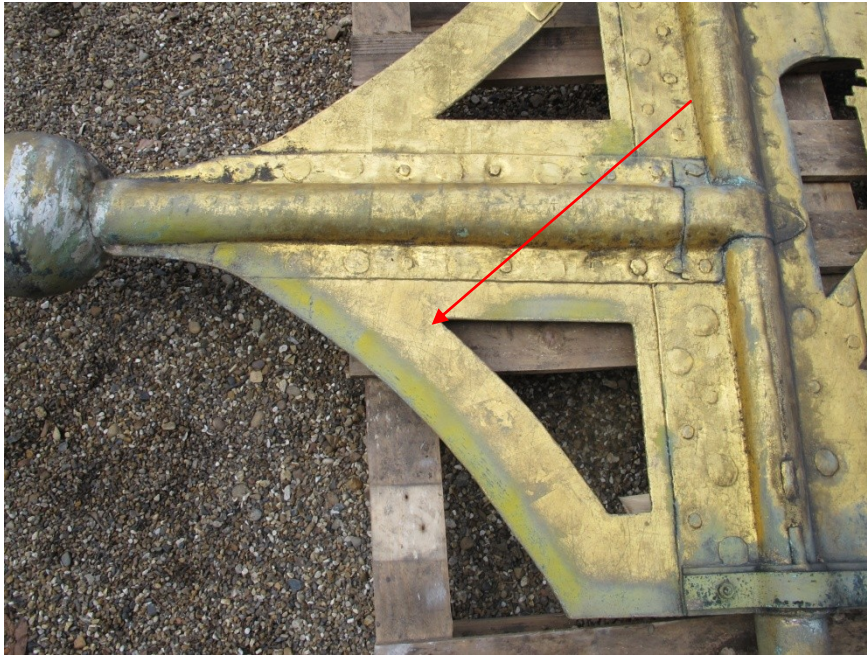
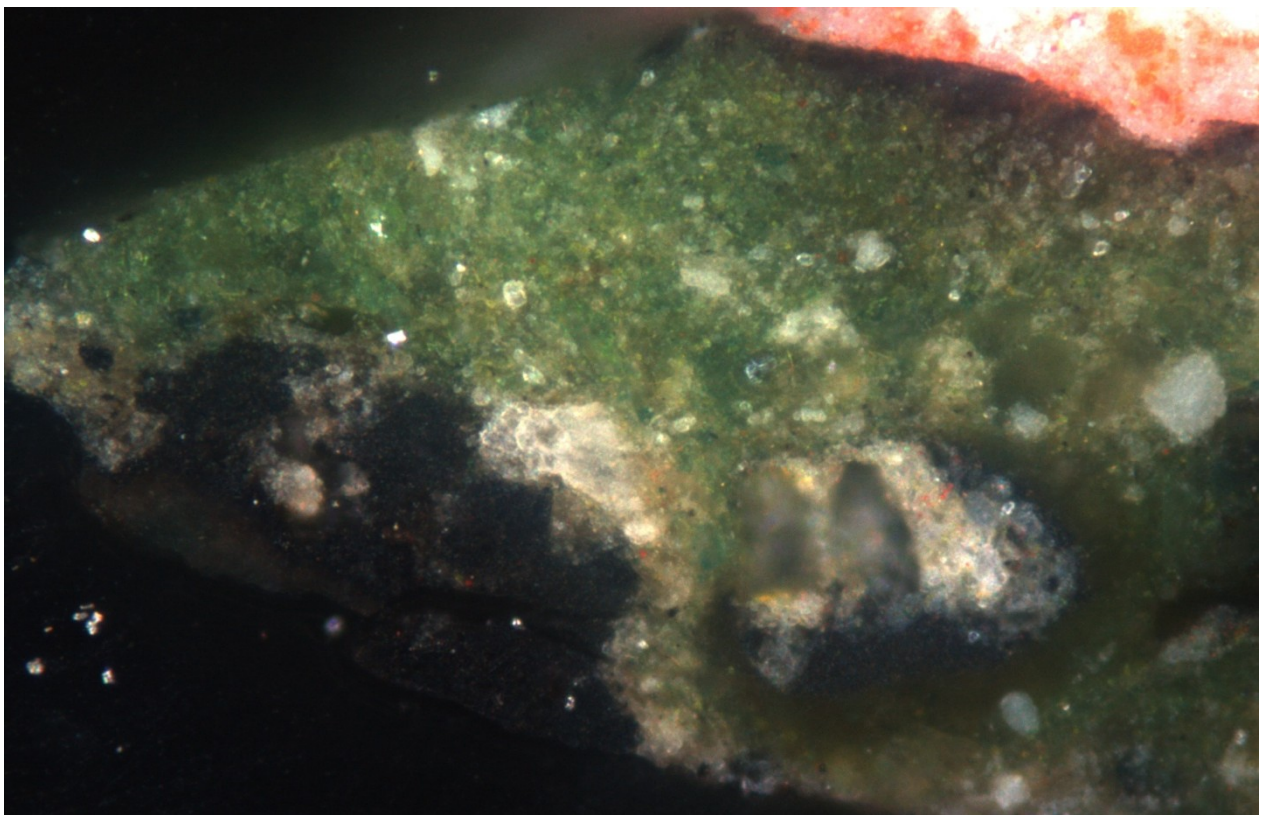
Sample 20 – Layer of Corrosion Verdigris or Green Paint Layer?

Figure 19 Thick deposit of bright green - applied paint or corrosion product

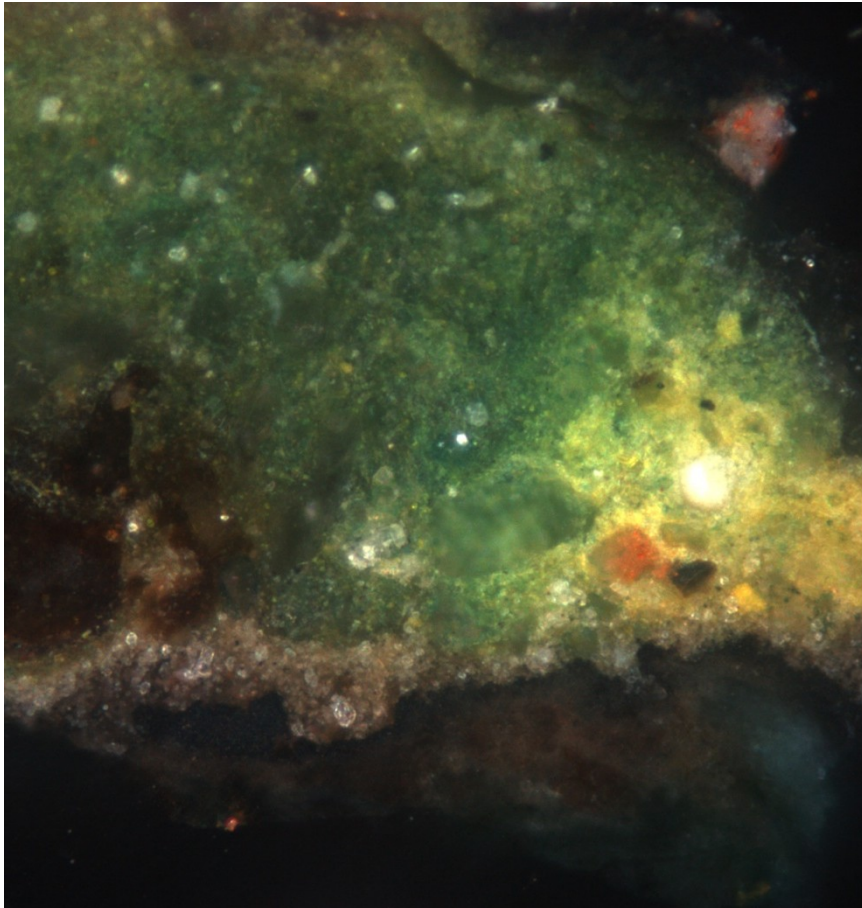
Sample 20 – Layer of Corrosion Verdigris or Green Paint Layer?

Bright Green

Paint or Copper Corrosion

Green layers appears to overlie a grey layer

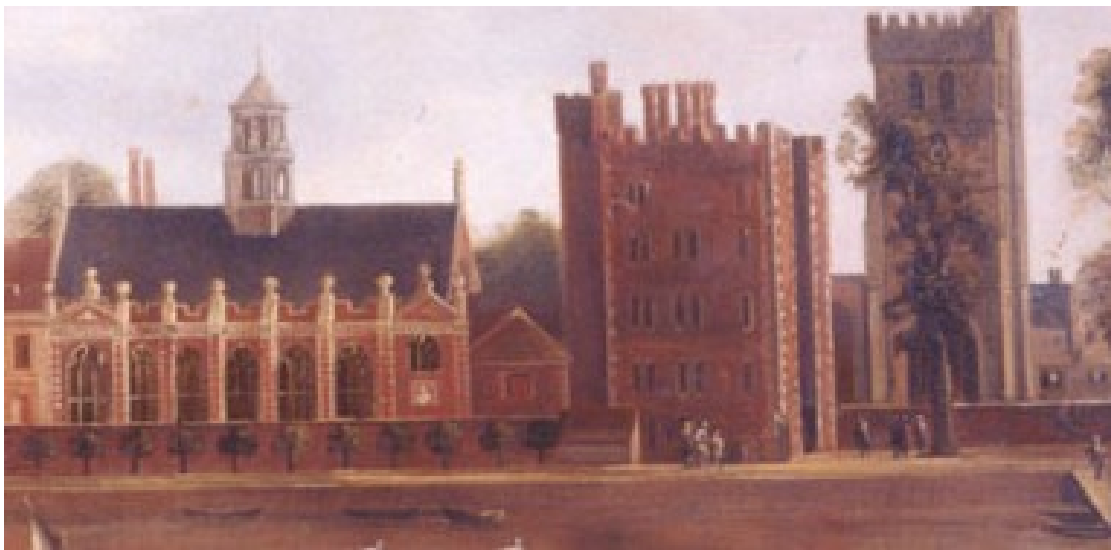
The Cupola was erected in c.1663. It is a two tier wooden construction which apart from the exposed sections of moulded wooden cornice and carved capitals, is covered in lead. Historic illustrations indicate that the entire exterior of the cupola (wood and lead) was **painted white**. The exterior of the cupola is currently painted black with the carved wooden capitals picked out in a terracotta red. The application of white paint not only protected the wooden elements but provided a uniform appearance which was intended to suggest that the cupola was a stone construction.

Figure 20 Historic Illustrations of Lambeth Palace - Cupola painted white

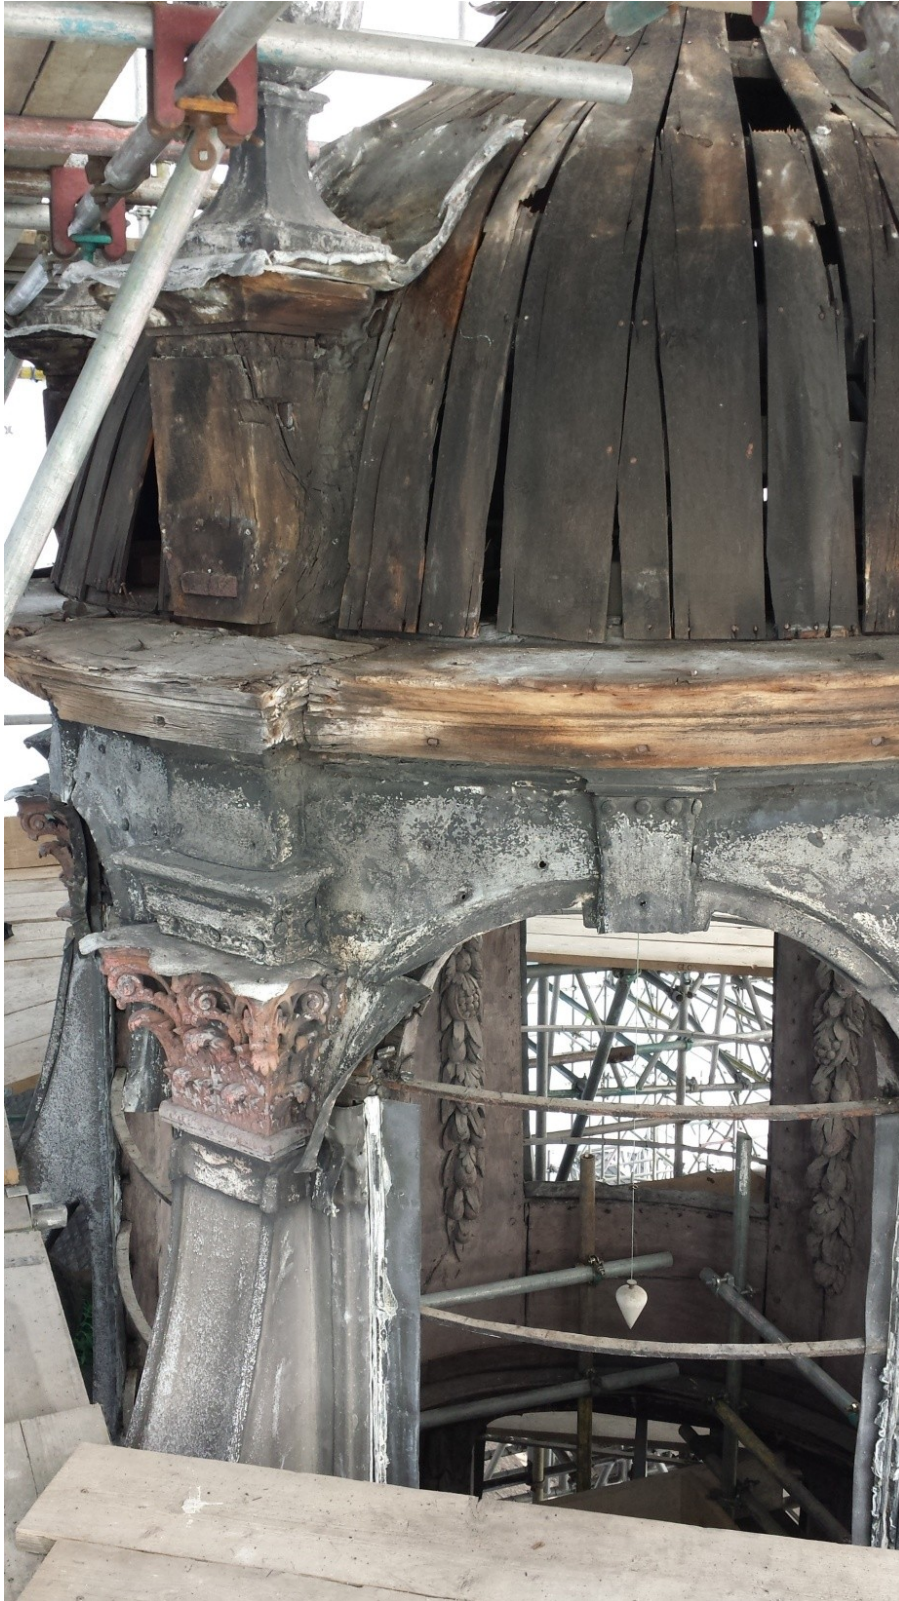
The existing decoration is a dark grey/black with the carved wooden capitals picked out in a terracotta red colour

Figure 21 Lambeth Palace Cupola Existing Decoration - Removal of lead from roof (March 2015)

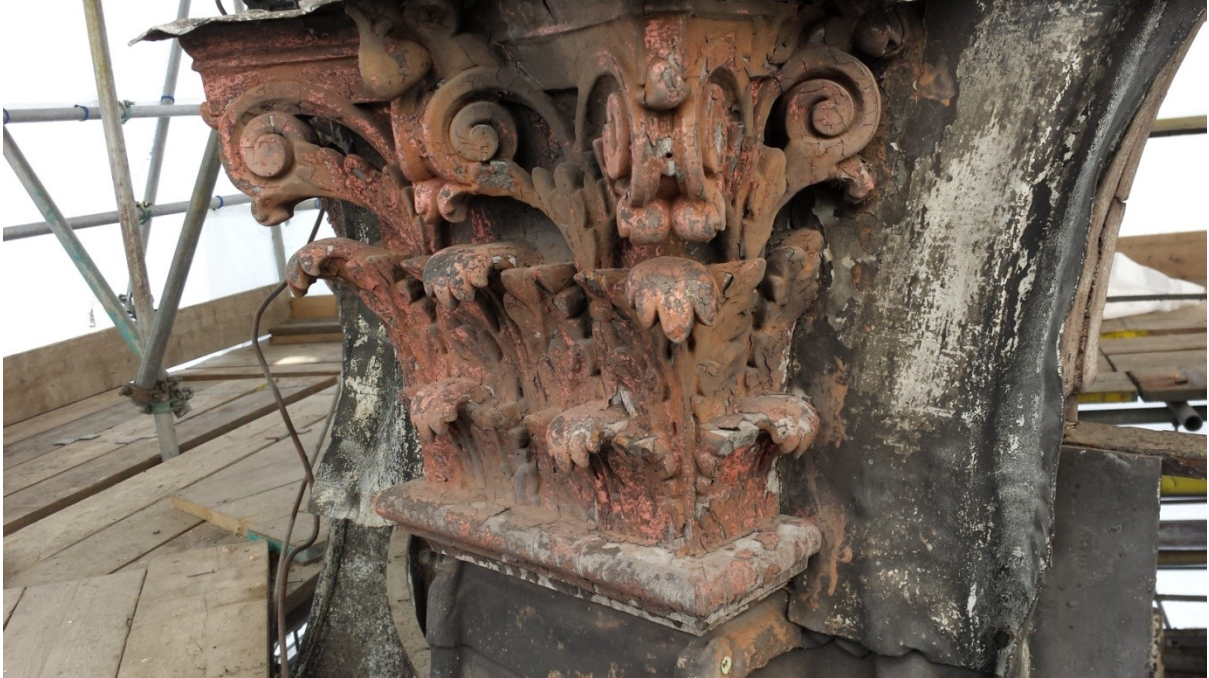
The wood and lead is very weathered. There is evidence that the applied paint layers have been stripped from the surface of the lead and wood. – but in places a heavy build-up of applied paint layers has survived. The cupola did suffer bomb damage during WWII and some elements will have been replaced. But there was no obvious indication that any of the capitals had been totally replaced

Figure 22 Lambeth Palace - Detail of surviving paint finishes on carved capitals

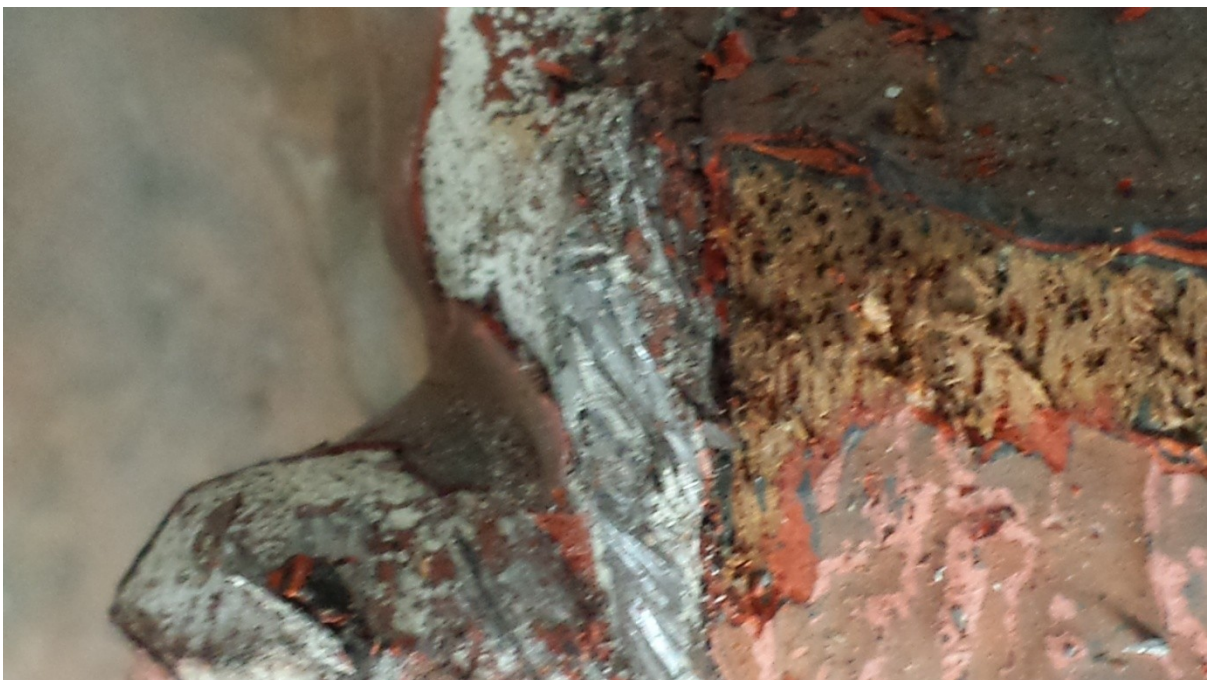
Figure 23 Detail of a section of a wooden capital which has been stripped of early paint layers - or replaced

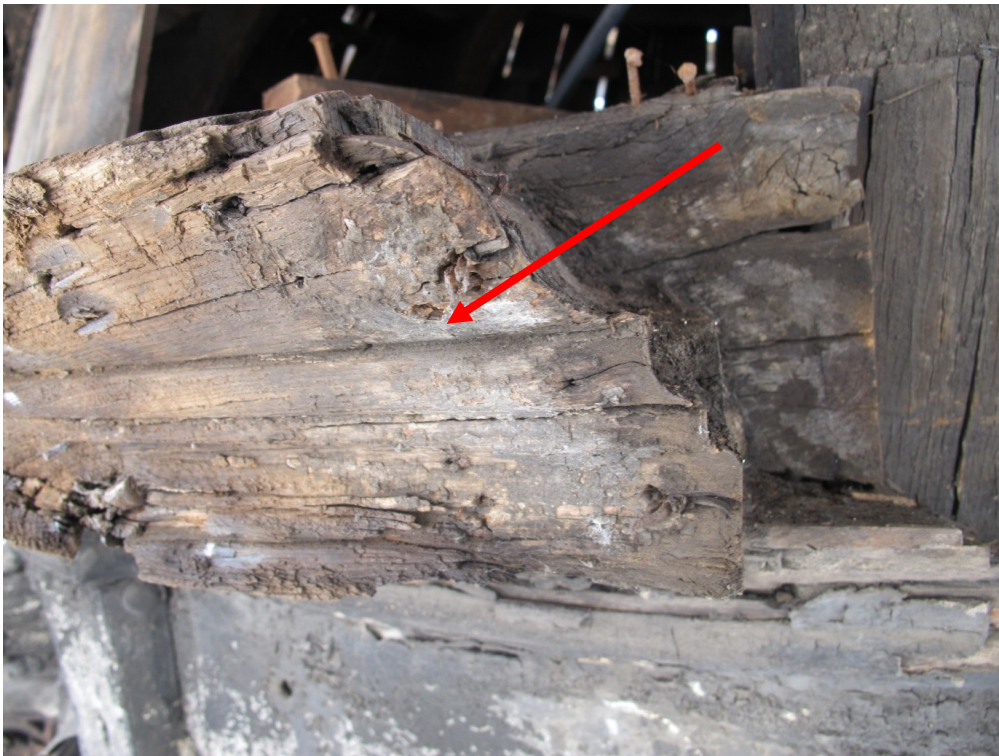
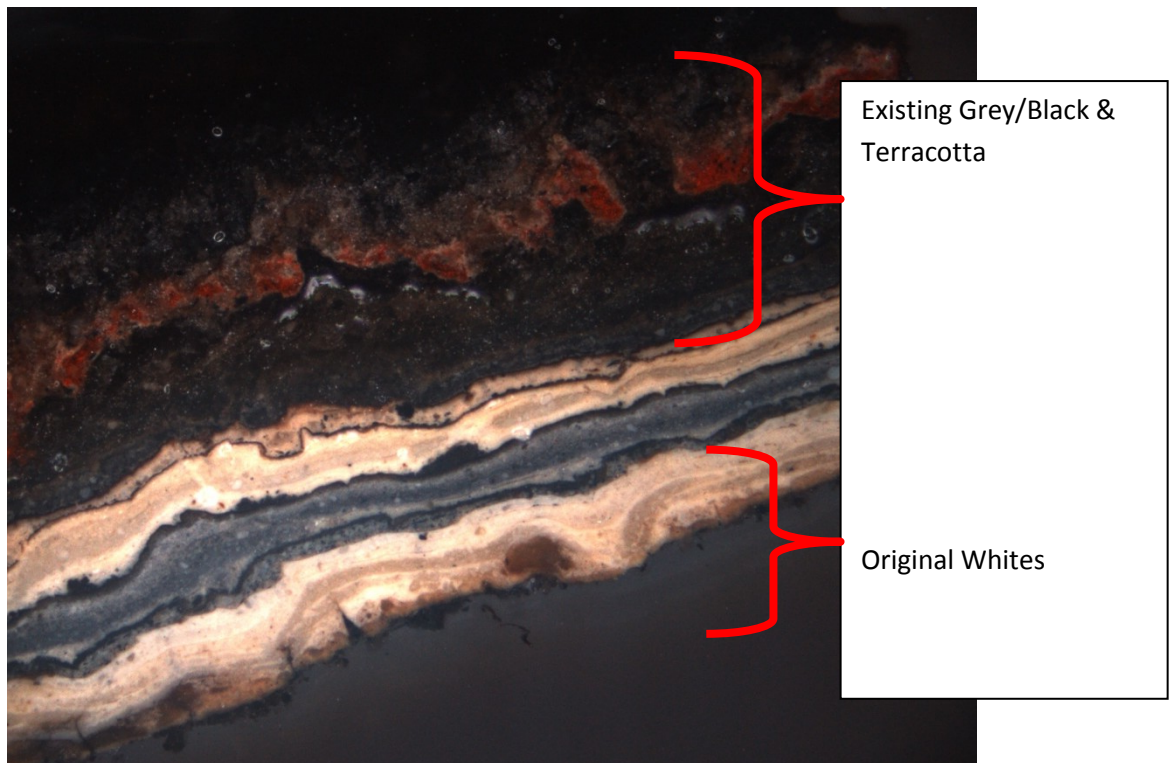
Paint Sample 1 Location – Wooden Cornice

Figure 24 Sample 1 Cross-section - Original White Oil paint on pink primer - later decorations

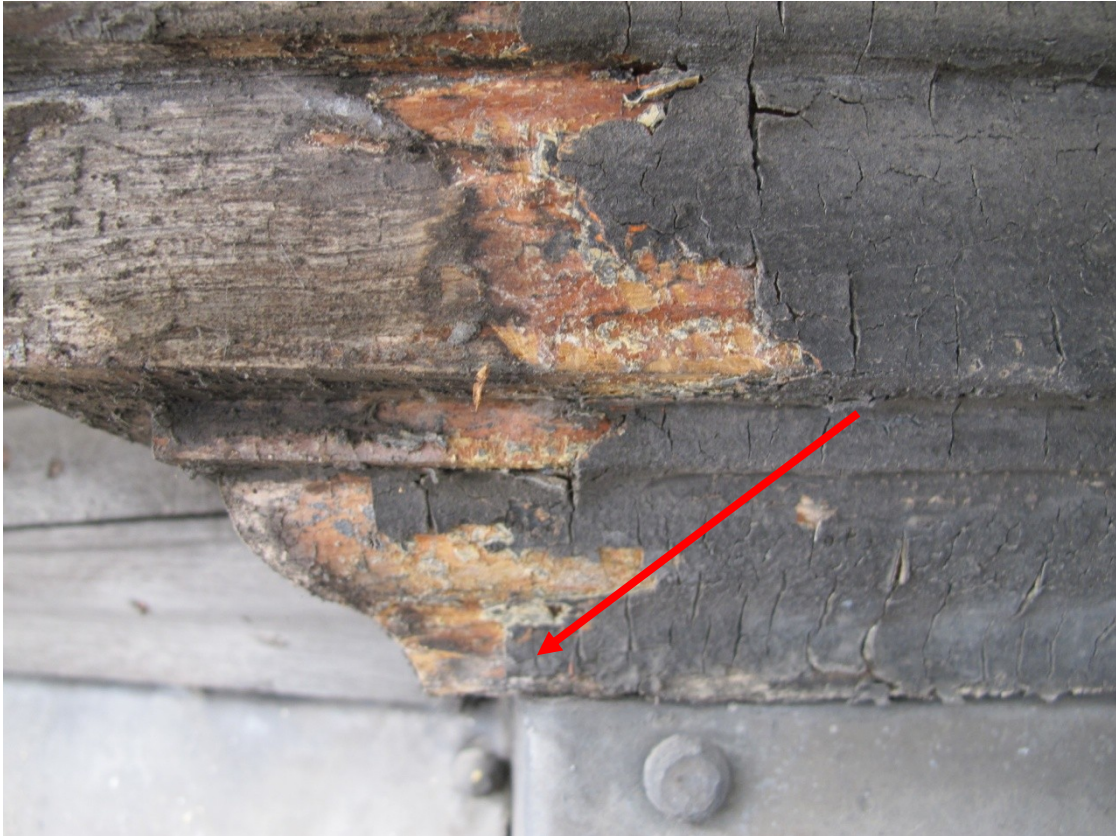
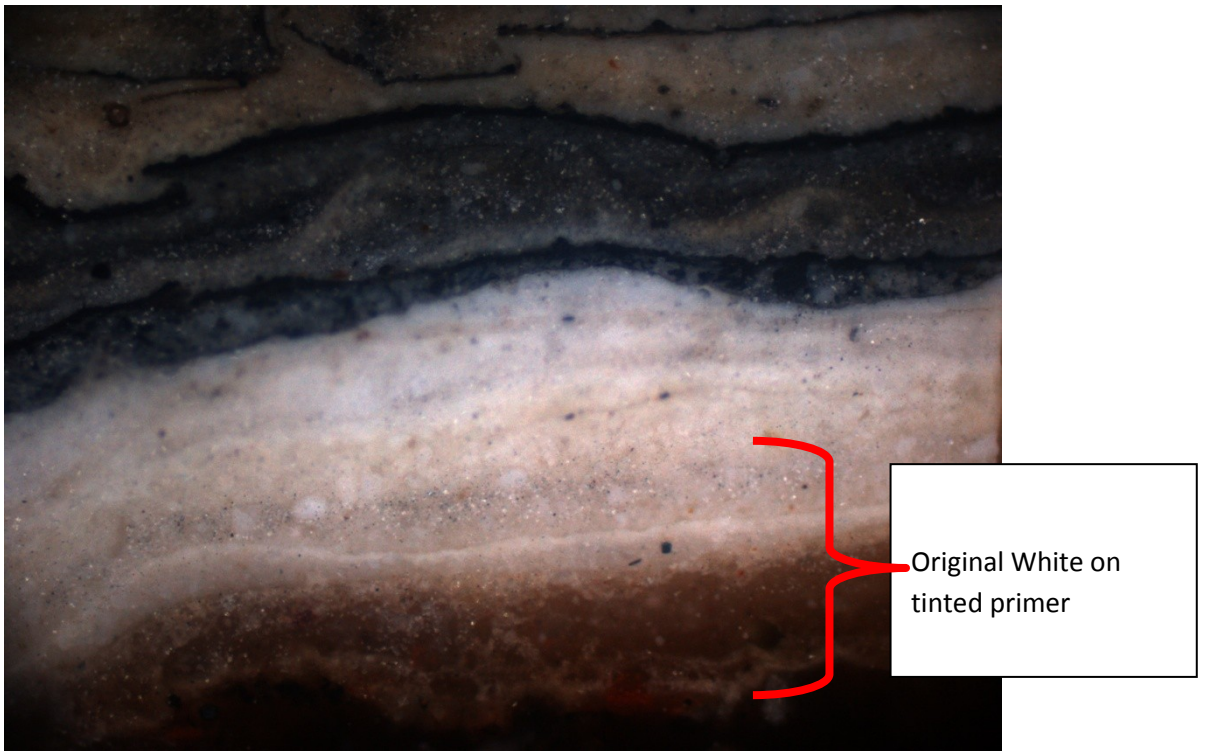
Sample 2 Location – Wooden Cornice lower

Figure 25 Cross-section Sample 2 - Original primer with red lead and early decorations in white oil paint

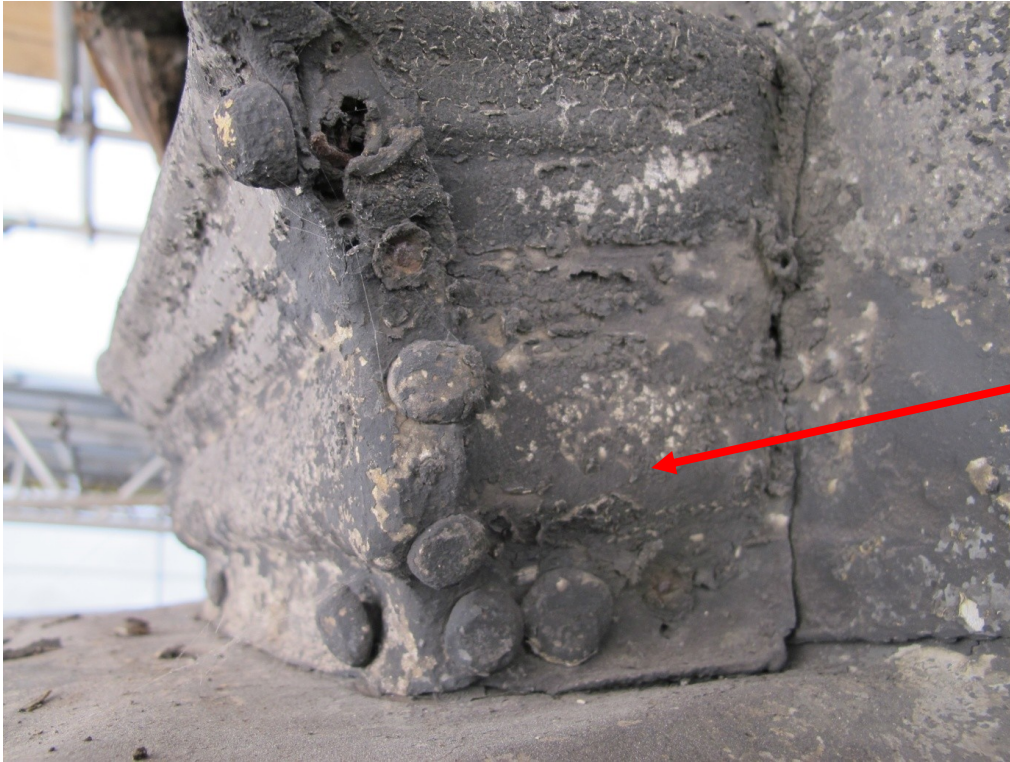
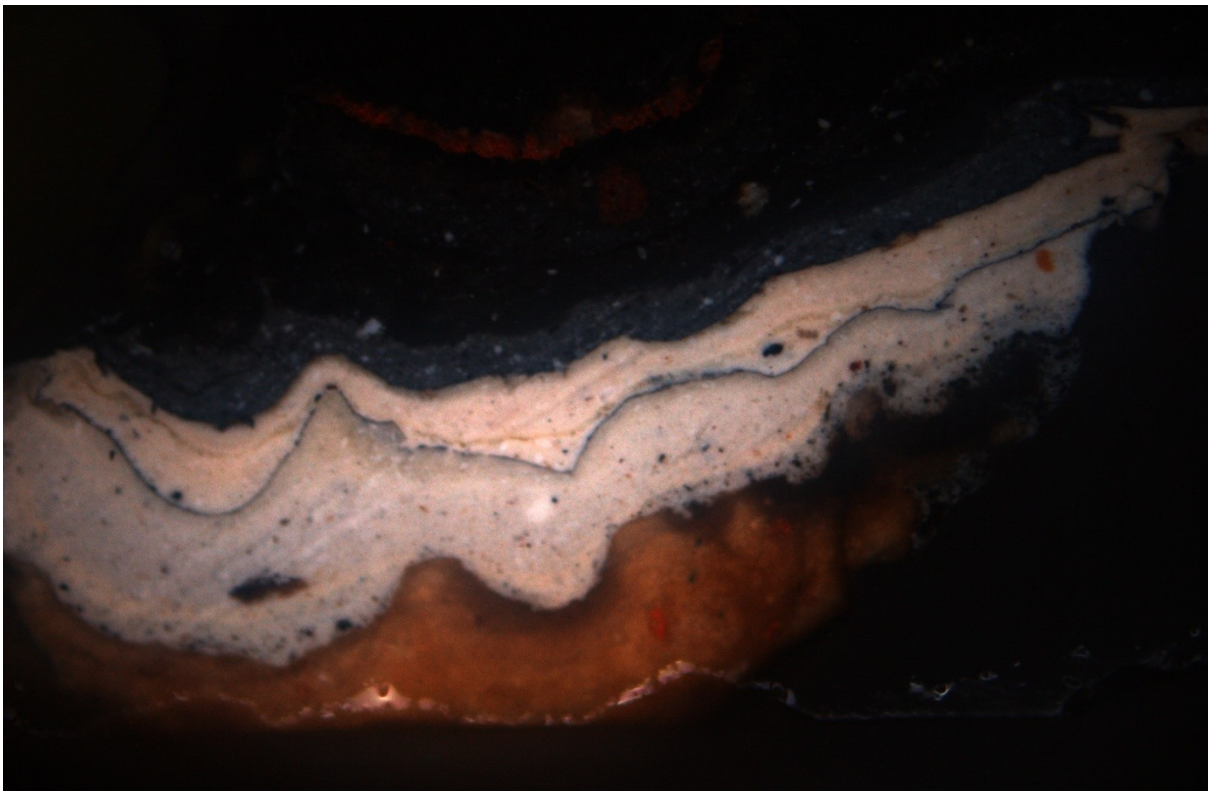
Sample 4 Location – Paint on lead below painted cornice

Figure 26 Cross-section Sample 4 - Traces of early white painted decoration and pink primer

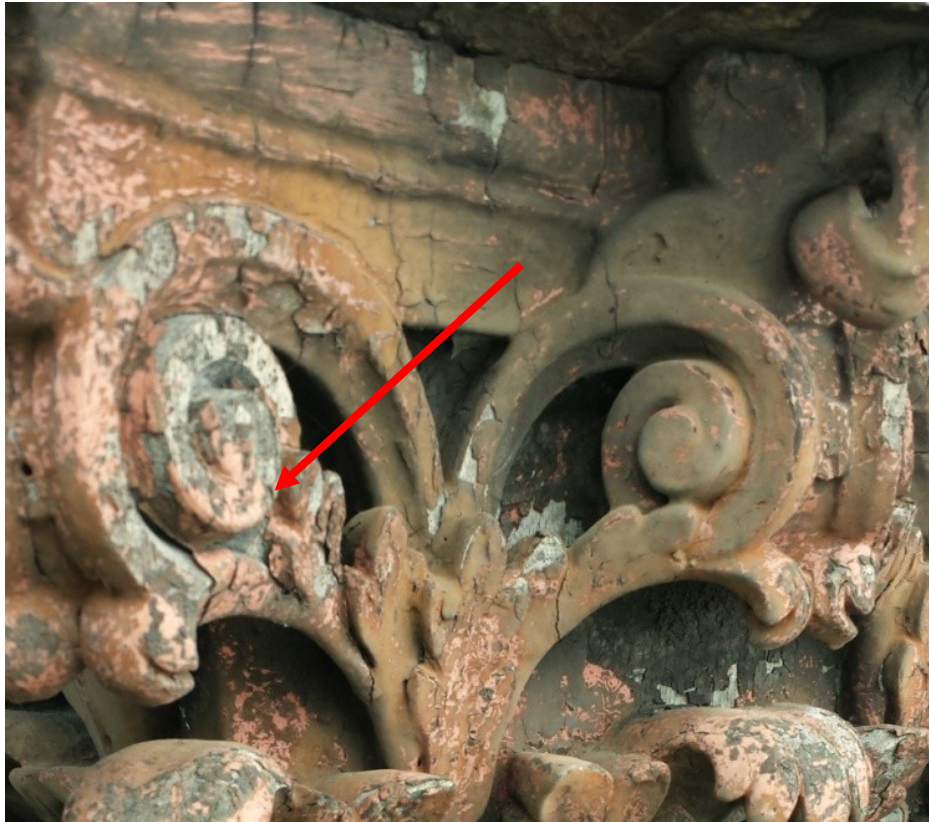
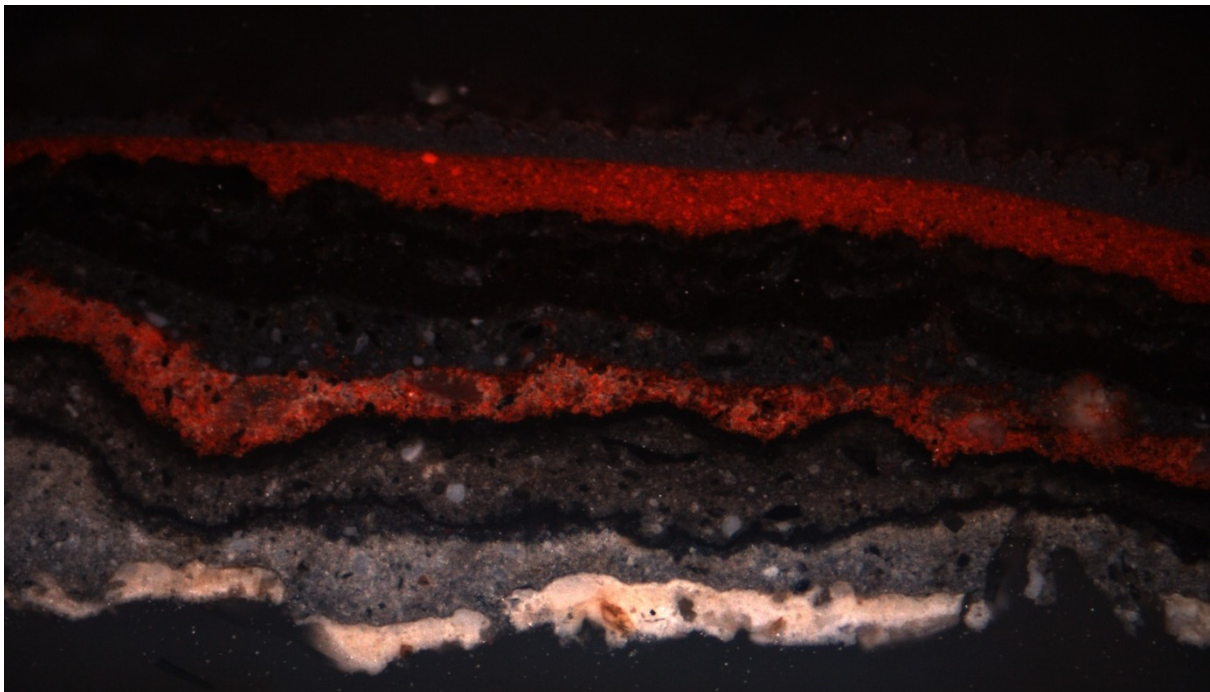
Sample 6 Location – Carved Capitals

Figure 27 Cross-section Sample 6 - Traces of white oil paint and later grey and terracotta decorations
