Lambeth Palace – Great Hall

Architectural Paint Investigation

Introduction

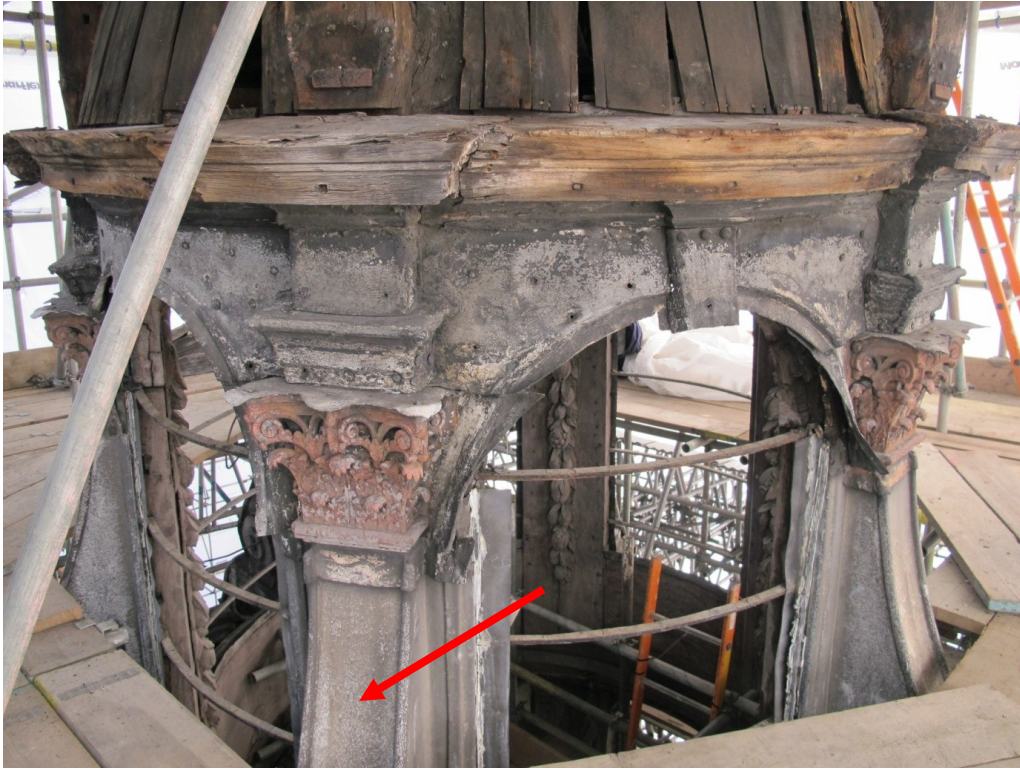
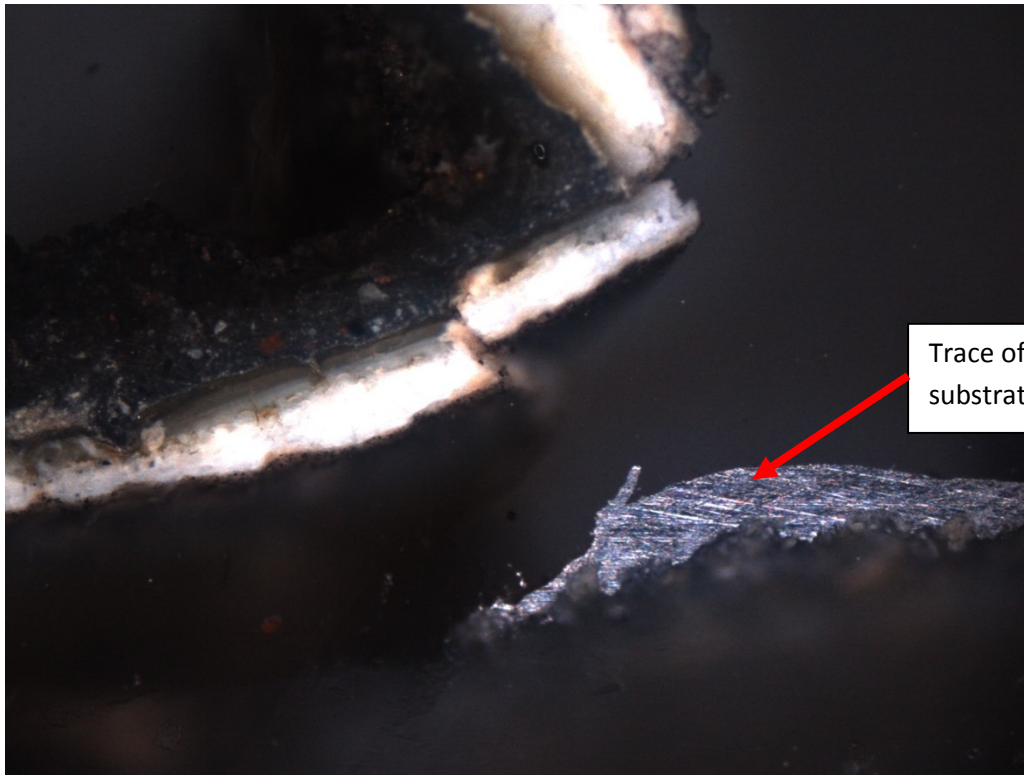
Sample 9 Location – Bed of pilaster

Figure 28 Cross-section Sample 9 - White oil paint on lead

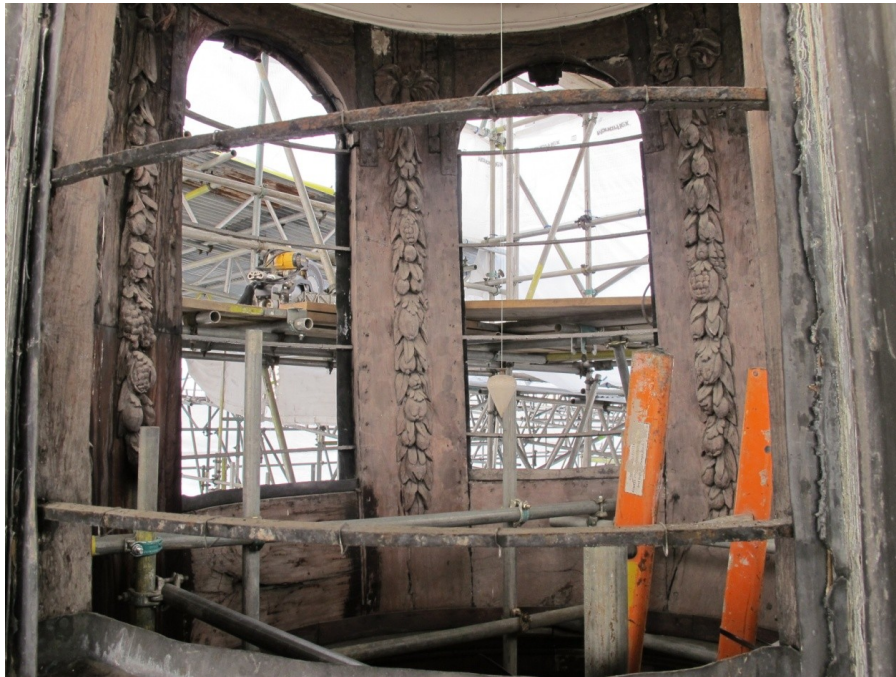
The interior of the cupola is made of wood. Sections of the west side have been replaced - presumably as part of the post-WWII renovations. The carving of the replacement sections lack the detailing of the original foliate swags. On close examination it is evident that the original wooden lining panels, the carved foliate swags and carved grotesque masks, have been stripped but still retain traces of accumulated paint.

Figure 29 Interior of the Cupola – Upper tier Foliate swags between the windows

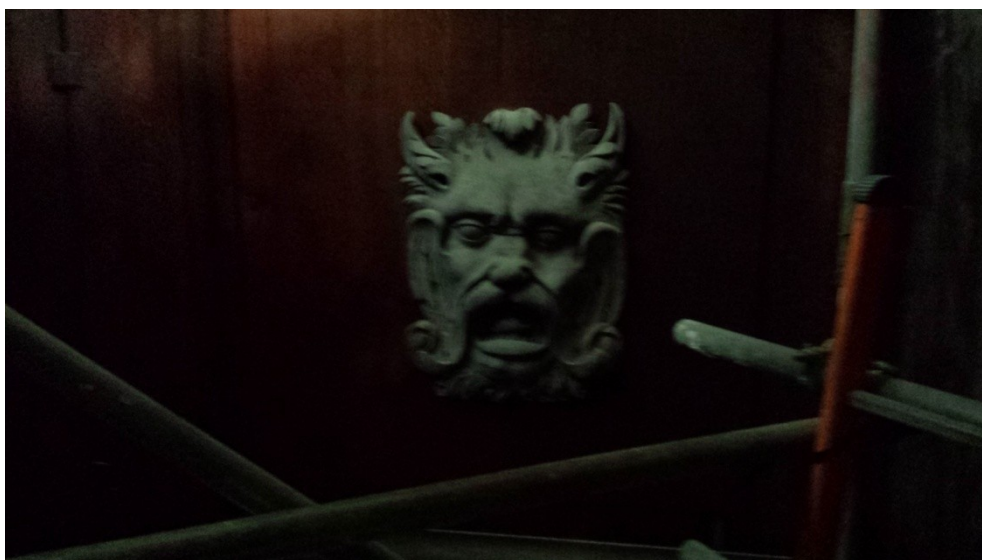
Figure 30 Interior of Cupola - Lower tier Grotesque Masks on replacement panelling.

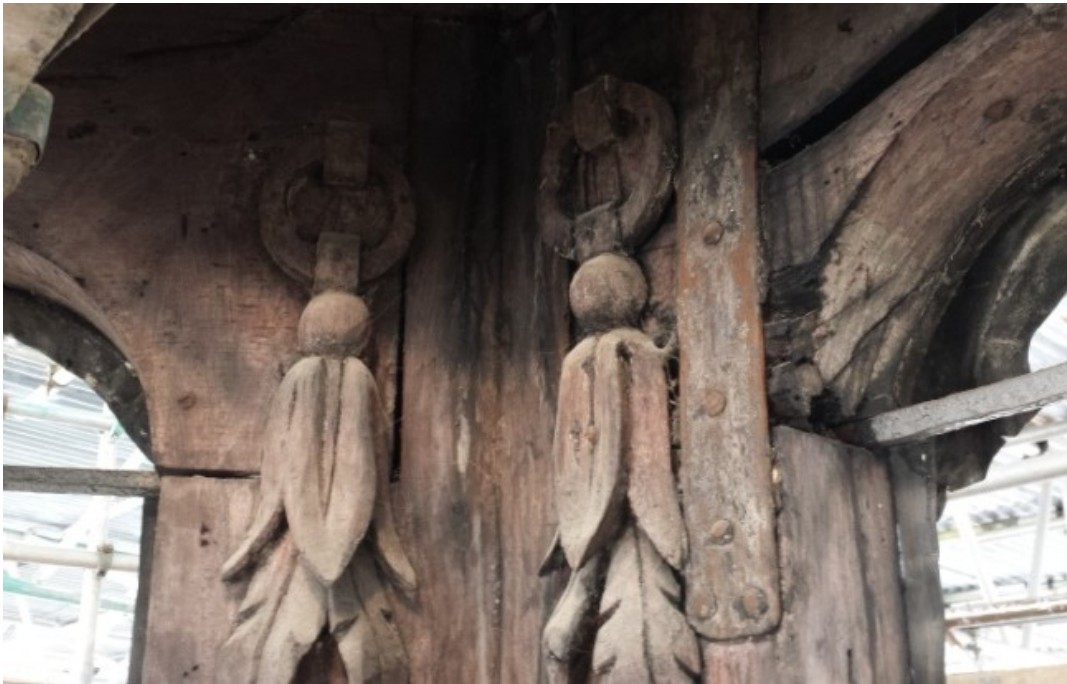
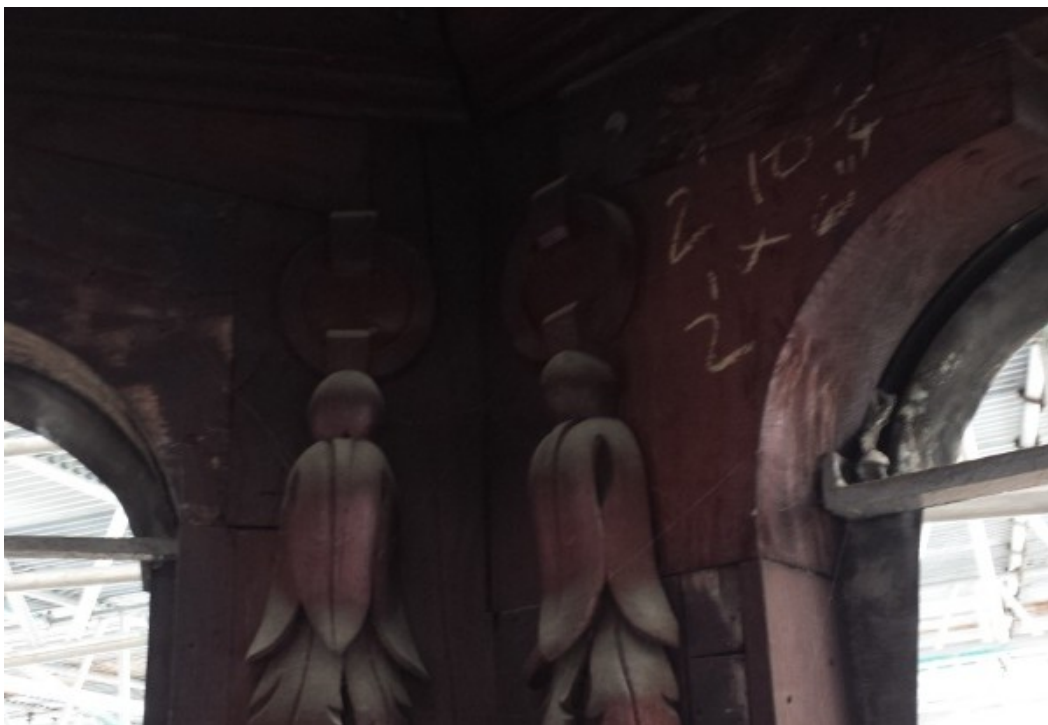
It seems probable that when the post WWII renovations were carried out and the new panelling was installed, an attempt was made **to remove all of the historic paint** applied to the original woodwork. This action was carried out due to the false assumption that the wood had not been painted originally. The new sections of wood were left unpainted – matching the stripped wood of the original elements. **The interior of the cupola was originally painted white.**

Figure 31 Sections of replacement joinery – western side

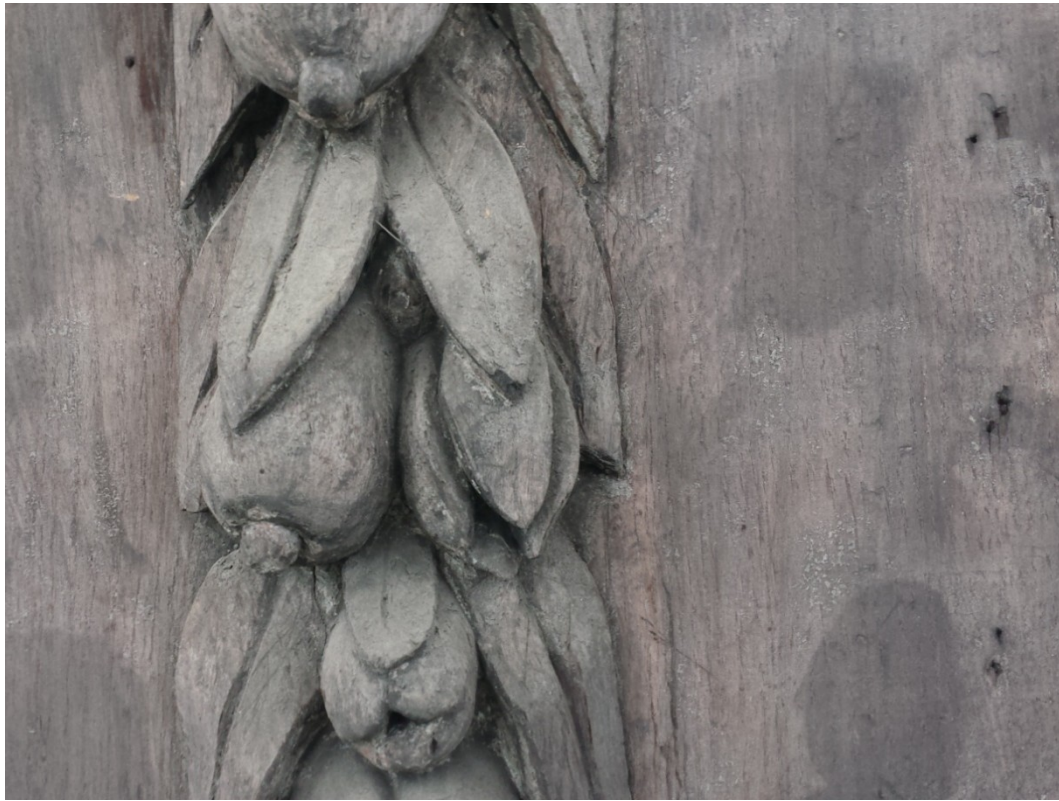
Figure 32 Interior of Cupola - Original joinery - stripped but traces of original paint are retained in mouldings

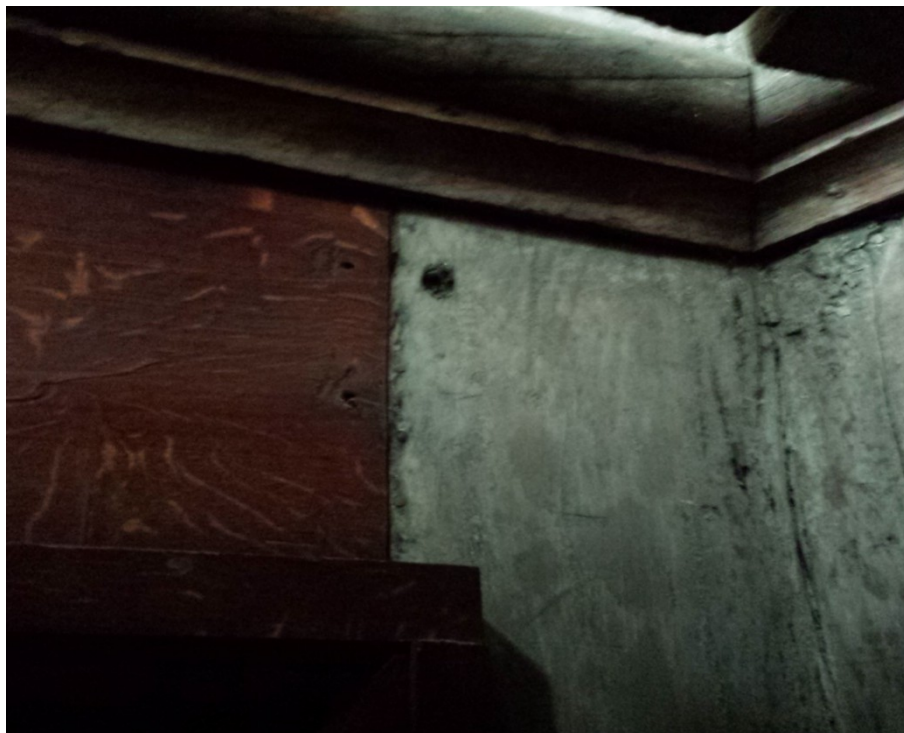
Figure 33 Interior Cupola – Junction of stripped original and replacement joinery - not painted

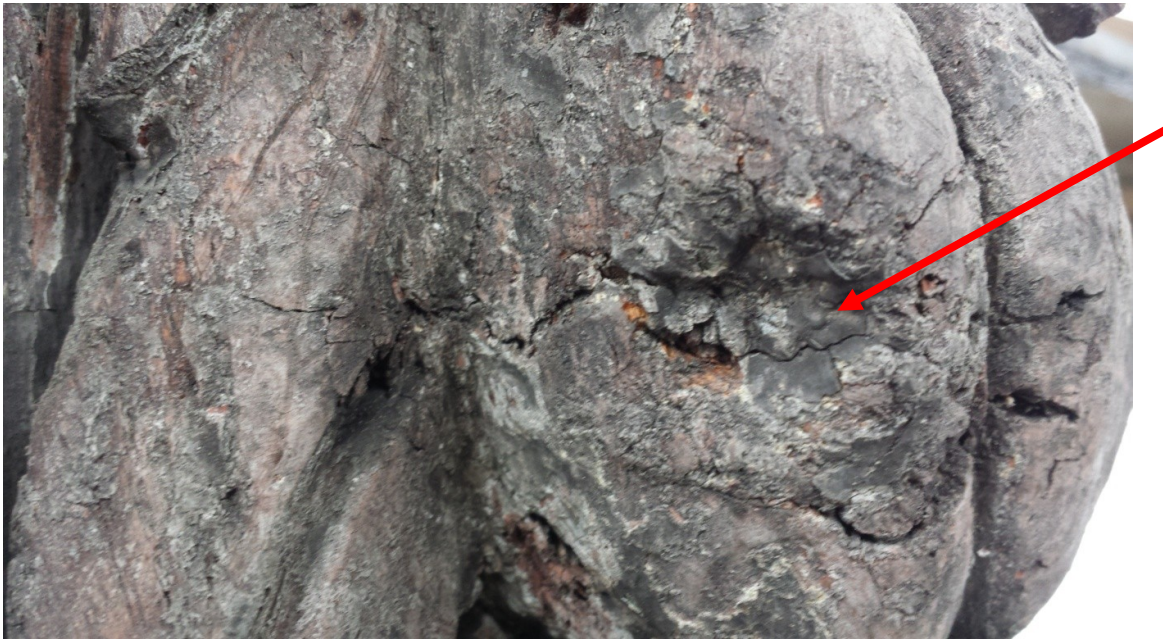
However traces of the successive decorations were retained in the recesses of the carvings and the ground behind the foliate swags. Examination of paint samples mounted in cross-section confirms that the interior of the cupola - like the exterior - had been **originally painted decorated in white coloured oil paint** but that these paint layers had been stripped off. (See below) . It is suggested that like the exterior the interior was intended to imitate dressed and carved stone . It would have been inappropriate to have left the wood in the late seventeenth century.

Figure 34 Cupola Upper Tier – Foliate relief -traces of early decorations

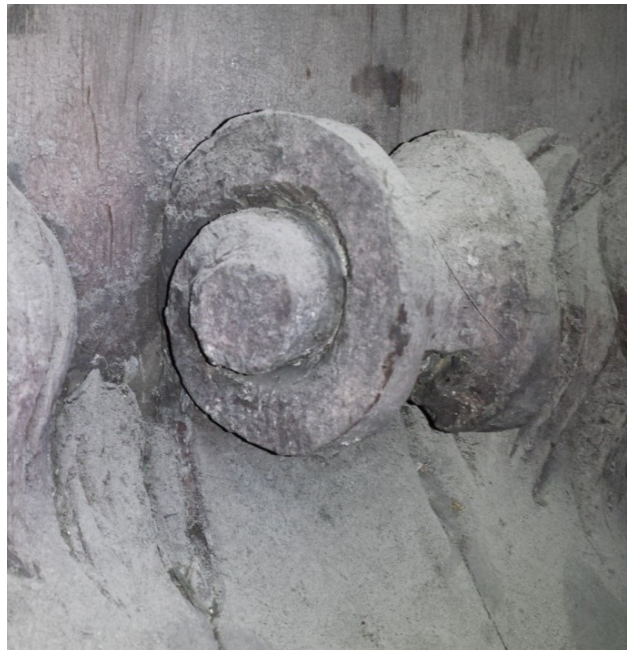
Figure 35 Cupola Lower Tier - Grotesque Mask - traces of early decorations

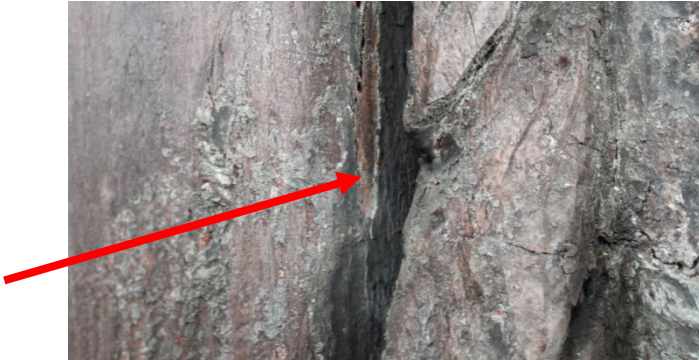
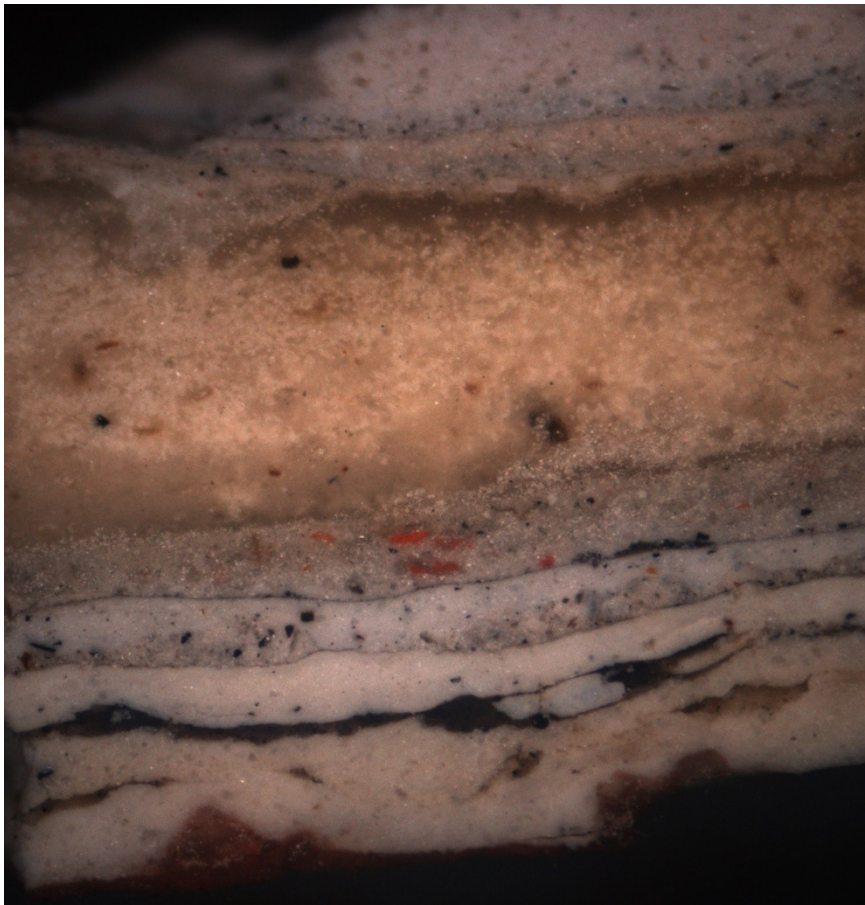
Locations Sample 5 Background

Later decorations in cream and broken whites

White on red primer

Detail of Original Red Primer

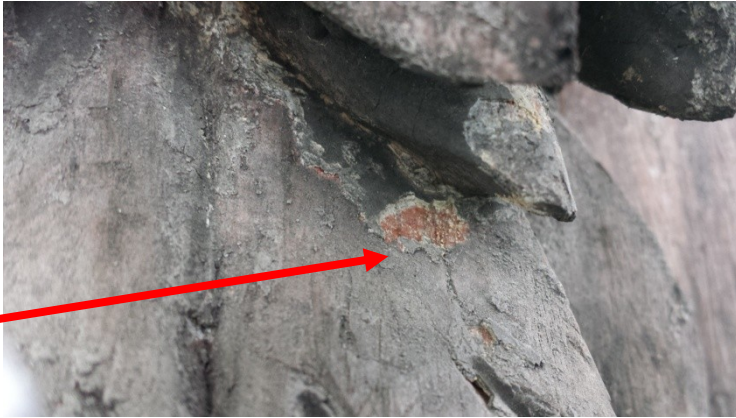
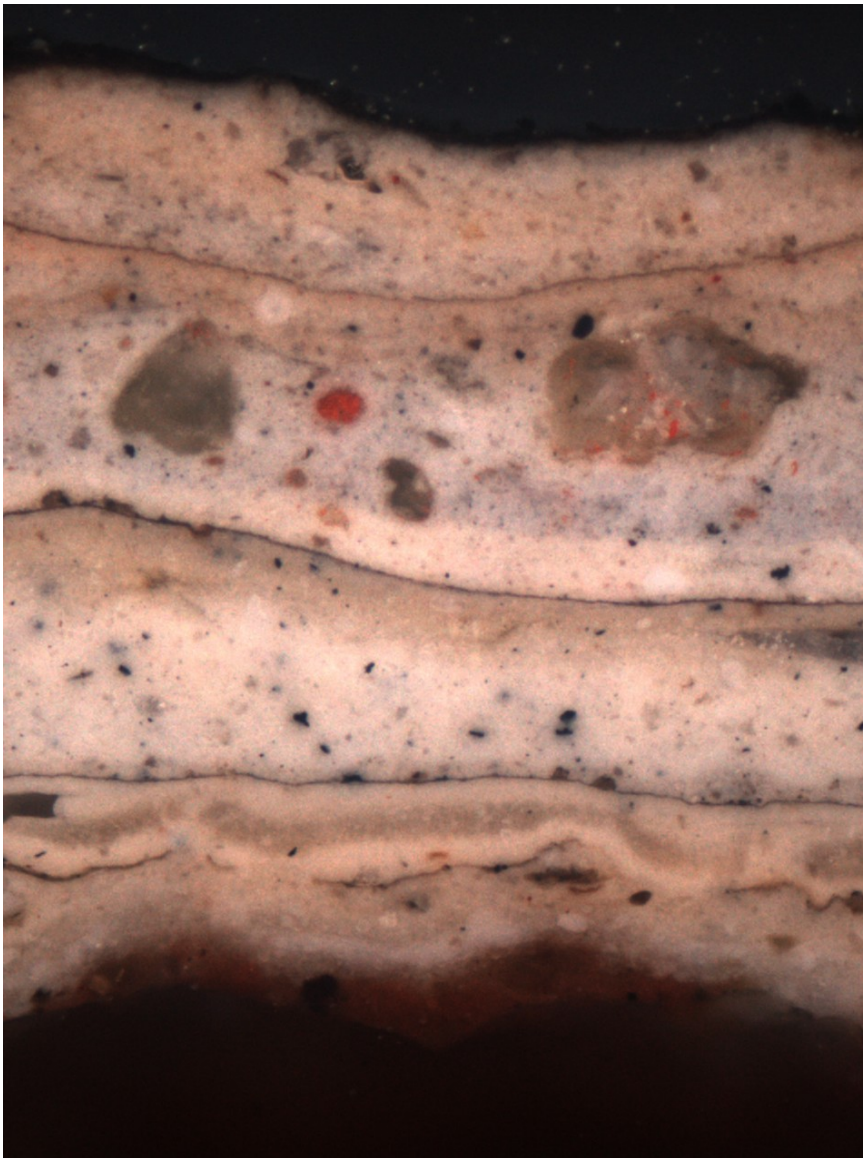
Sample 7 Carved Relief SE Swag

Later decorations in cream and broken whites

White on red primer

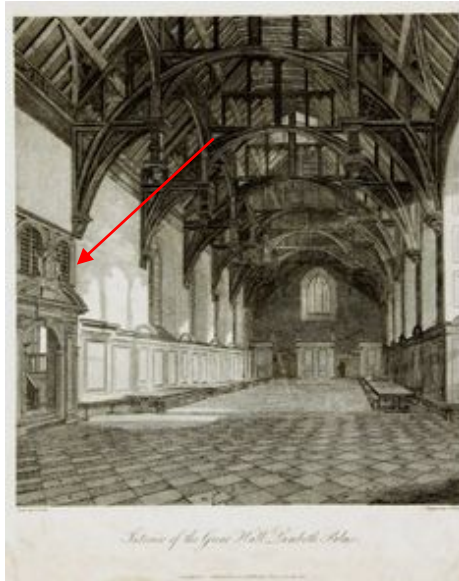
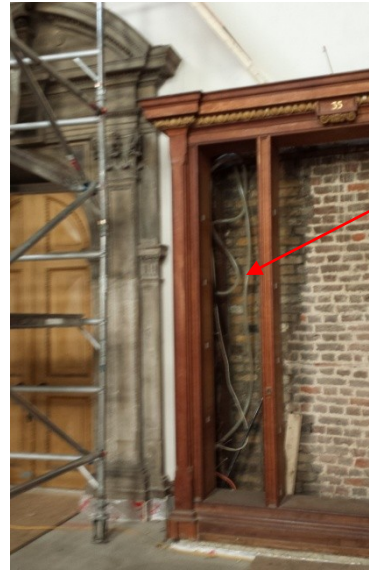
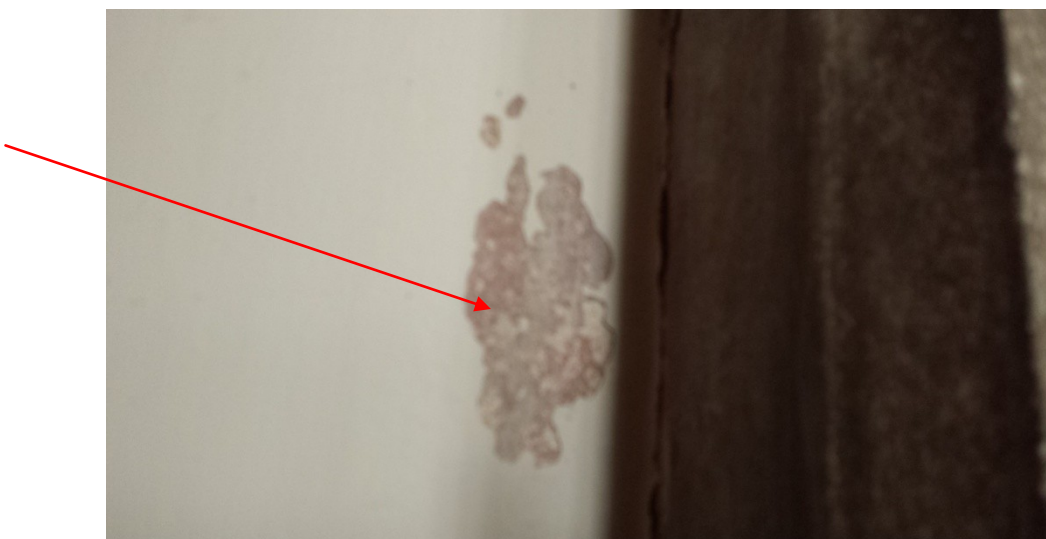
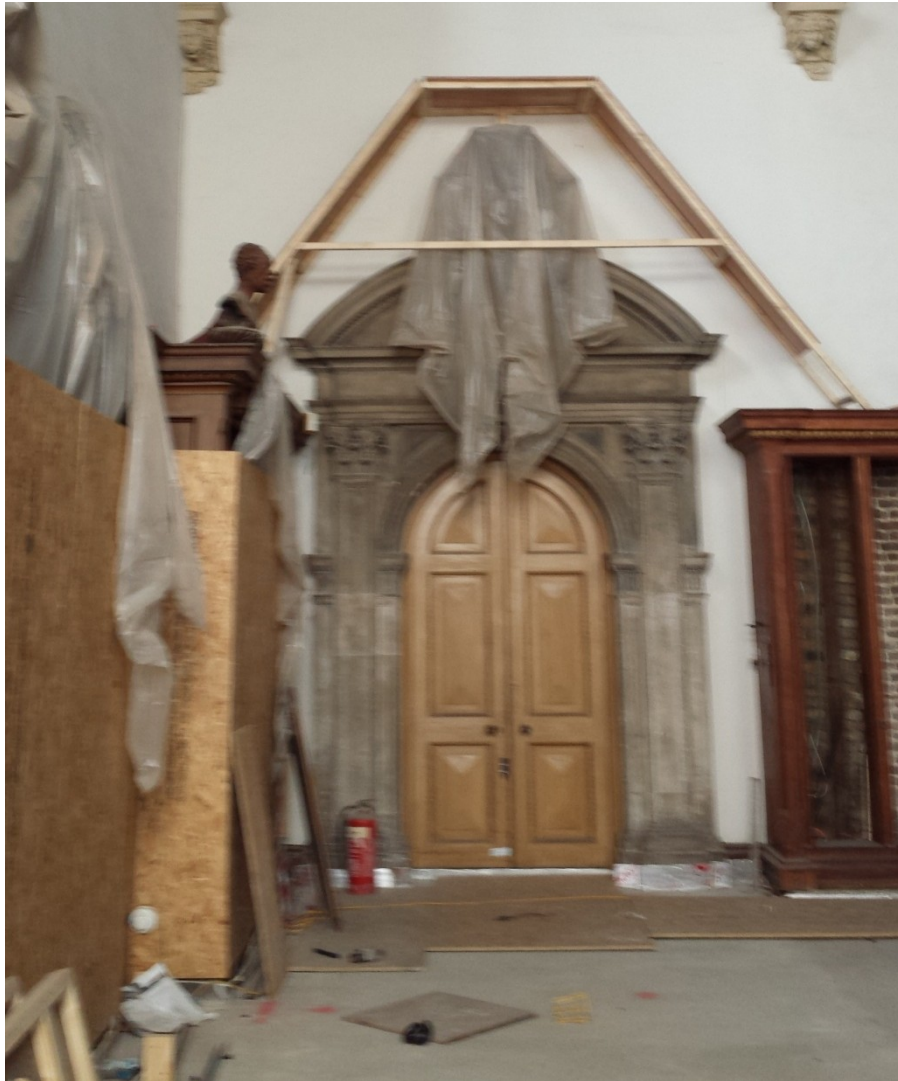
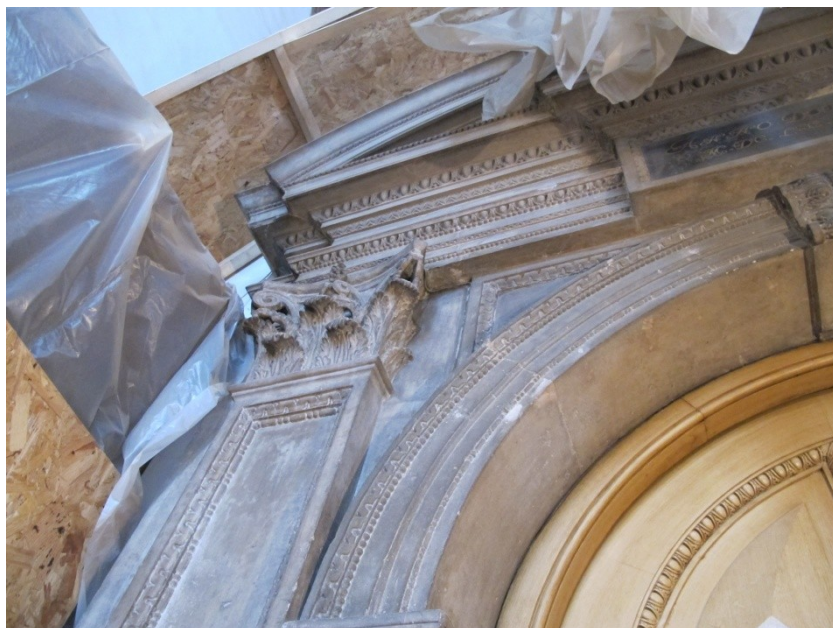
Figure 36 The Great Hall - The Italian Door Architrave

The Italianate Door Architrave is located in the eastern end of the south wall. It has been noted that does not match the rest of the fittings in the Great Hall – suggesting that the design of the room was modified as the Great Hall was built. An early view of the room (c.1800) indicates that the doorway was surmounted by a window. This feature was probably removed or blocked by Blore during the 1830s alterations

Examination of the walls surrounding the stone architraves revealed that the wall plaster above and to the right of the door architrave has been recently replaced. But the plaster to the left of the architrave retains early plaster and traces of a red/pink paint and a translucent grey/green paint. NB The translucent grey/green paint was also found on the stone architrave and sections of plaster on the North Wall.

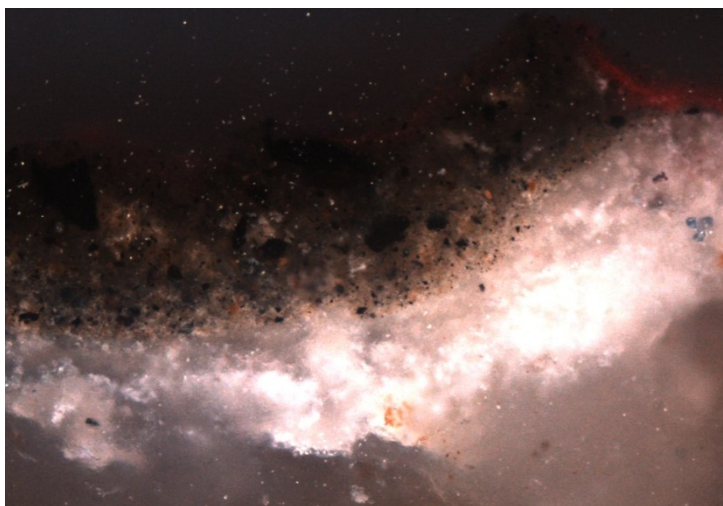
Trace of Red/Pink Paint

Translucent Green/Grey paint

Plaster

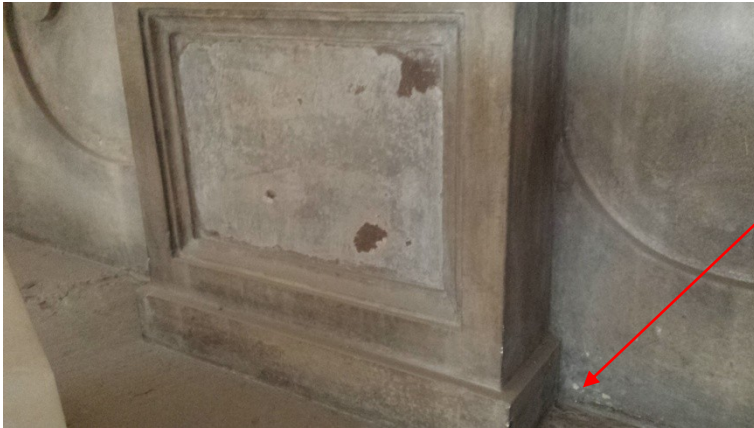
Italian Door Architrave – Dressed stone

Grey/Green Translucent Paint

Contains coarse Black and yellow pigment particles and is consistent in appearance to paints applied in the late 17th century.

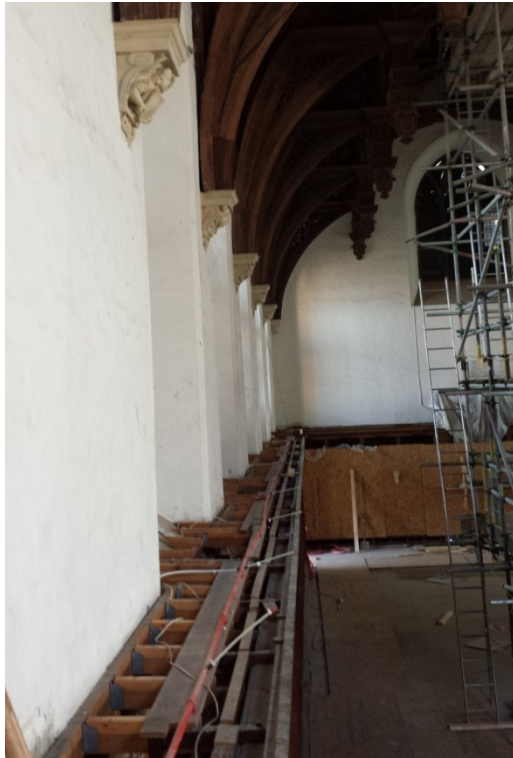
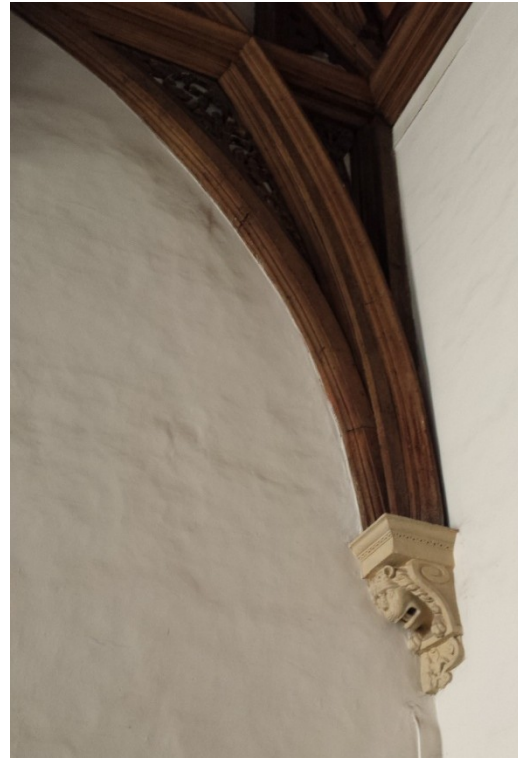
The walls of the Great Hall are built of brick covered with plaster. The original plaster has been stripped from wall faces behind the bookcases (by Blore) but traces of this early hair bound plaster were discovered behind the bookcases on the northern wall. These bore layers of paint.

Figure 37 Geat Hall - Detail sof wall plaster

The brick walls were originally plastered in horse-hair plaster. Traces of a **translucent green/grey containing coarsely pigment particles** were found on the surface of the plaster. This paint probably dates from the 17th century.

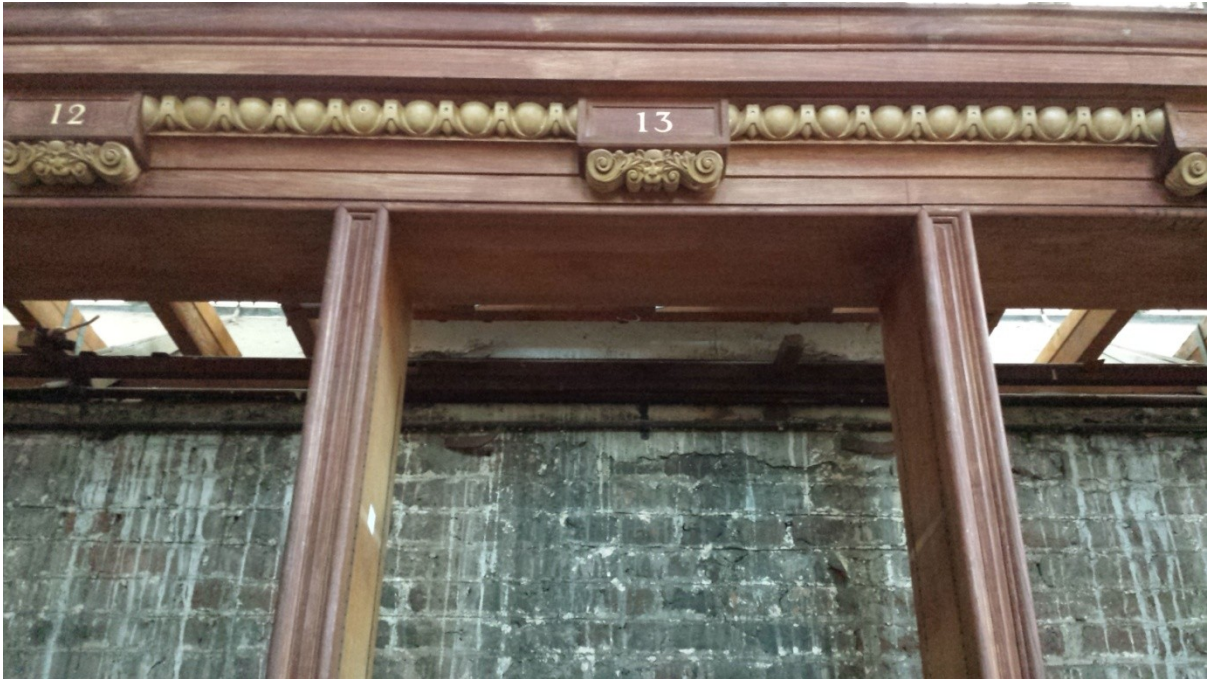
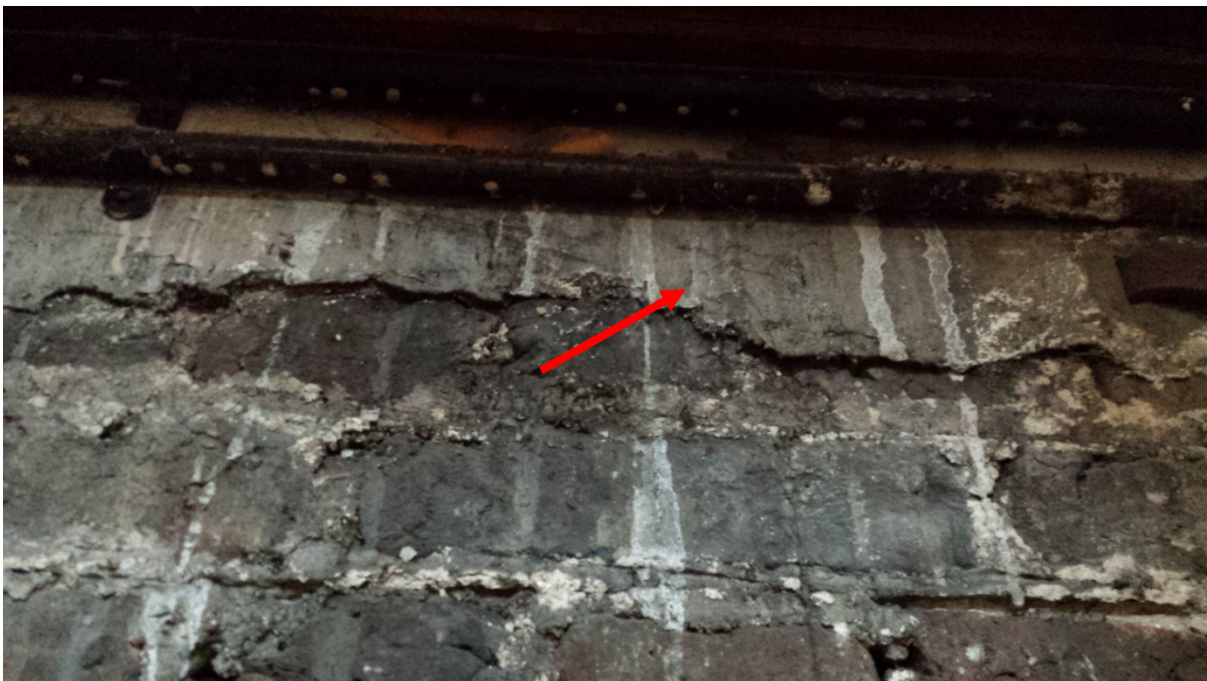
Traces of plaster of pre-1830s plaster and paint finishes are retained behind the bookcases. Analysis of the plaster and paint revealed traces of **horse hair plaster and early late 17th century translucent paint or colour washes.**

Figure 38 North wall - Bookcase 13 - traces of early plaster and paint

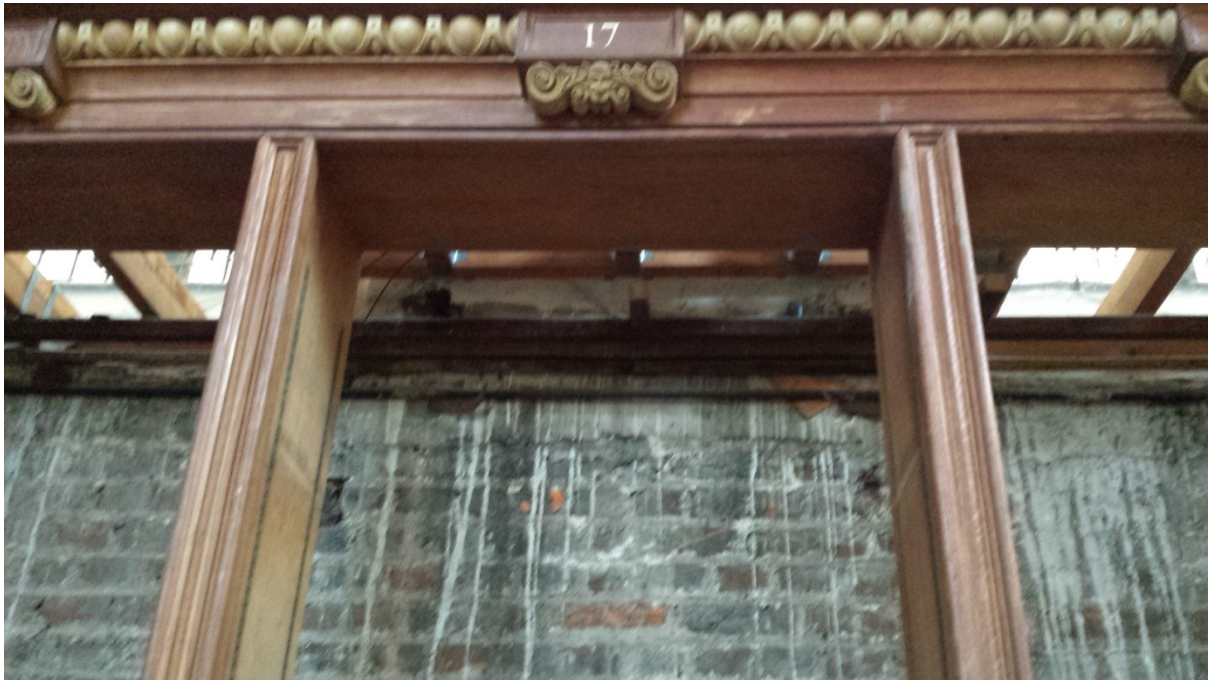
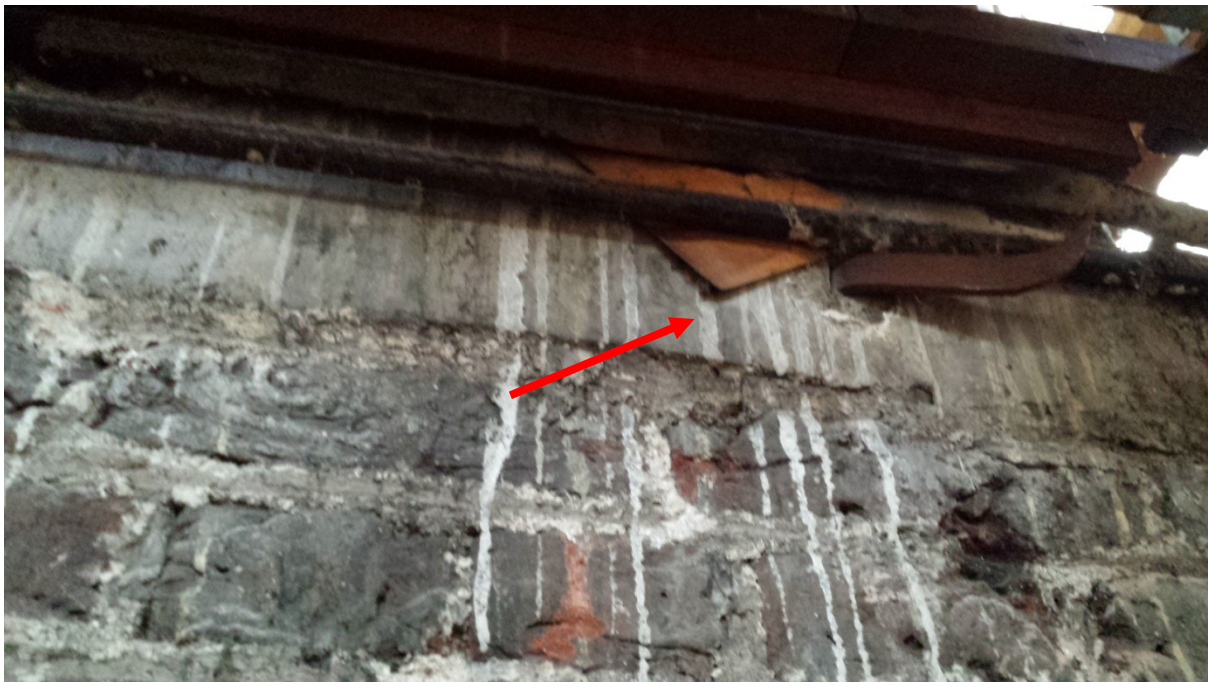
Figure 39 North wall - Bookcase 17 - traces of plaster and paint

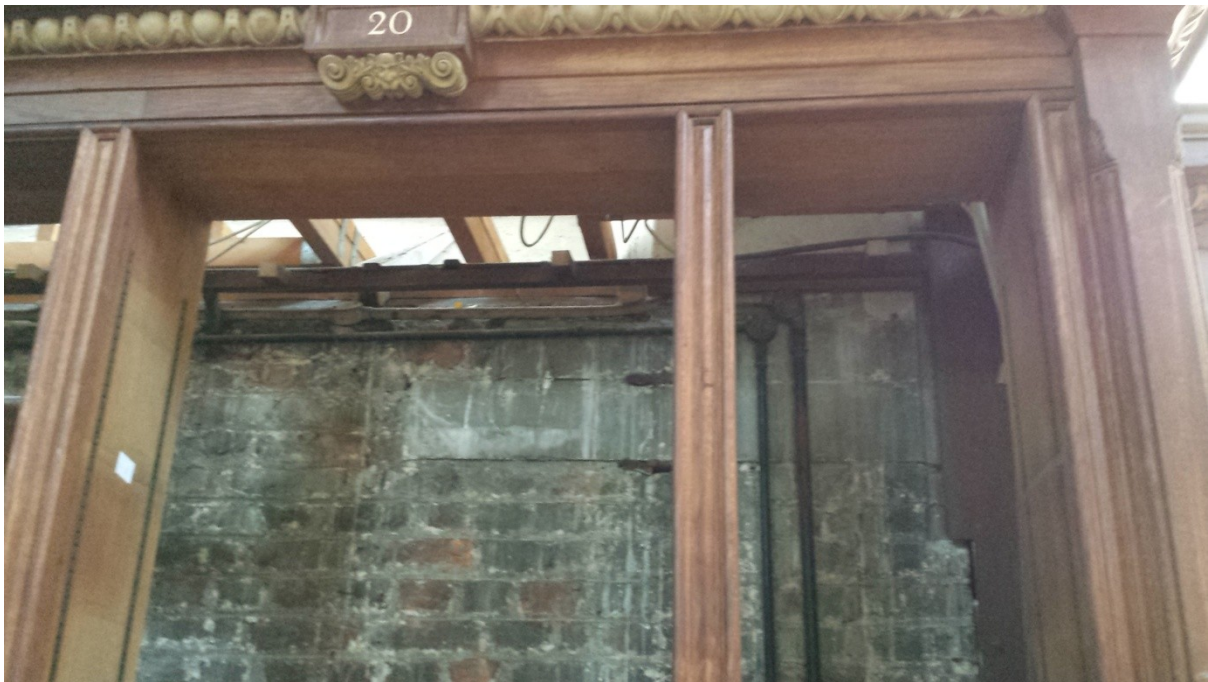
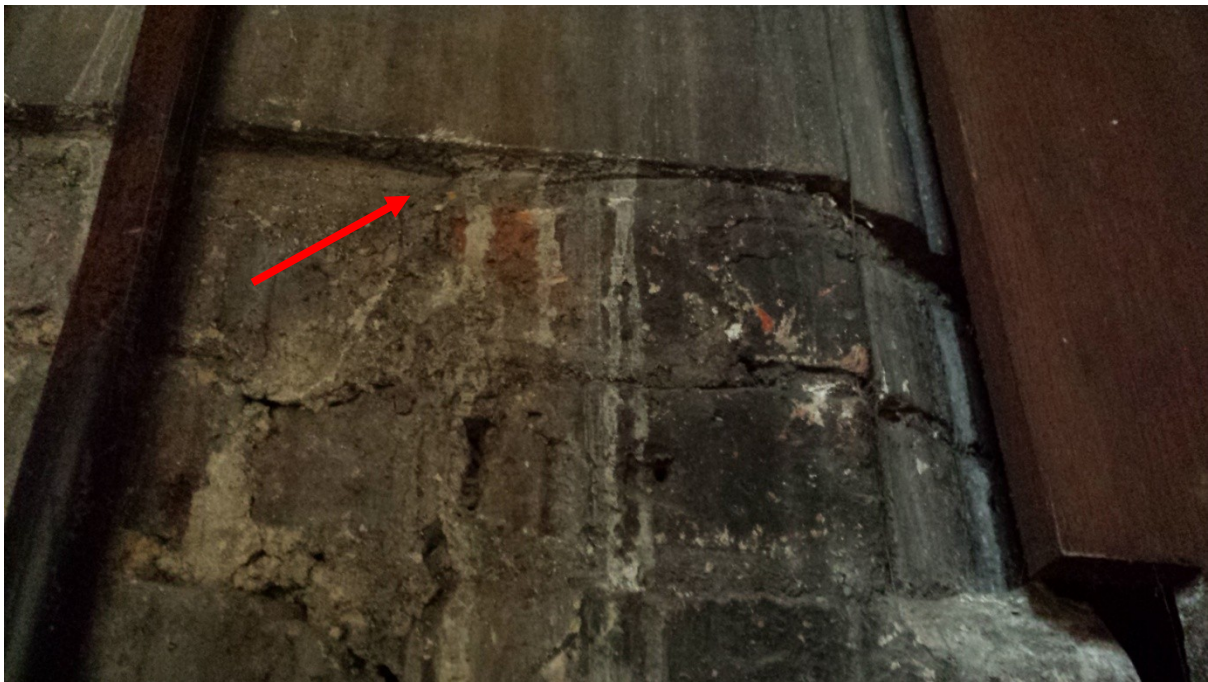
Figure 40 North Wall - Bookcase 20 - dressed stone, shaped bricks, and traces of plaster and paint

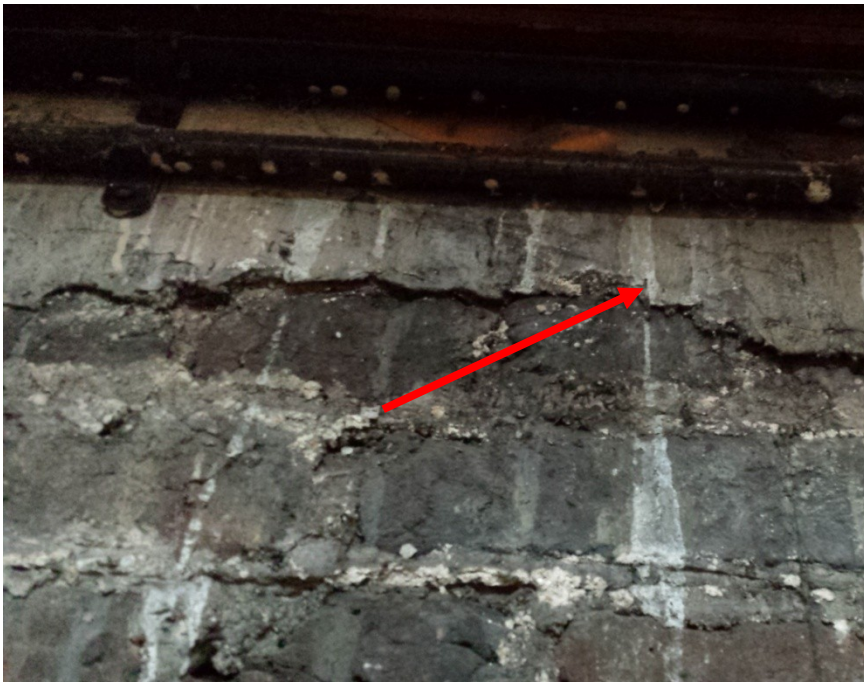
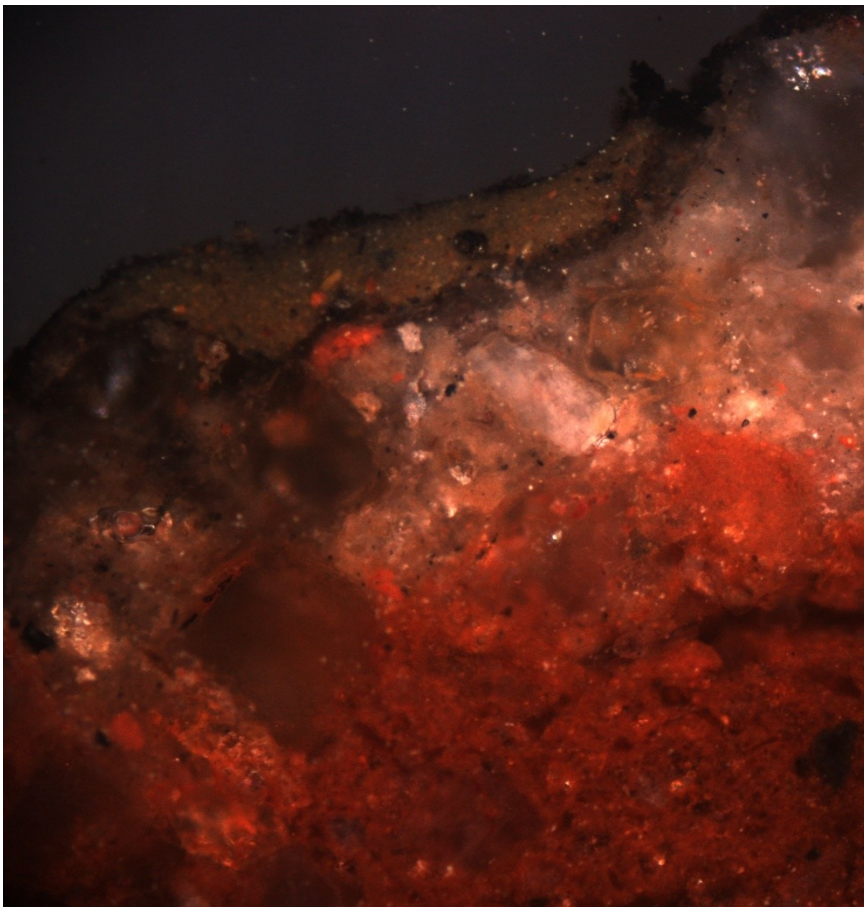
Location 13 – Traces of plaster on bricks (Pre-1830s)

Yellow Paint (translucent 17th century type)

Grey Paint (Translucent 17th century type)

Plaster

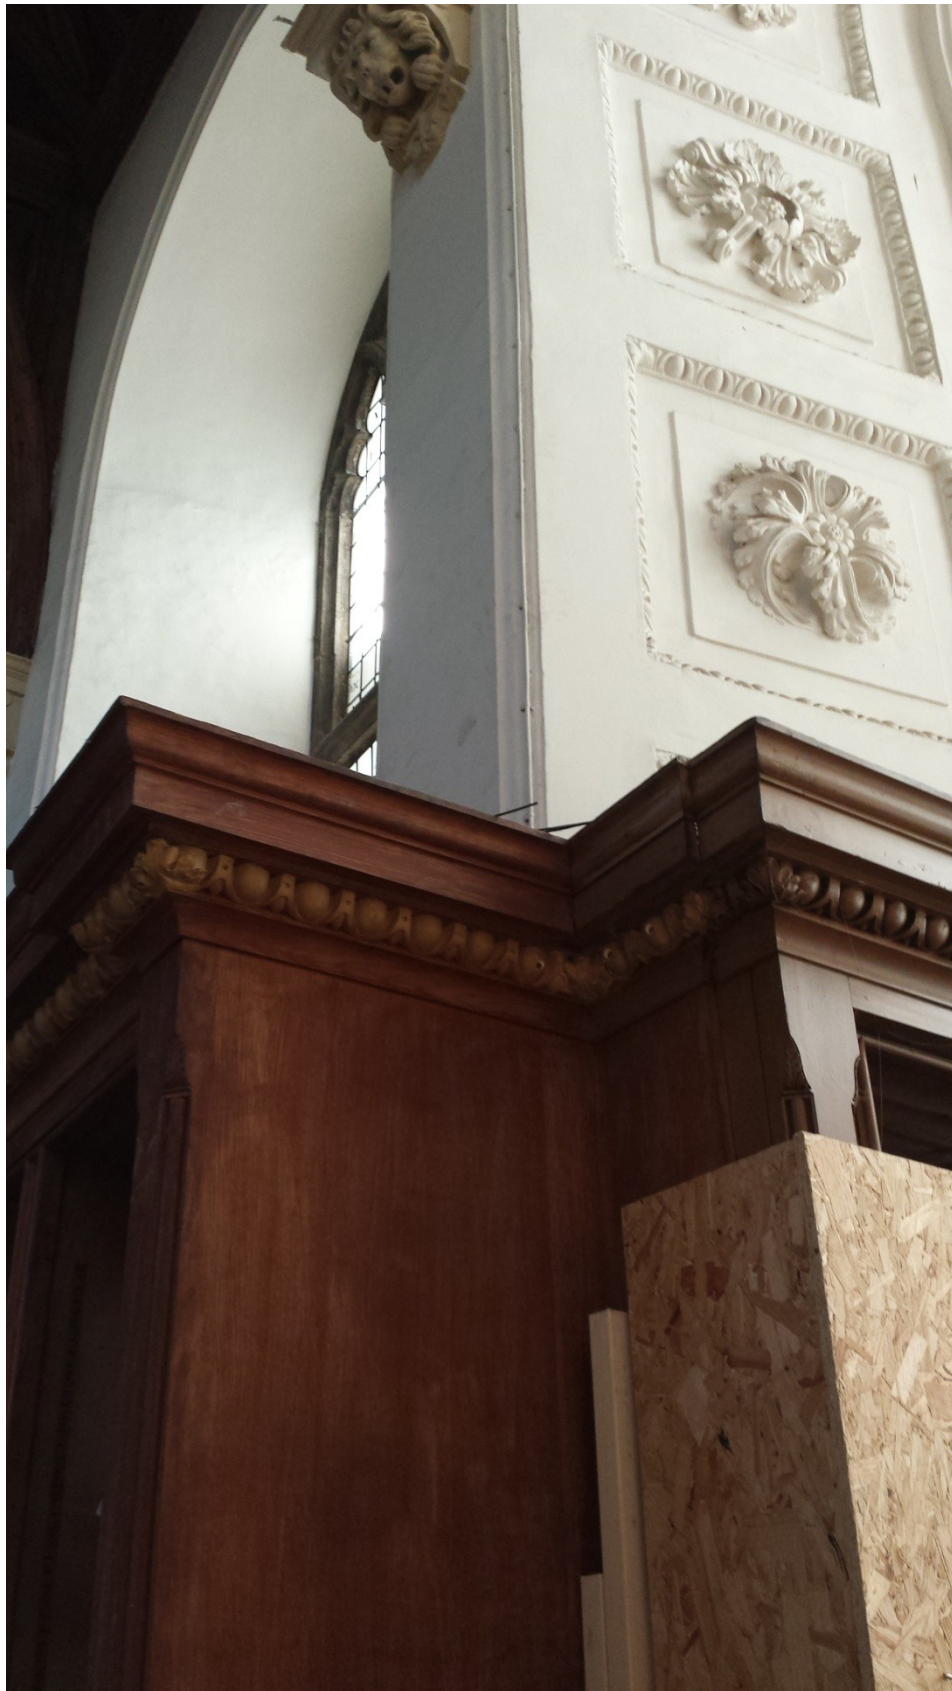
Figure 41 Junction of North Wall & NE Window Bay

The junction between the moulding of the window reveal architrave and the brick wall had been fitted with shaped bricks. Trace of horse hairplaster and early paint was found in this area. No access was available to remove samples from the moulded areas.

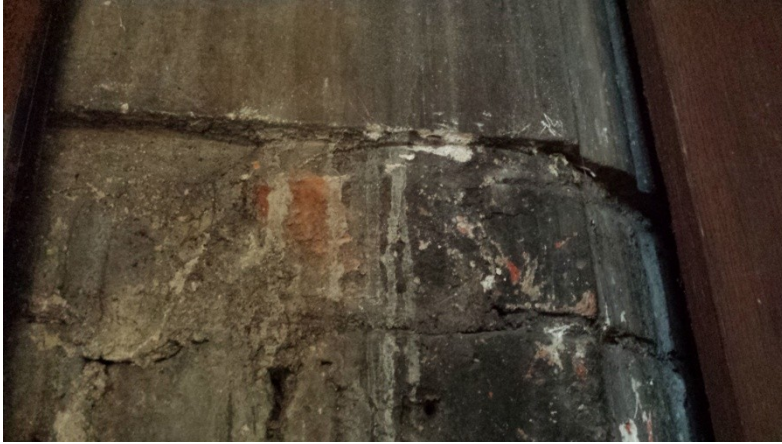
20A – Dressed Stone – with paint

Paint on stone

Stone

The junction between the moulding of the window reveal architrave and the brick wall had been fitted with shaped bricks. Traces of horse hair plaster and early paint were also found in this area. No access was available to remove samples from the higher moulded detailing of the window bay.
