Lambeth Palace – Great Hall

Architectural Paint Investigation

Introduction

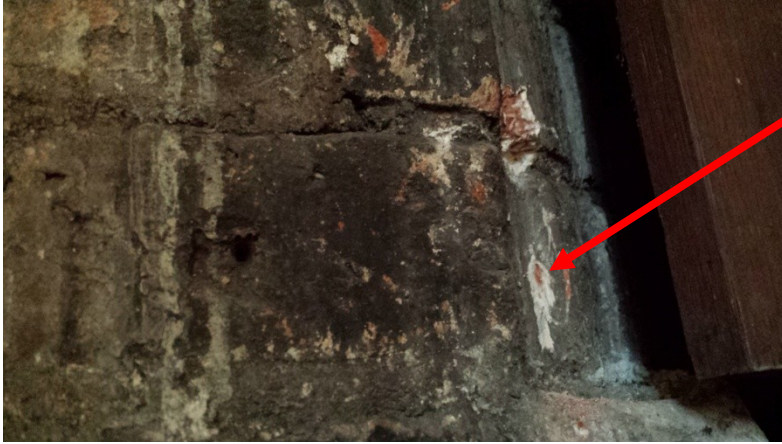
20C – Shaped stone – with paint

Surface Dirt

Plaster

The junction between the moulding of the window reveal architrave and the brick wall had been fitted with shaped bricks. Trace of horse hairplaster and early paint was found in this area. No access was available to remove samples from the moulded areas.

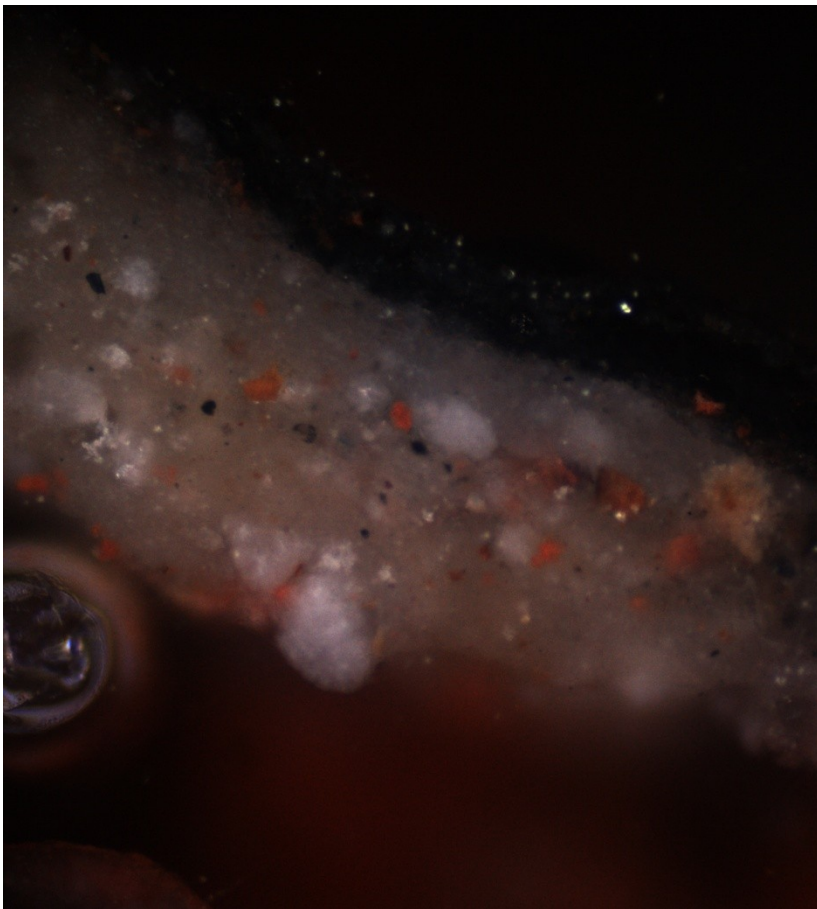
Shaped brick

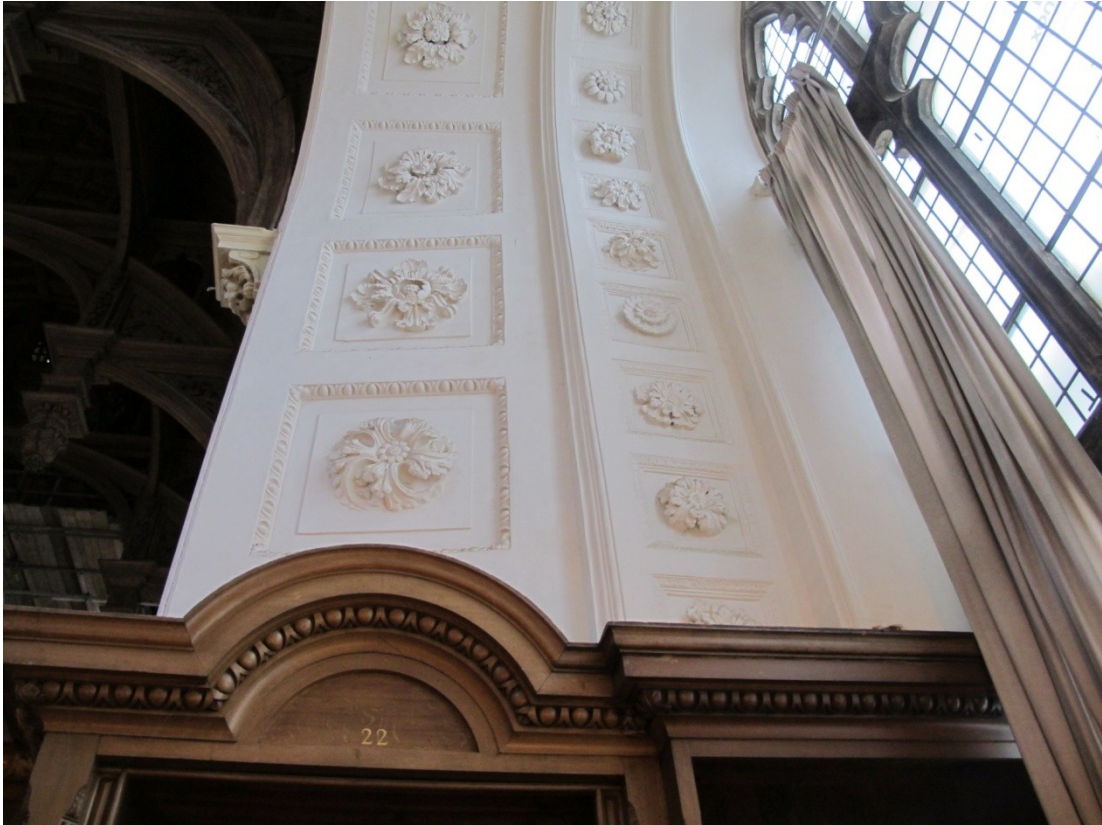
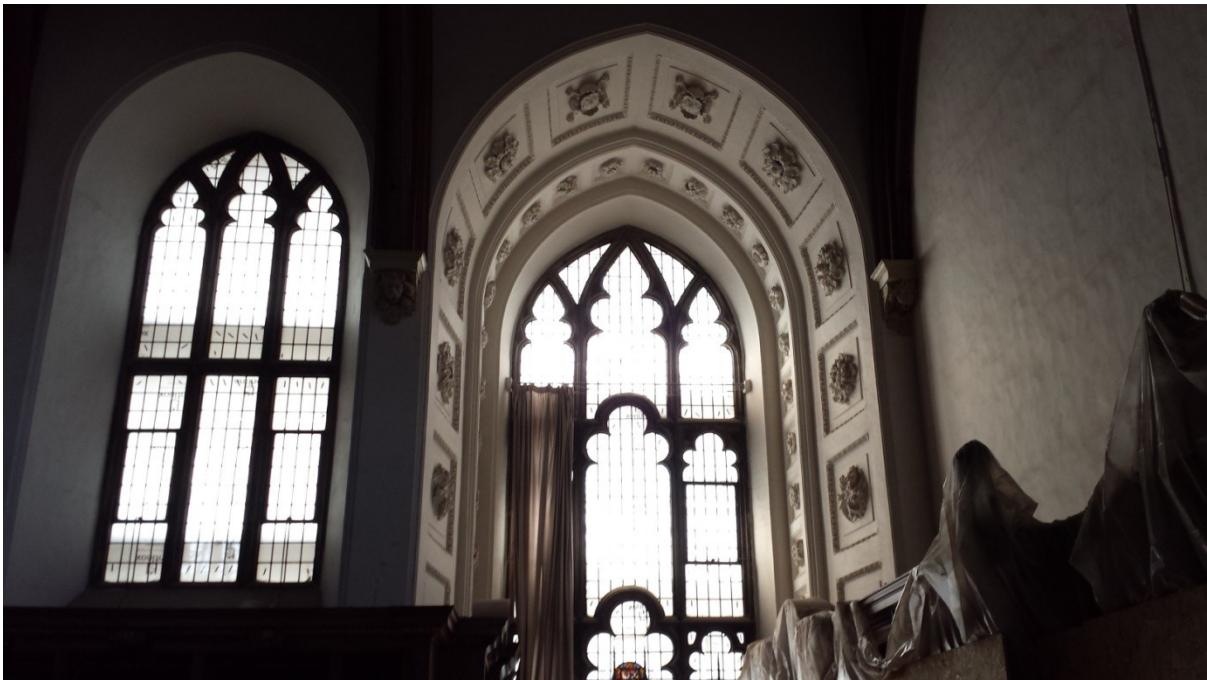
This element is part of the original design of the Great Hall. It was not possible to access the surface of the window reveal to remove samples of plaster and paint.

Figure 42 North East Window Reveal - Details
