Historic Interiors Research and Conservation

Arthur Road – No. 12

Investigation of Decorative Finishes (Exterior & Interiors)

August 2015

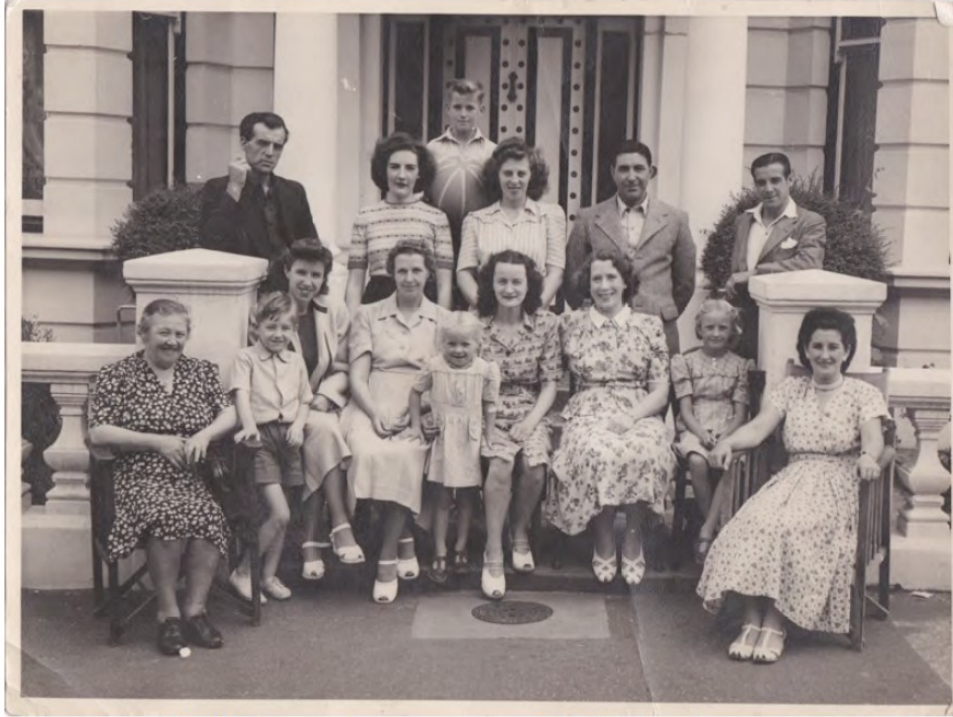
Undated photo (1950/60s?) showing the front elevation of No. 12 before changes were made to the front door. Photo from the collection of Emma Black.

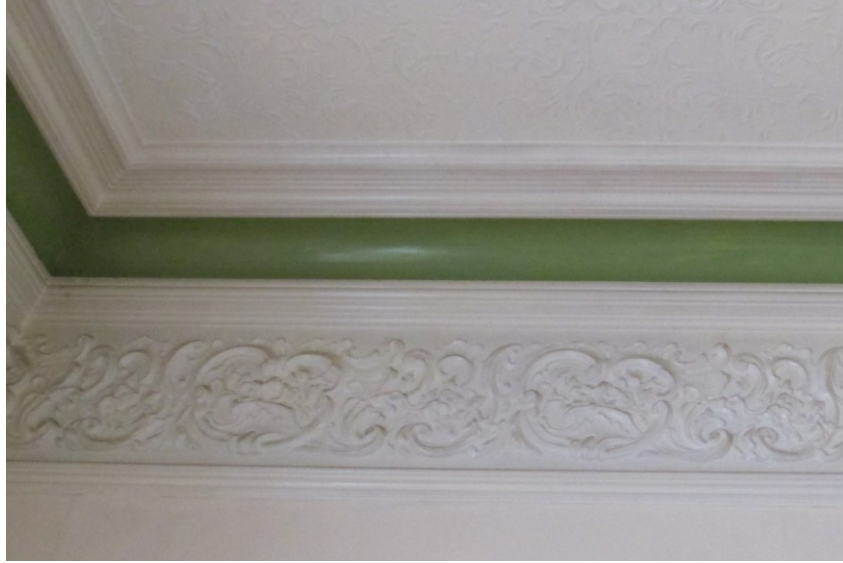
Figure 3 Rear Drawing Room (R0.03) - Detail of Frieze Anaglypta and an embossed ceiling paper

The decoration of the **Entrance Hall** and the **three Ground Floor Reception Rooms** of No.12 Margate were fitted with embossed ceiling and frieze wallpapers and provide an important example of middle class fashions c.1900 when the interiors were being fitted out. This style of interior decoration continued to be popular – indeed Lincrusta and Anaglypta are still available today.

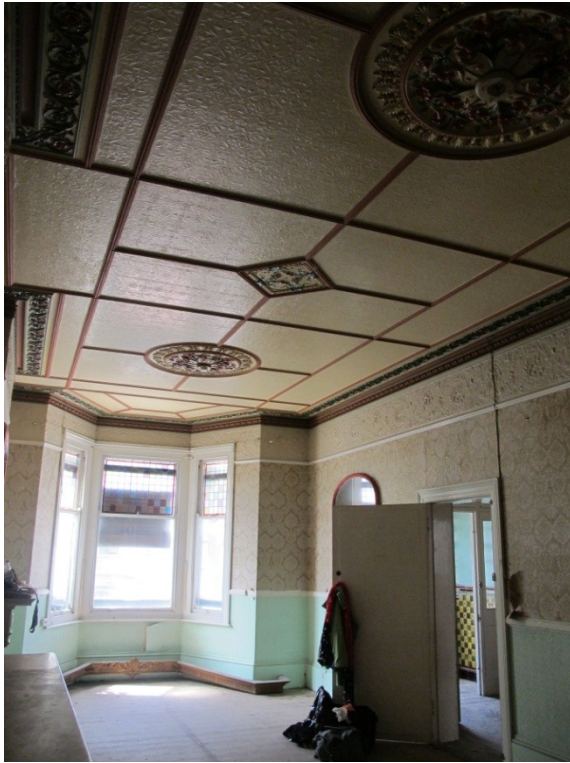
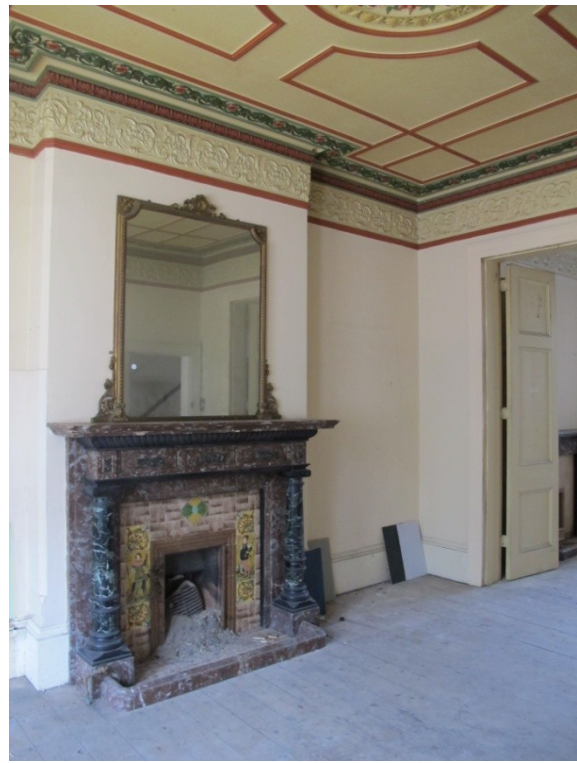
Figure 4 Main Reception Room (R0.01) & the Front Drawing Room (R0.02)

The rooms are fitted with plaster ceiling roses plaster ribs and an ornate foliate plaster borders and a small cornice. An embossed Anaglypta type paper has been applied to the ceiling bed and a high relief Anaglypta has been applied to the frieze area. The bottom of the frieze is bordered with a wooden moulding which was originally grained in imitation of a hardwood (light oak).

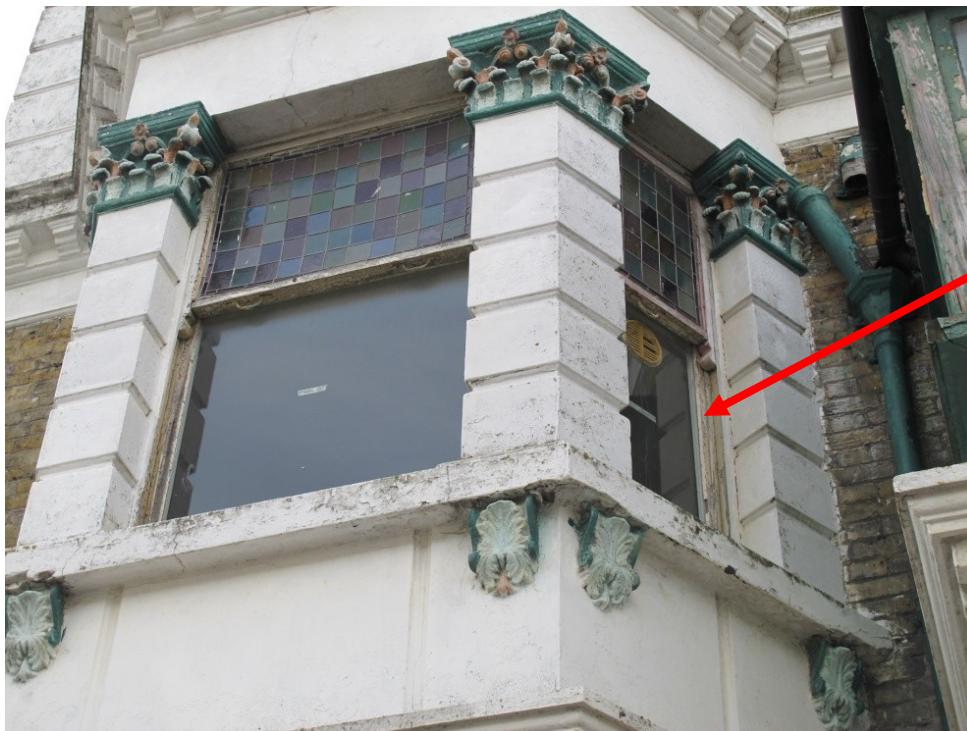
Figure 6 First Floor External Windows - Windows and window frames repeatedly grained in imitation of hardwood

From the 1820s it became fashionable to decorate elements of joinery in imitation of hardwood. Developments in glazes used for producing fictive wood graining had advanced by this period and decorators could produce highly sophisticated imitations of a wide range of hard woods such as mahogany, walnut, bird's eye-maple and oak. Light oak became a popular alternative to plain white or cream oil paint finishes for the decoration of all elements of joinery throughout the remainder of the 19th century and the early 20th century – eventually going out of fashion during the 1950s.

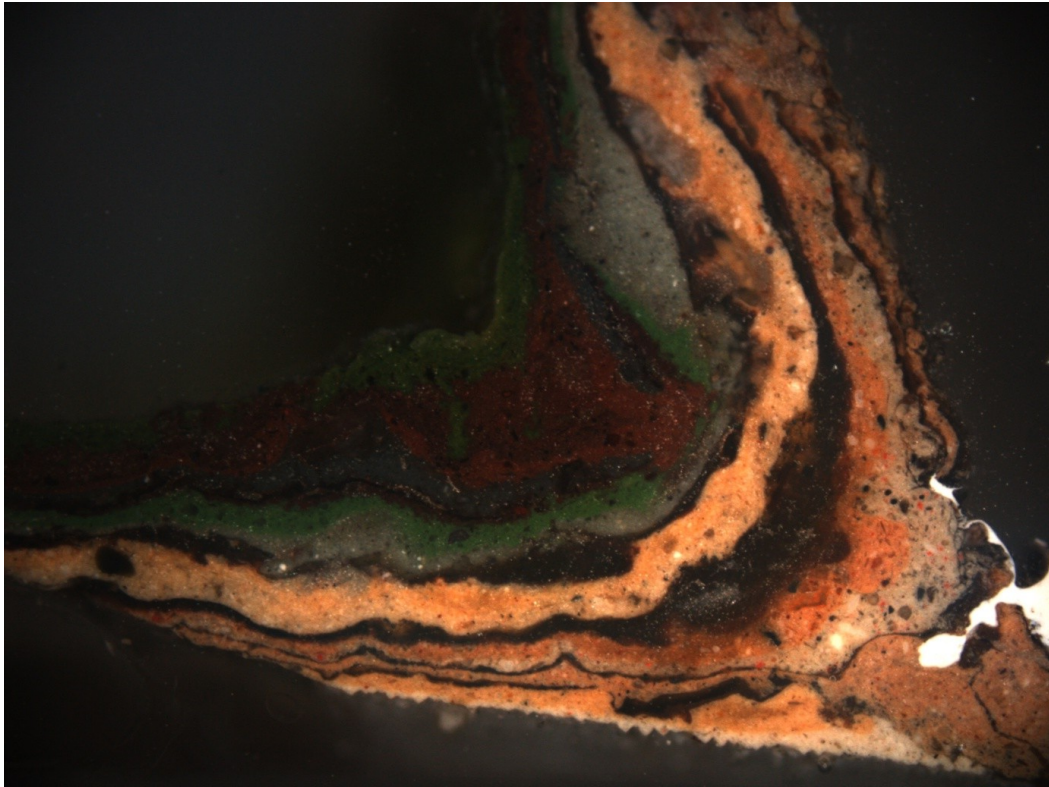
Figure 7 Cross -section of paint sample 102 - Four grained decorations at early levels – Later green decorations

The distinctive layers of painted grained decorations and the protective varnish layers are readily identifiable in cross-section under high magnification. When viewed under ultra-violet illumination these varnish layers appear as a white milky coloured layers. The zinc-based paints (used during the 1930s) can also be identified under ultra—violet illumination by the bright sparkling of the zinc pigment particles.

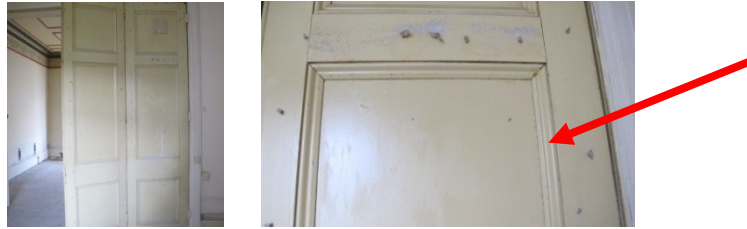
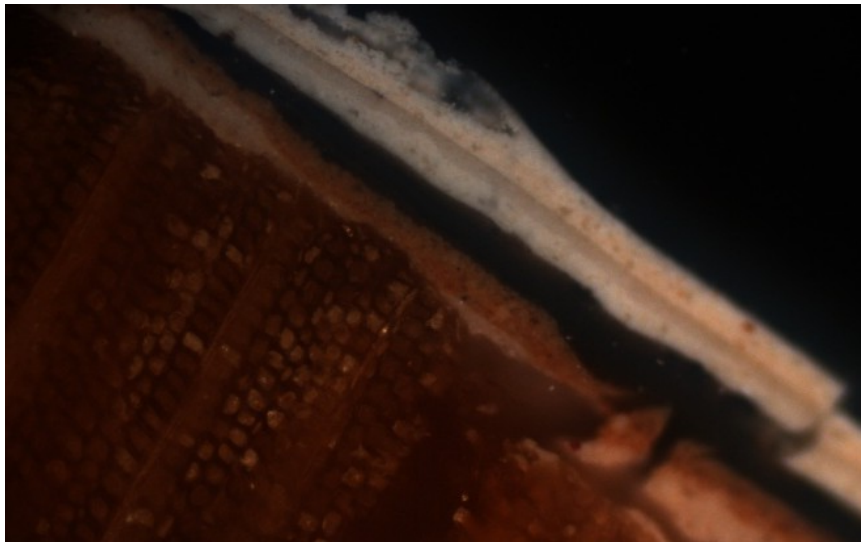
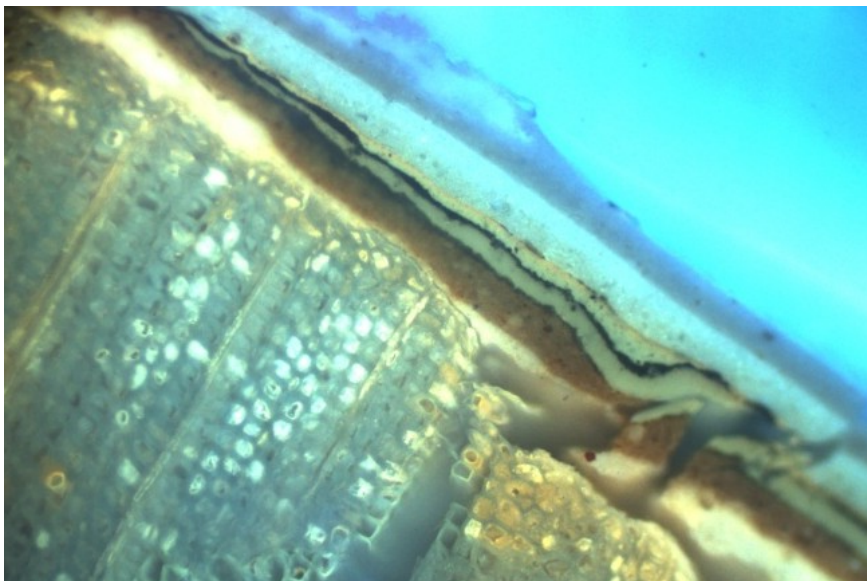
Figure 9 Folding Door between R0.02 & R0.03 - Cross-section sample 32 Original graining over painted c.1950 and then boarded over during the 1960s

The folding doors dividing the two northern Drawing Rooms retain (beneath later paint layers) substantial remains of the original grained decoration which was applied to all of the joinery (window frames, window sashes, doors, door archtraves, skirtings and staircases). **The extensive fictive graining in imitation of a light oak would have been a very distinctive feature of the interiors of 12 Arthur Road from c.1900 until the 1950s graining.** The early grained decorations when worn and dirty had been revarnished to revitalise an existing grained scheme .

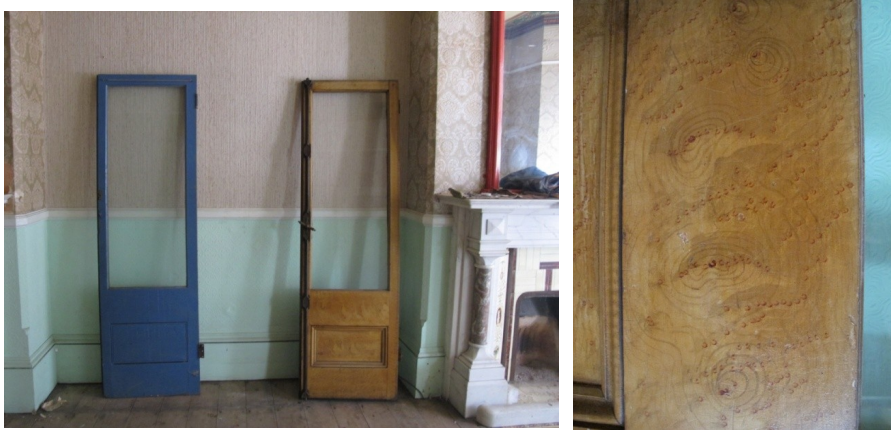
Figure 10 French Windows - High quality c.1950s grained decoration not over painted

An example of very high quality graining has survived on the face of the French windows which lead to the Long Room (R0.06). Paint analysis has established that these doors – unlike all the other joinery elements within the house were not grained but repeatedly decorated in white. The distinctive grained decoration was probably applied in the 1950s. Some elements of replaced doors and windows were grained at this period.

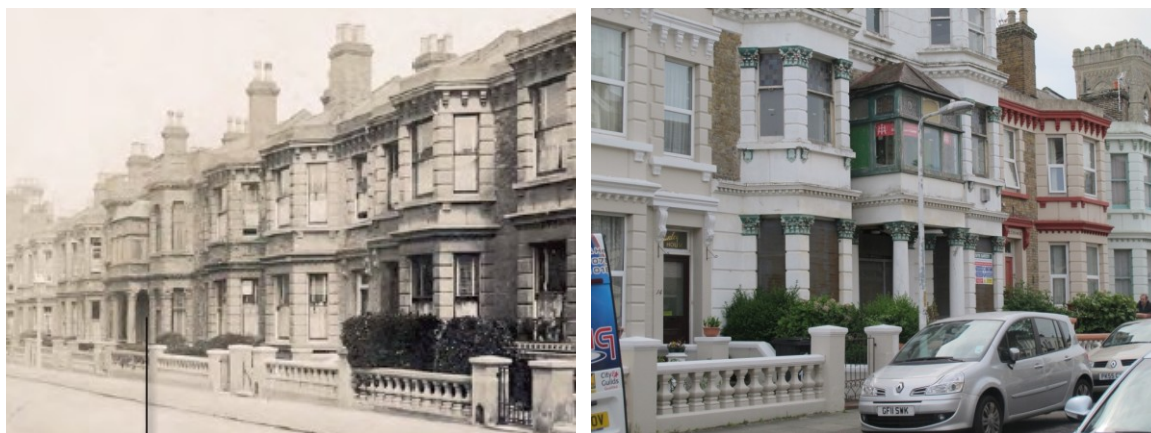
Figure 12 12 Arthur Road before the 1930s extension was added & existing appearance 2015

Paints for use on the exterior of houses has developed since No12 Arthur Road was first built. The bright white titanium based paints which now dominate the facades of the houses in the street is the product of post WWII developments.

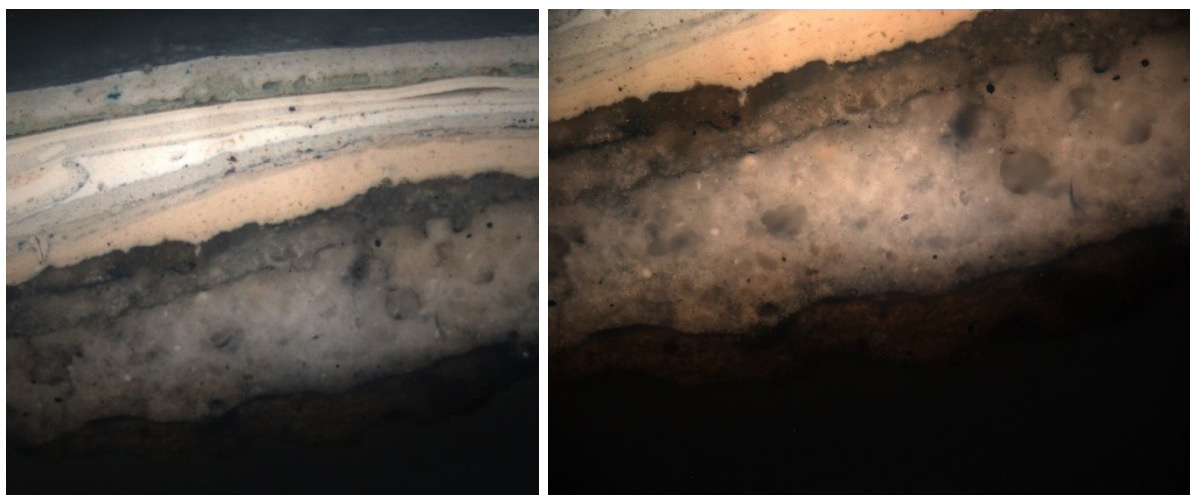
Figure 13 Cross-section of sample 97 - Original mid-brown coloured paint finish with heavy dirt layer x50 & x200

Paint analysis suggests that the facade of the building, the portico and the garden wall was originally decorated in some type of **mid-brown coloured lime wash**.

This mid- dark brown coloured finish bears a very heavy dirt layer suggesting that it saw considerable wear. This colour was probably intended to suggest that the building was built of stone. Traces of this early finish are also found on the capitals of the portico columns. Sample 108 C is taken from the volute of the capital which is currently painted orange/brown. Cross-section analysis of the samples reveals that the capital was originally painted in the mid-brown coloured finish applied to the rest of the facade and garden balustrade. The element was redecorated in a brown coloured paint before

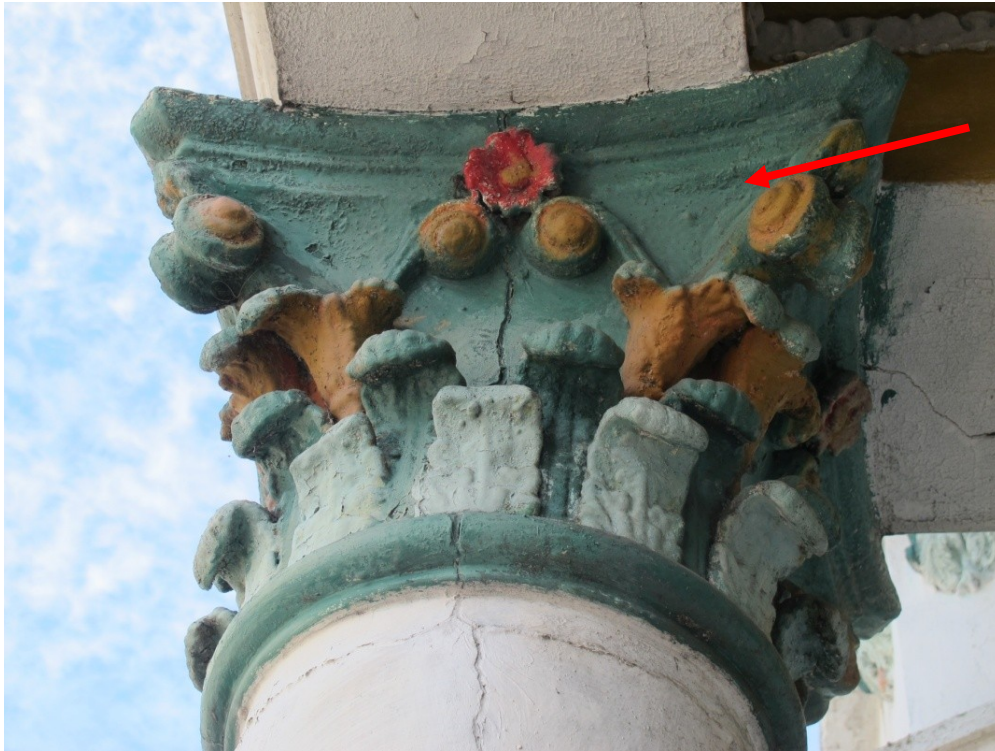
Figure 14 Capital of portico column - Location of sample 108C

being painted in a numerous applications of whites and creams. The current polychrome decoration of the column capital probably dates from the 1960s/1970s – this echoes the green picking out of the ceiling details in the main reception rooms which was probably carried out at this time.

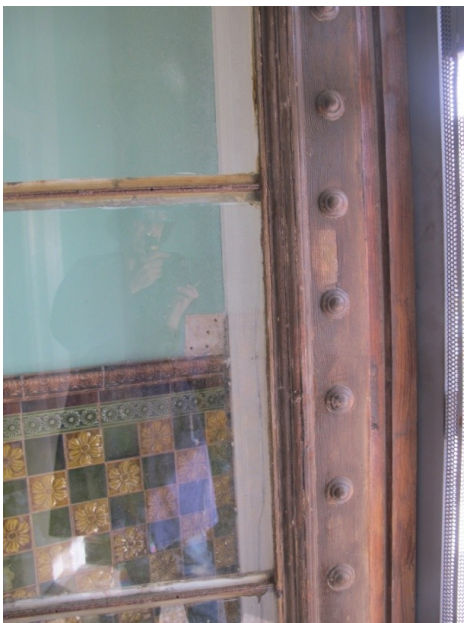
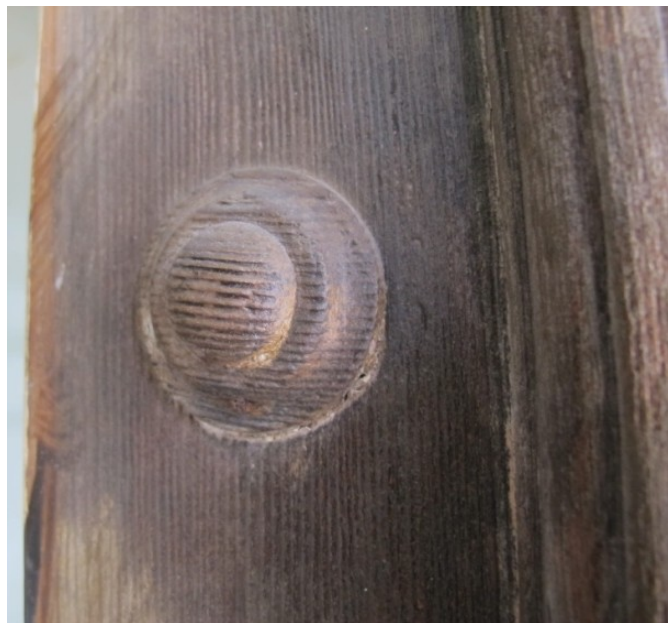
Figure 16 Front Door - Detail of new glass panel and stripped wood

The paint has been stripped from the face of the door to reveal the bare wood.

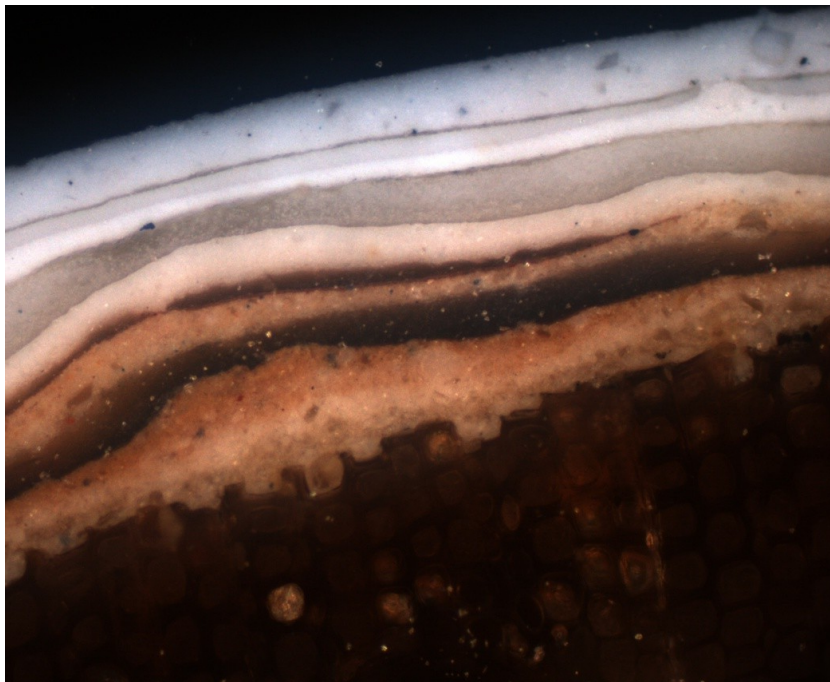
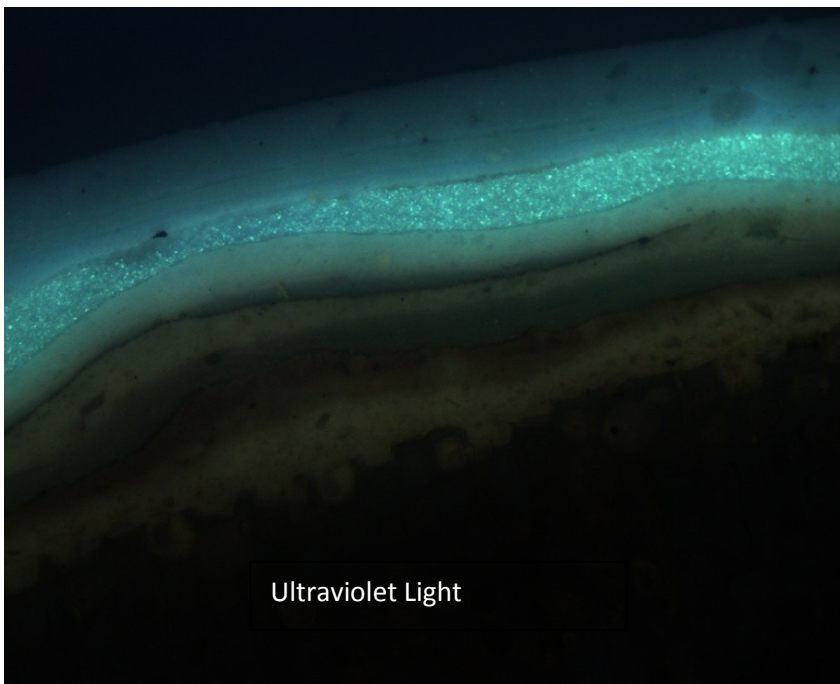
Front Door

The grained decoration was overpainted in a lead white based paint

- Recent white*
- Zinc Based White*
- Lead-based white*
- Original Graining (repeated once)*

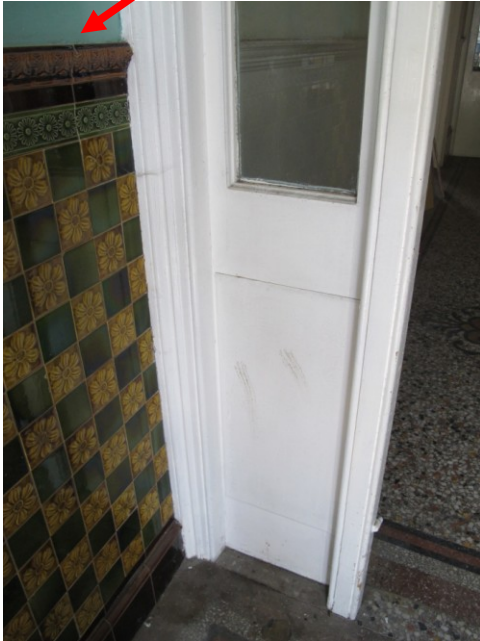
The lobby retains its original flooring and tiling. But the upper wall plaster may have been renewed. Paint samples removed bear only one layer of paint - the existing green

Existing green

New Plaster??

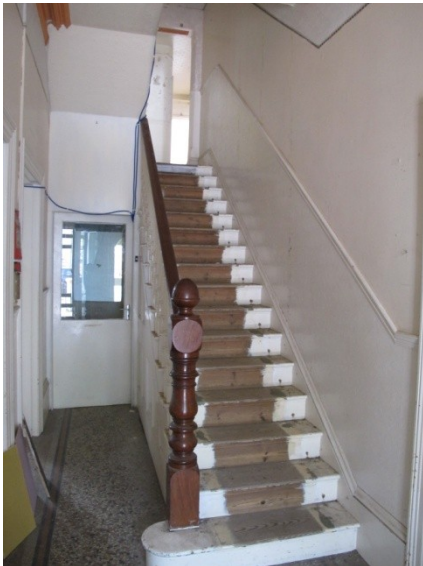
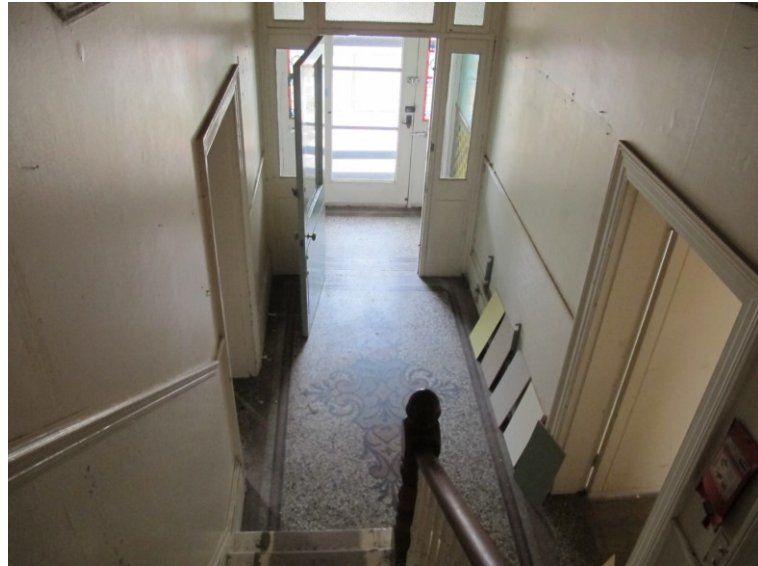
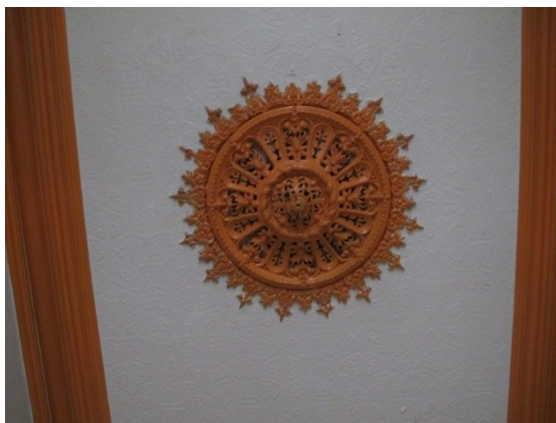
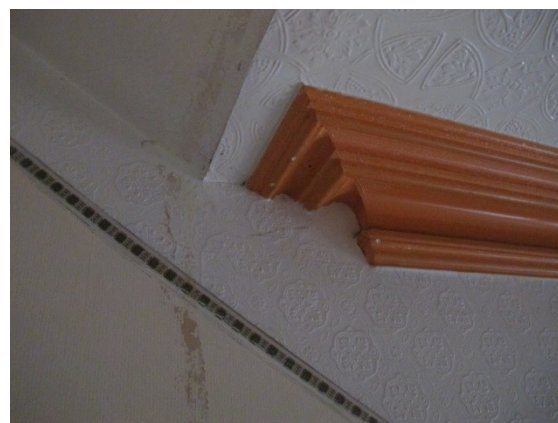
The Entrance Hall ceiling is decorated with an embossed paper. The frieze is decorated with a smaller patterned embossed paper. The main paper has been stripped from the main lower sections of the wall. It is possible that the two ornate orange papers which survive on the first floor landing were also applied to the walls of the Entrance Hall. (See Room by Room Survey – First Floor)

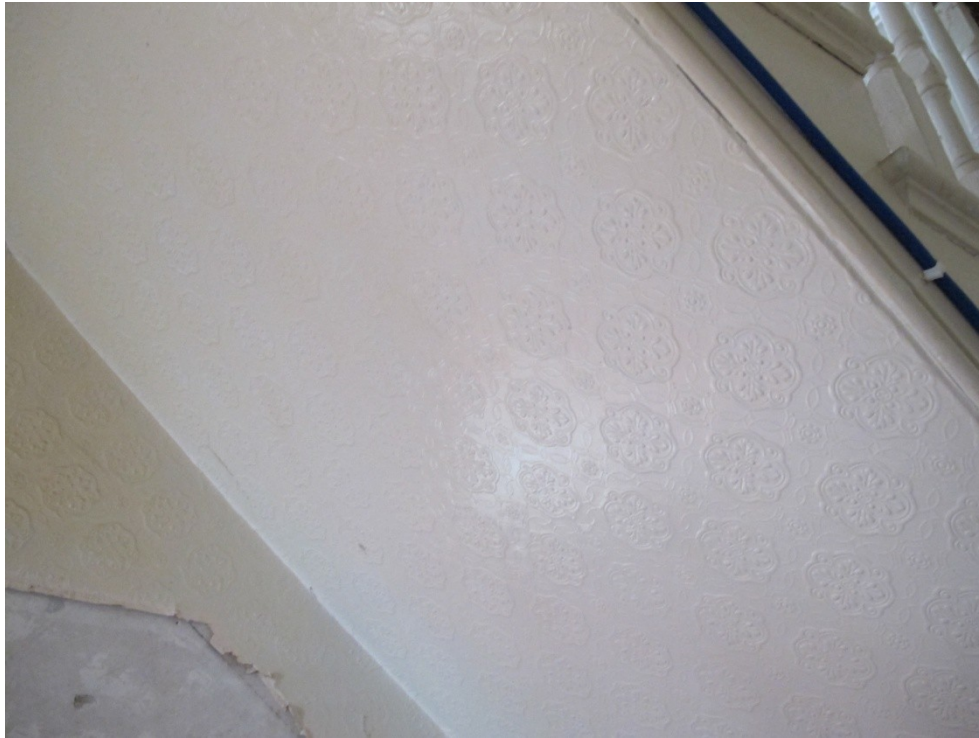
A smaller scale embossed paper applied to the underside of the stair has been carried down onto the frieze section of the wall face of the Entrance Hall.

A small green fillet masks the join with the filling wallpaper - possibly a later feature

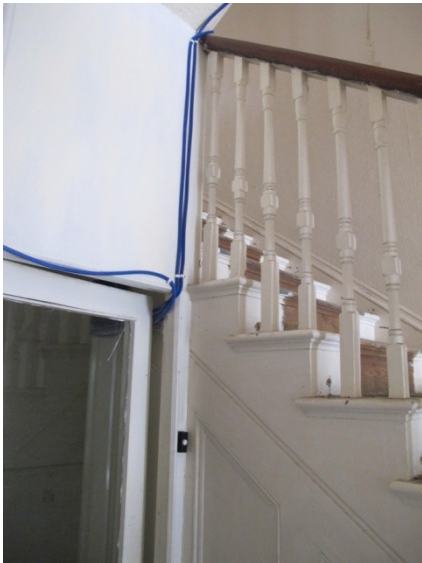
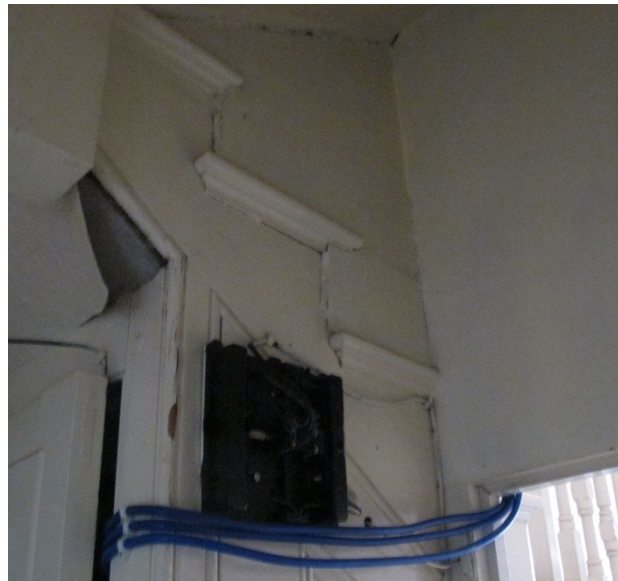
Staircase

The joinery of the staircase was originally grained.

Sample 56 – Side of Stair – Original graining revarnished and repeated – before being paint brown (same finished found on later dado). Painted White.

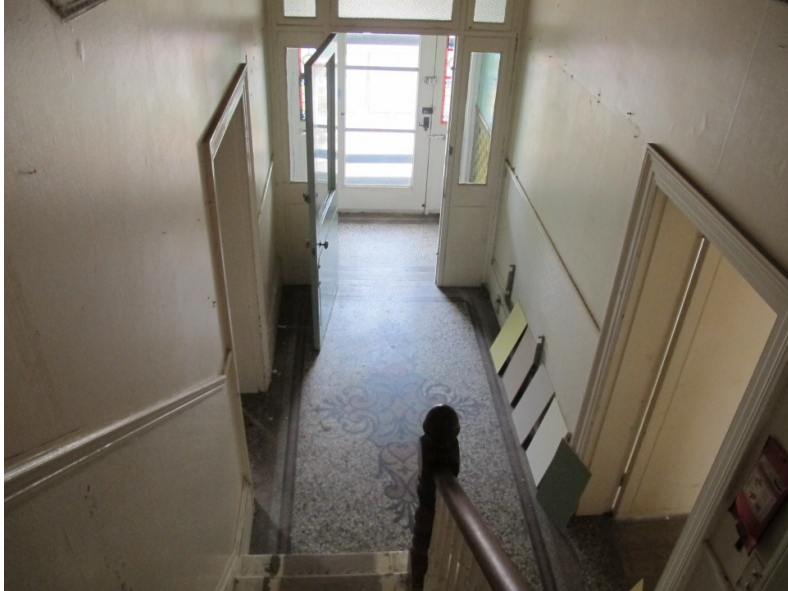
Sample 53 Dado Rail – Later insertion

The dado rail is a later addition. The later dado rail can be identified by the white and grey undercoat layers. This dado rail was also applied to the first floor landing – most likely in the 1950s.

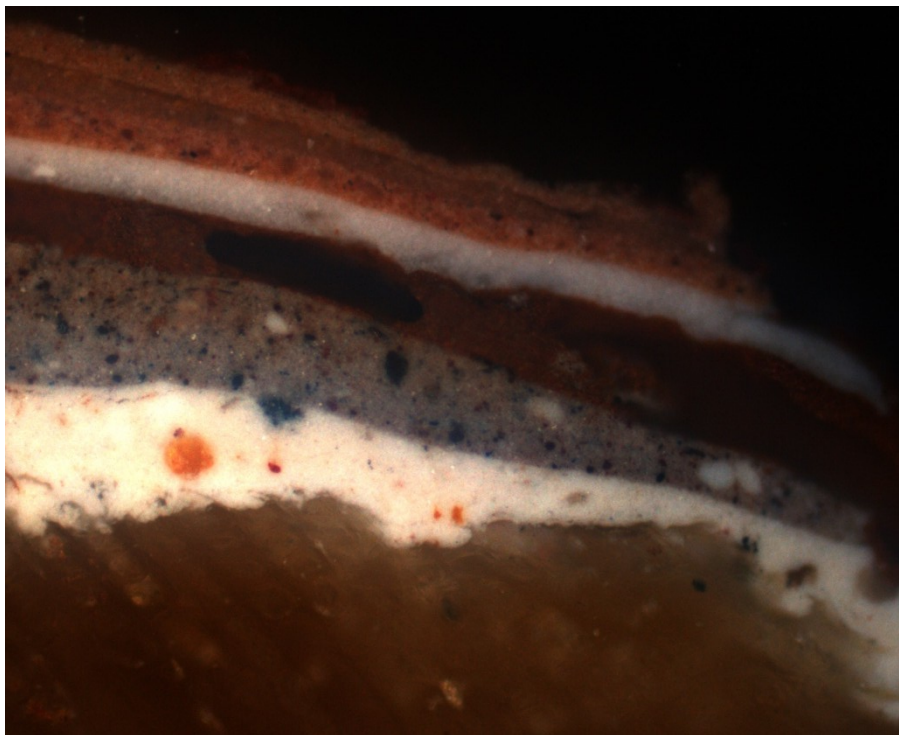
Dado Rail in Entrance Hall

Paint analysis has confirmed that the dado rails in the **Reception Room** and the **Entrance Hall & Staircase** are later additions – probably added during the 1950s alterations when the interiors were repaired and redecorated. The dado rails do not bear any traces of the early grained decoration found on all of the original joinery. It is suggested that the current arrangement of the walls of the **Front and Rear Drawing Rooms** (R0.02 & R0.03) is more indicative of the early decoration of all of the rooms prior to the 1950s post WWII renovations and redecoration programmes.

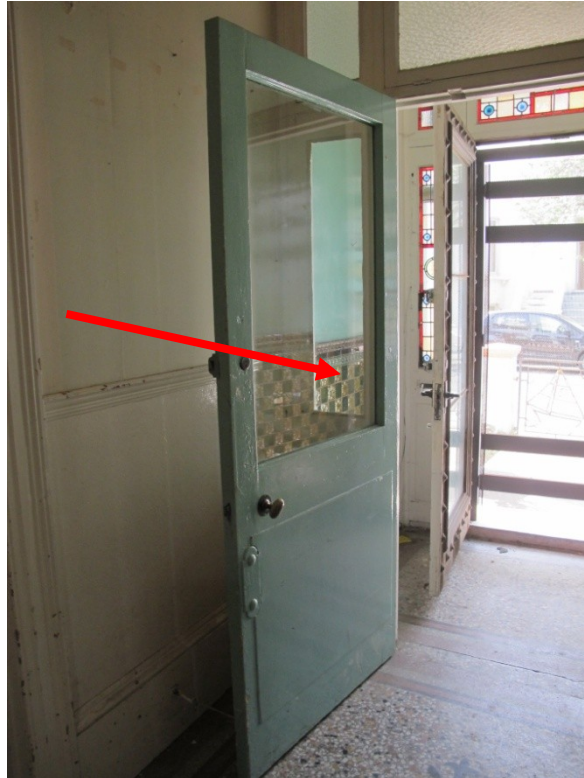
Sample 50 – Gold leaf on varnish layer of graining– Inner Screen (Was this a Cecil upgrade?)

The middle door was also grained. The wooden semiglazed surround was also grained and at some date specific elements were embellished with a layer of gold leaf.

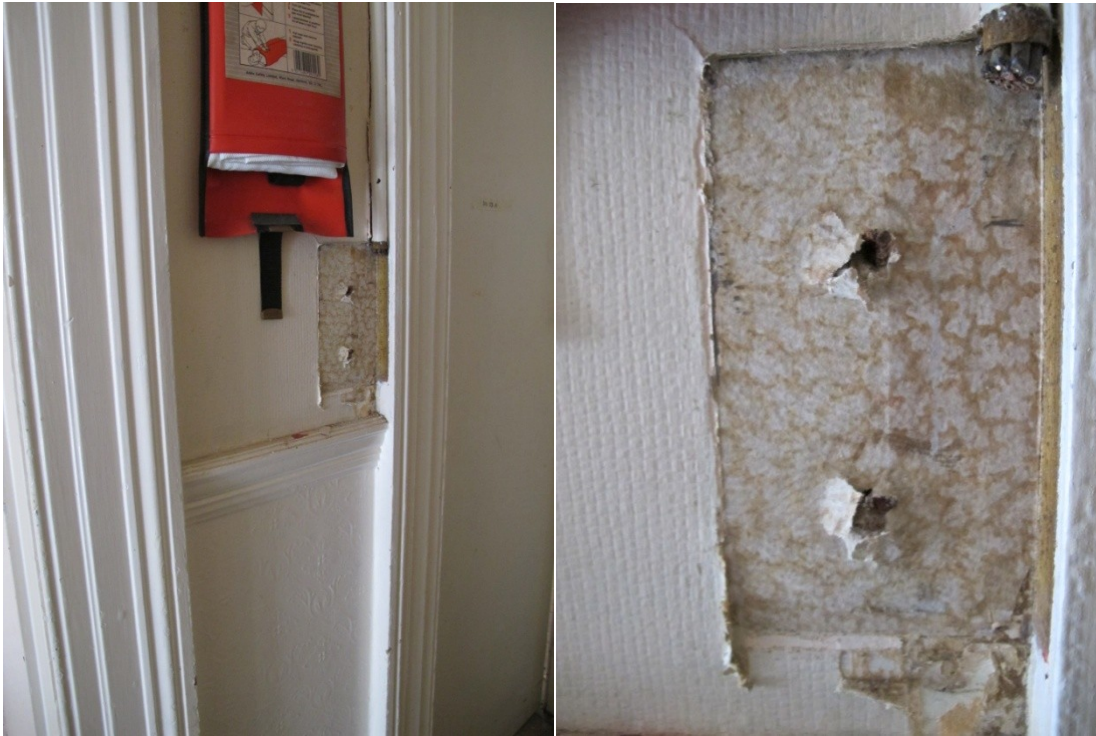
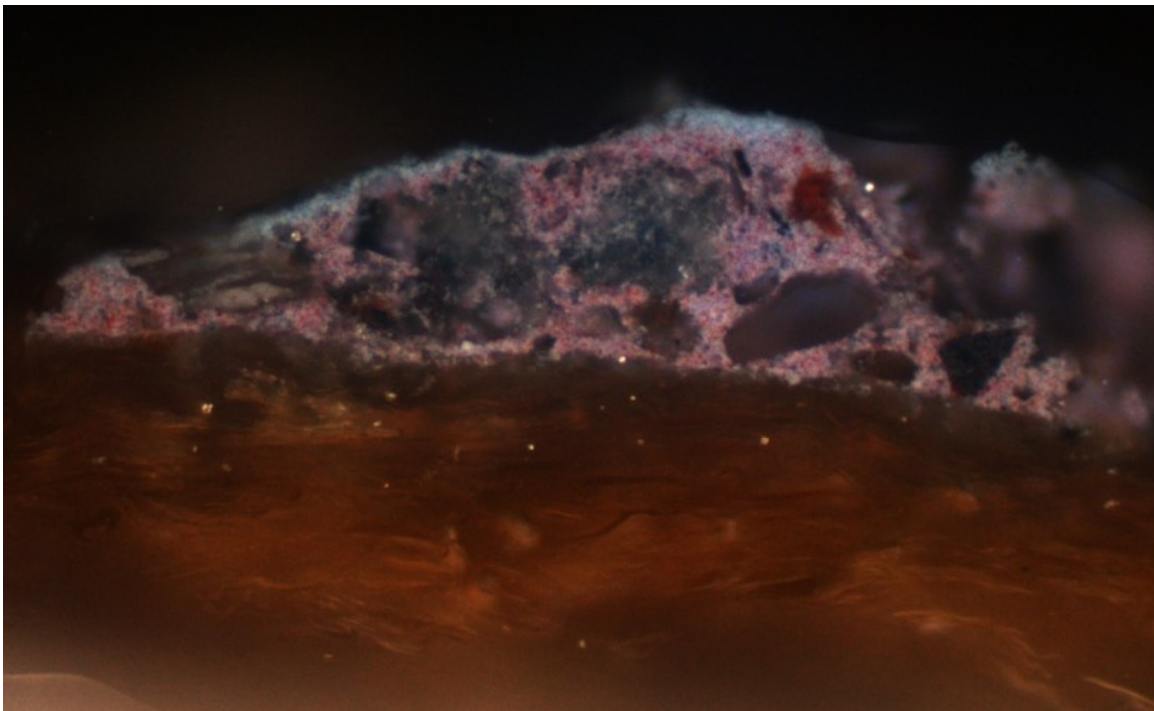
Wallpaper Sample 52 – North Wall Hall (R0.04)

Wallpaper – protected by electric light switch - North Wall

The exposed area of wallpaper is typical of the 'Porridge & Pudding' wallpapers popular in the 1930s and 1950s. This paper must have replaced an early c.1900 paper. It was protected from stripping by the electric socket.

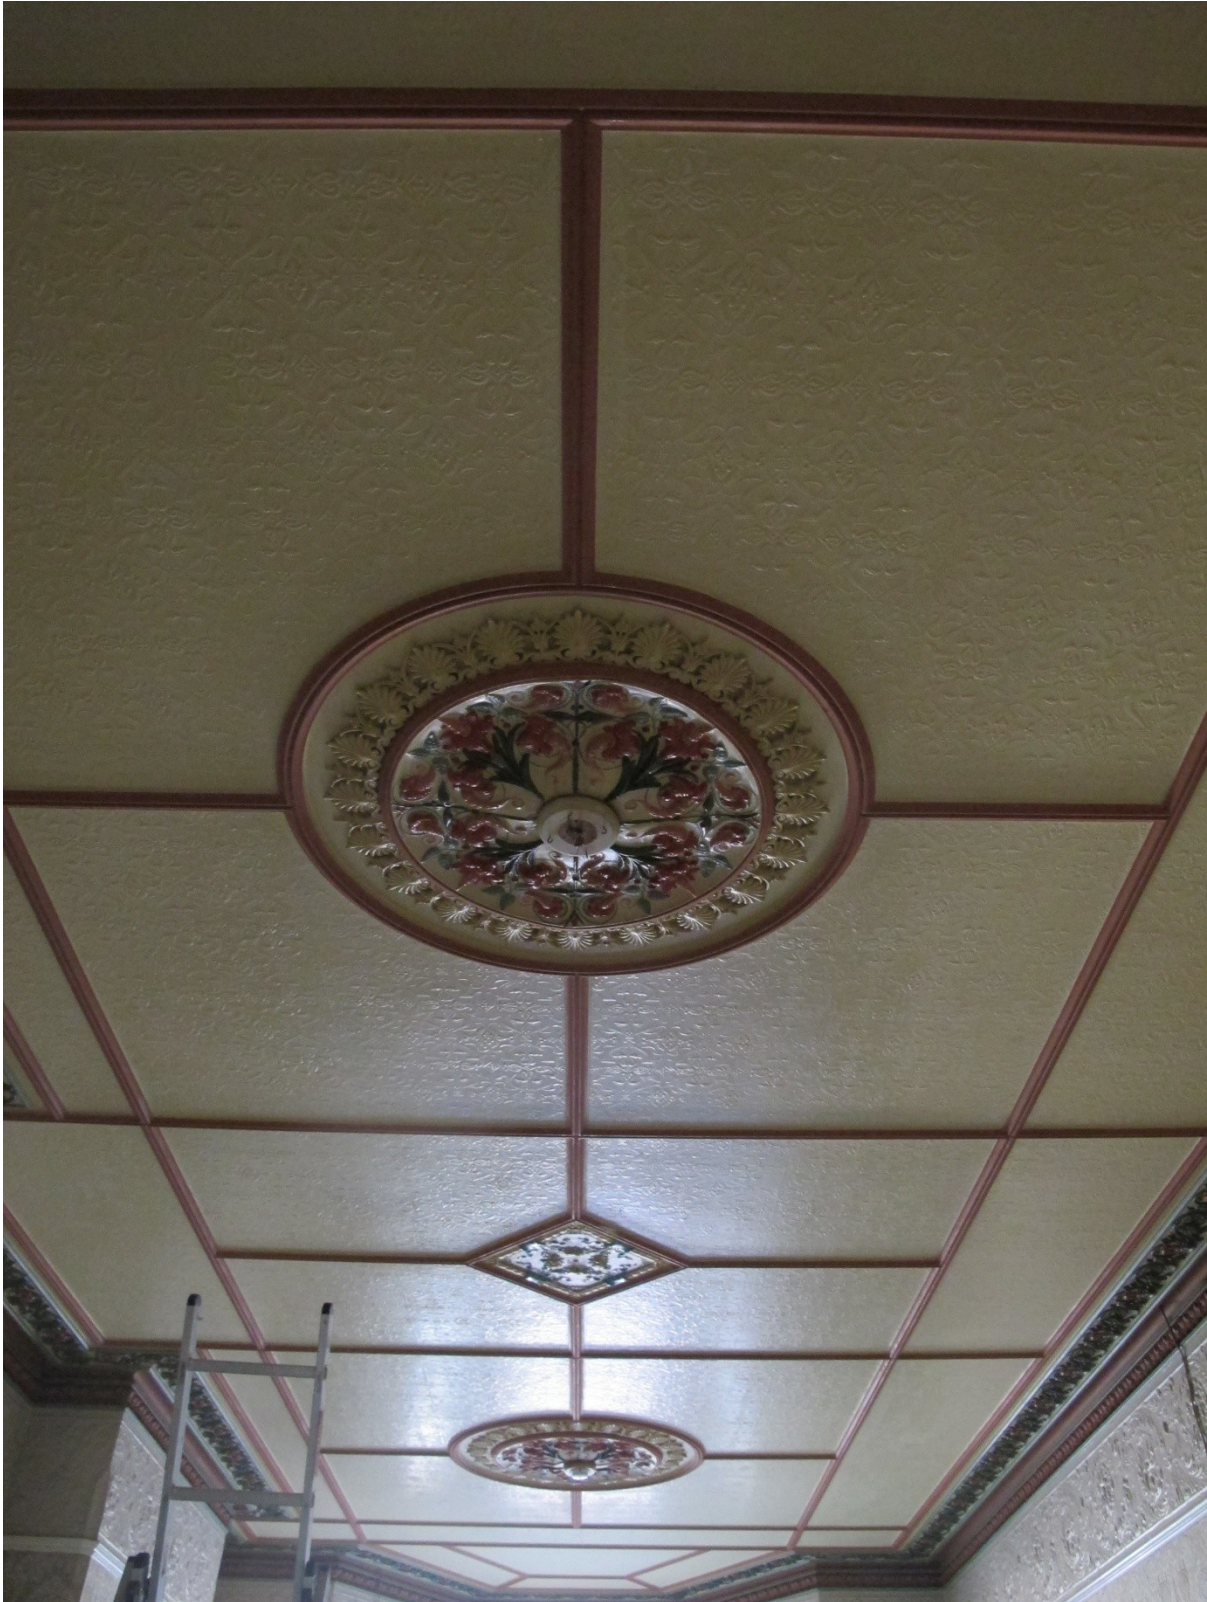
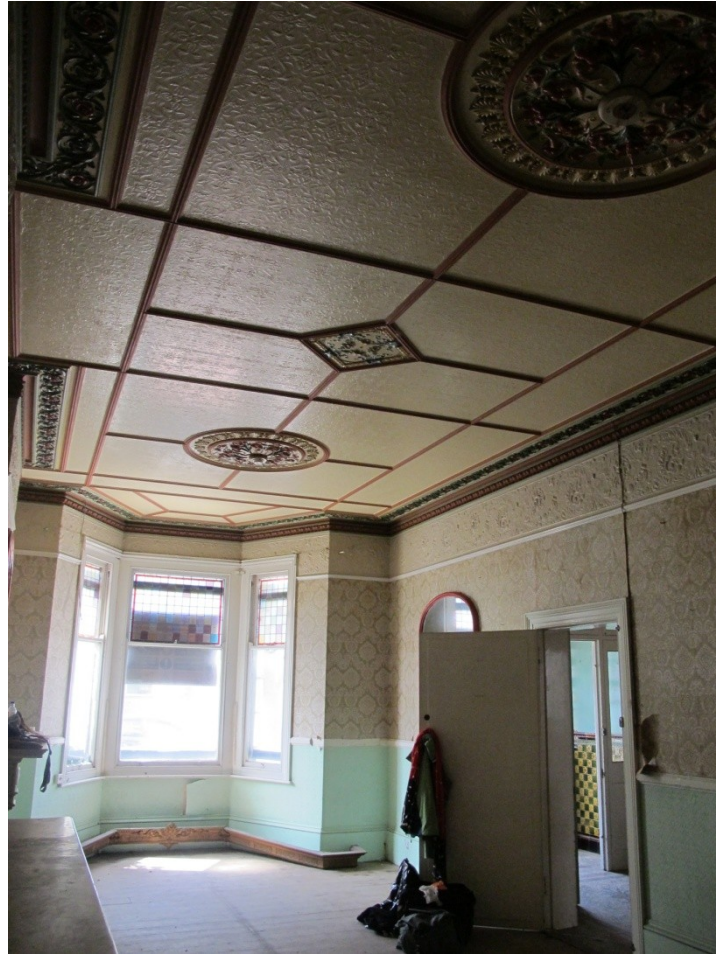
Principal Reception Room (R0.01)

This room was the main reception room. It was fitted with two ornate marble chimneypieces. It is accessed from the Entrance Hall. A door in the North/East corner connects the room to the Kitchen Corridor. The room is also linked to the original Long Room (altered in the 1950s).

The ceiling, cornice and frieze are in remarkably good condition. They appear to date from the original or early fitting out of the house. Paint samples taken from these elements seem to confirm this assumption. The ceiling bed is decorated with an embossed paper which was originally decorated in a plain off-white oilpaint. This has a distinct dirt layer on its surface. The paper has only been painted once in a greyed white zinc-based paint. The existing paint was probably applied during the 1930s or possibly during the post WWII redecorations. Old stocks of pre-WWII may have been available.

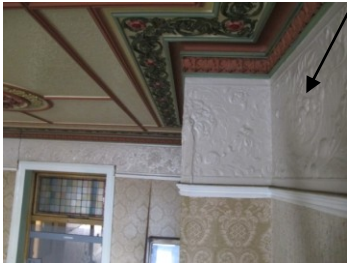
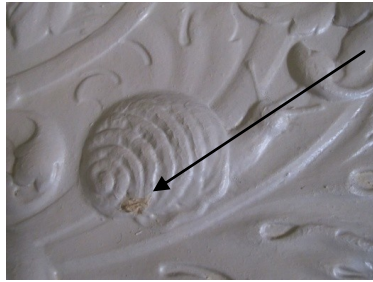
Modern Off-white Acrylic – 1960s

Zinc-based White 1930s/50s

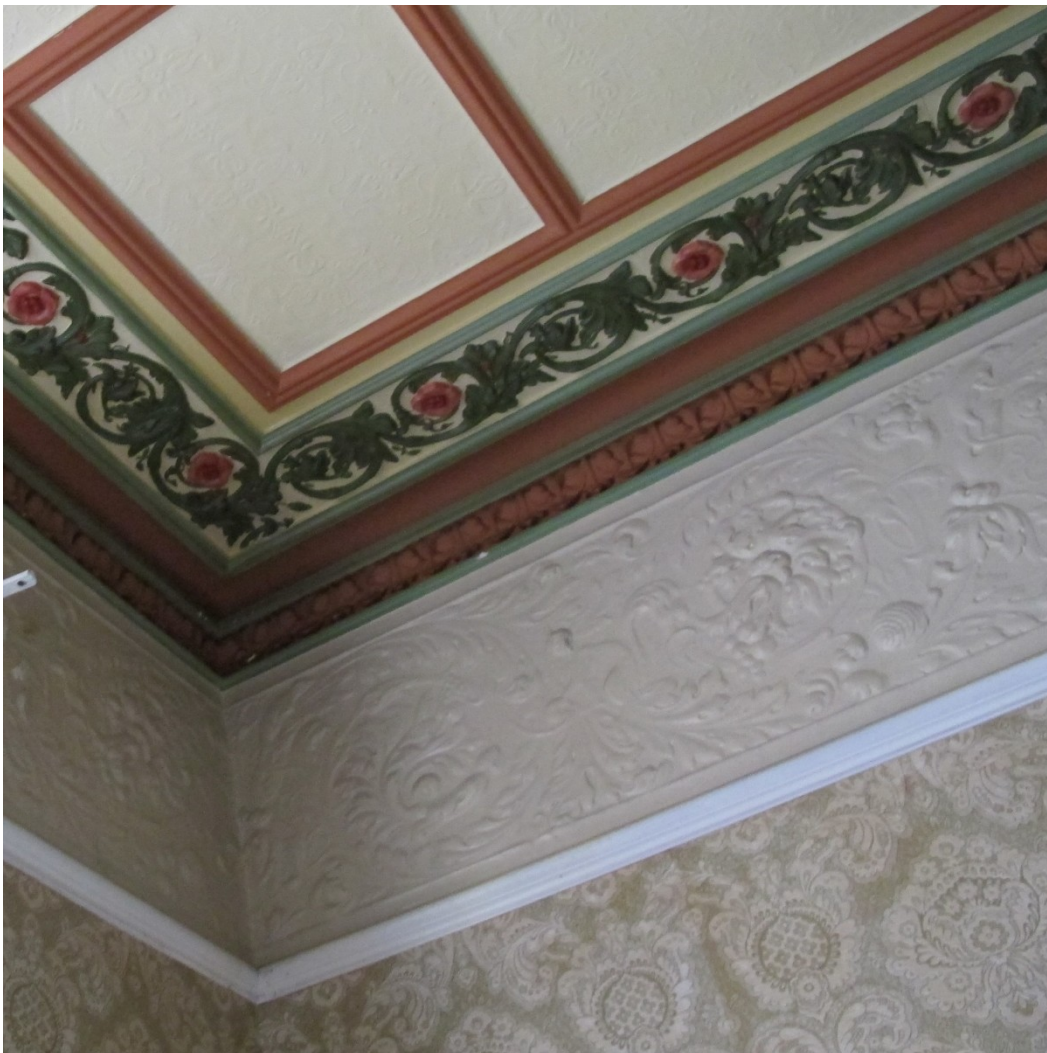
Wall face Wallpaper – surviving example (what date?)

Beneath the existing wallpaper is a 'porridge & pudding style paper'. These papers were popular in the 1930s and 1950s. No trace of this paper was found below the dado rail.

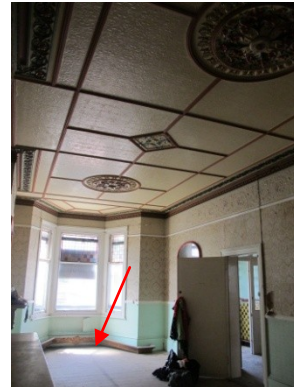
Pelmets Sample 19

All of the Mirrors and Pelmet on the Ground floor were original decorated in **high quality gold leaf (water gilding on bole)**. These have been redecorated in cheaper gold paint – and later the existing red paint (applied over a white undercoat)

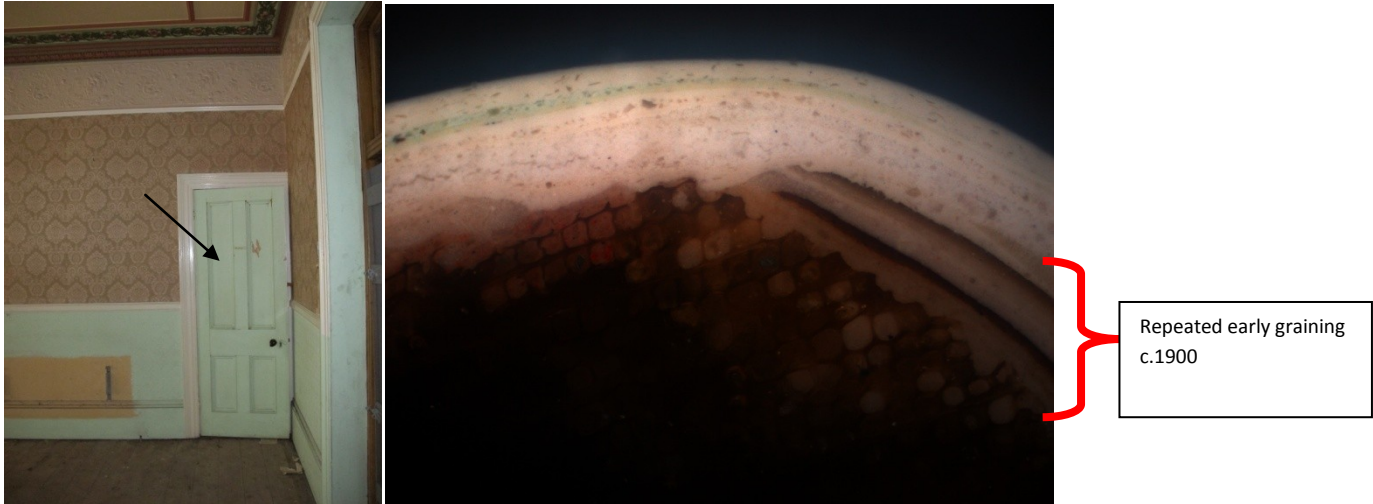
Main Door – Possibly replaced in the 1950s/1960s

The wood has been properly primed with a red lead primer and the revealed graining is simialr to that found on the French Doors.
