Historic Interiors Research and Conservation

Arthur Road – No. 12

Investigation of Decorative Finishes (Exterior & Interiors)

August 2015

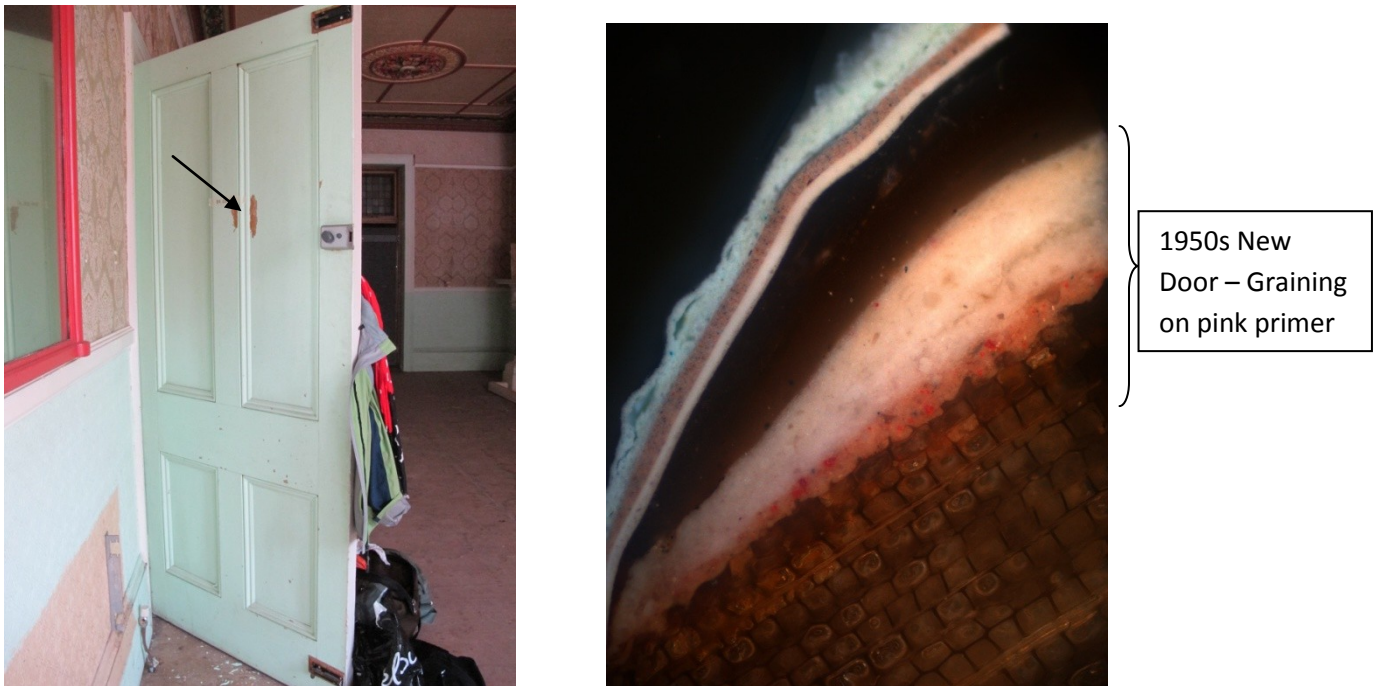
Main Door – Possibly replaced in the 1950s/1960s

The wood has been properly primed with a red lead primer and the revealed graining is simialr to that found on the French Doors.

An example of very high quality graining has survived on the face of the French windows which lead to the Long Room (R0.06). Paint analysis has established that these doors – unlike all the other joinery elements within the house were not grained but repeatedly decorated in white. The distinctive grained decoration was probably applied in the 1950s.

An example of very high quality graining has survived on the face of the French windows which lead to the Long Room (R0.06). Paint analysis has established that these doors – unlike all the other joinery elements within the house were not grained but repeatedly decorated in white. The distinctive grained decoration was probably applied in the 1950s. Some elements of replaced doors and windows were grained at this period.

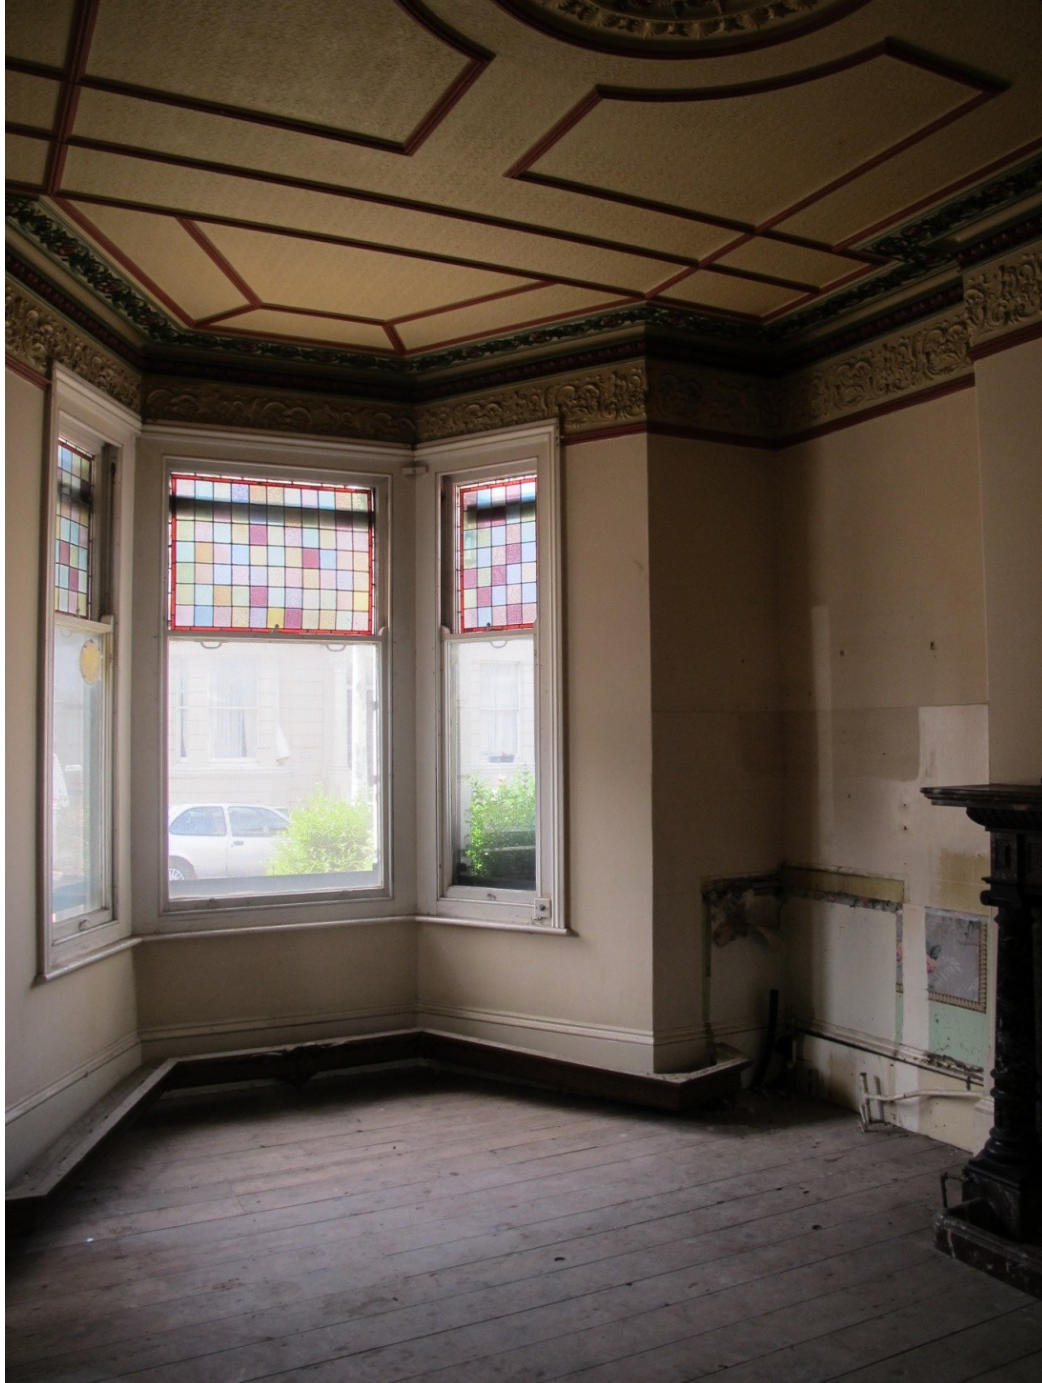
Front Drawing Room (R0.02)

Ceiling Rib – Pale Green c.1900

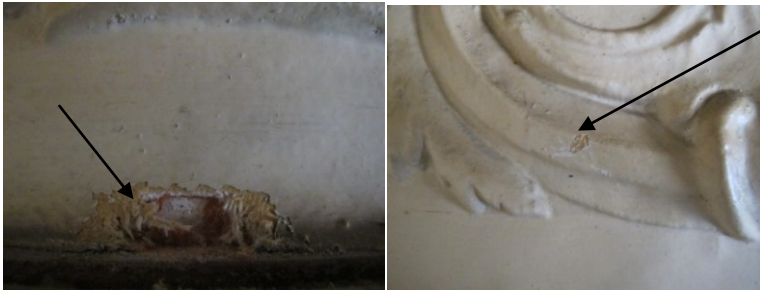
Anaglypta Frieze

Sample 149 Background & 150 Relief - Sage Green

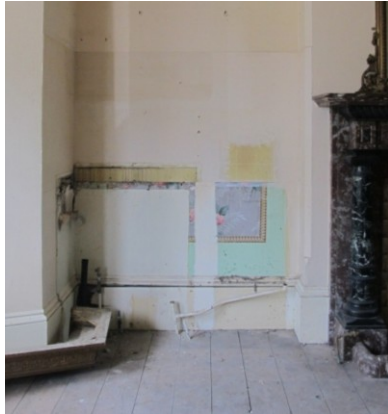
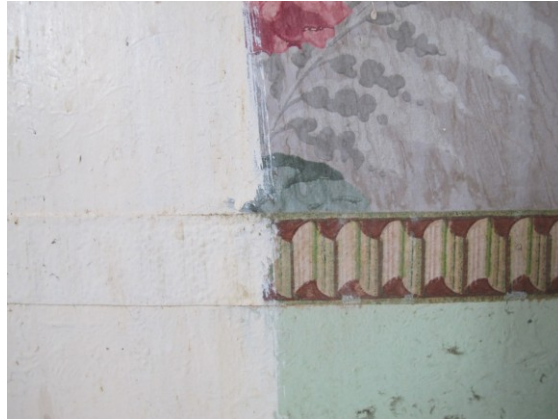
Wallpaper under kitchenette

Sections of an earlier wallpaper were retained behind the 1960s kitchenette corner. These wallpapers probably date from the 1930s or 1950 renovations.

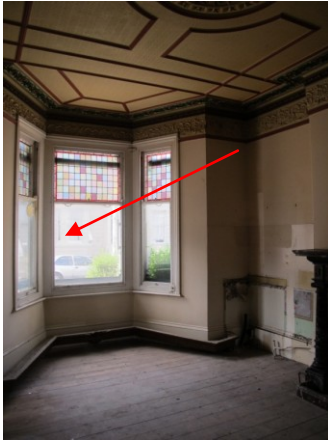
Window - Sample 24

It is possible that the windows in this room have been replaced – possibly in the 1930s or 1950s . They do not show any evidence of early graining which is found on the door archtraves and folding doors.

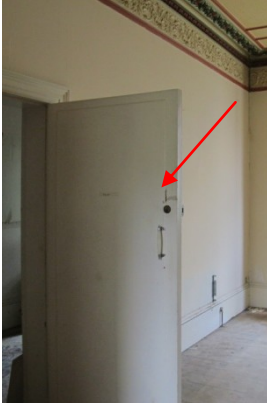
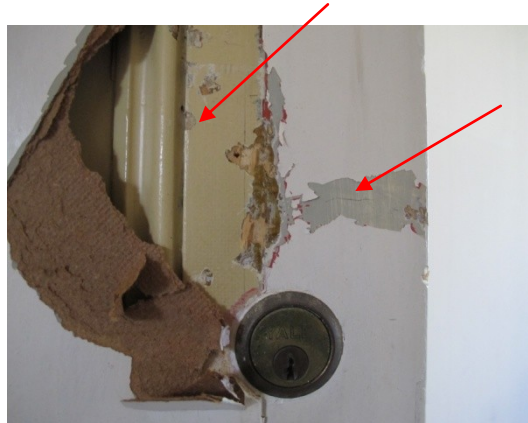
Main door – Boarded side to Entance Hall

The panelled doors were covered in boading probably in the 1960s/1970s to make them look more appear more modern

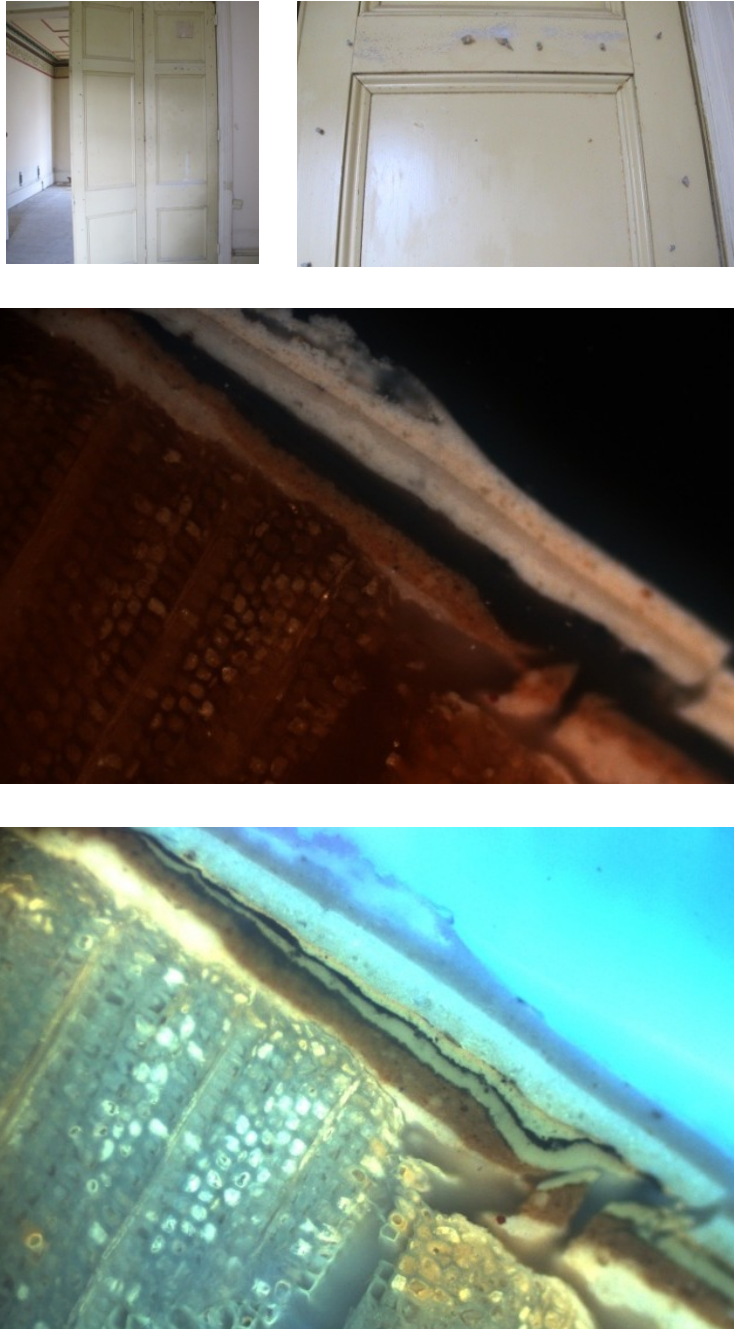
Figure 19 Folding Door between R0.02 & R0.03 - Cross-section sample 32 Original graining over painted c.1950 and then boarded over during the 1960s

The folding doors dividing the two northern Drawing Rooms retains substantial remains of the original grained decoration applied to all of the joinery (window frames, window sashes, doors, door archtraves, skirtings and staircases) The extensive fictive graining in imitation of a light oak would have been a very distinctive feature of the interiors of 12 Arthur Road from c.1900 until the 1950s graining. The early grained when worn and dirty had been revarnished to revitalise the scheme .

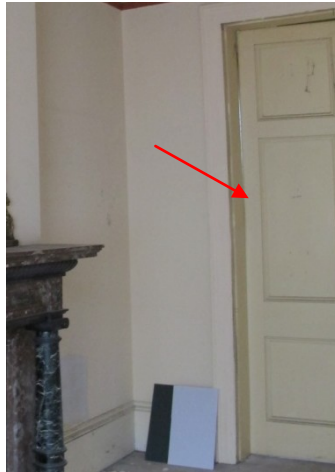
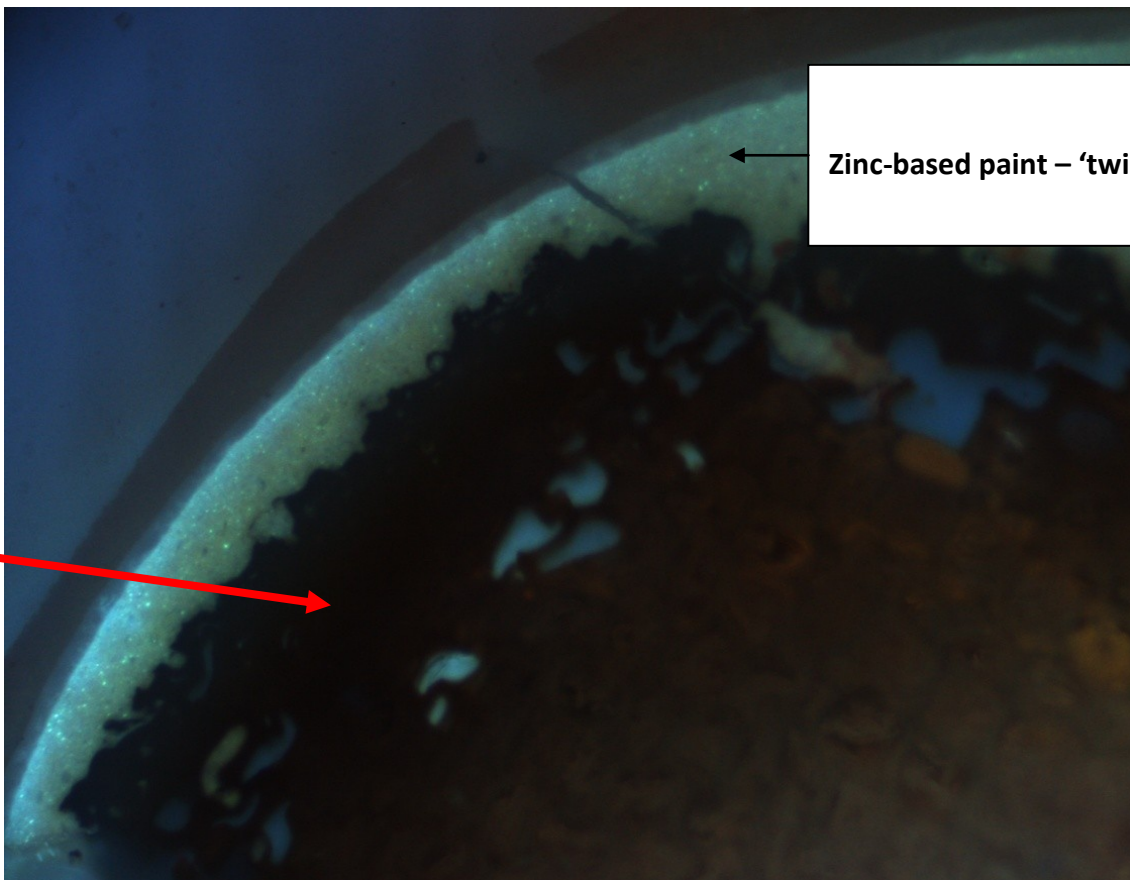
Architrave of folding doors (North Side R0.02 side) - Sample 31

Signs of Fire Damage - Architrave

There are signs of sections of the archtrave of the folding doors being damaged by burning. The charred wood has been over painted using a zinc based paint (commonly associated with 1930s but possibly old stock used in the 1950s)

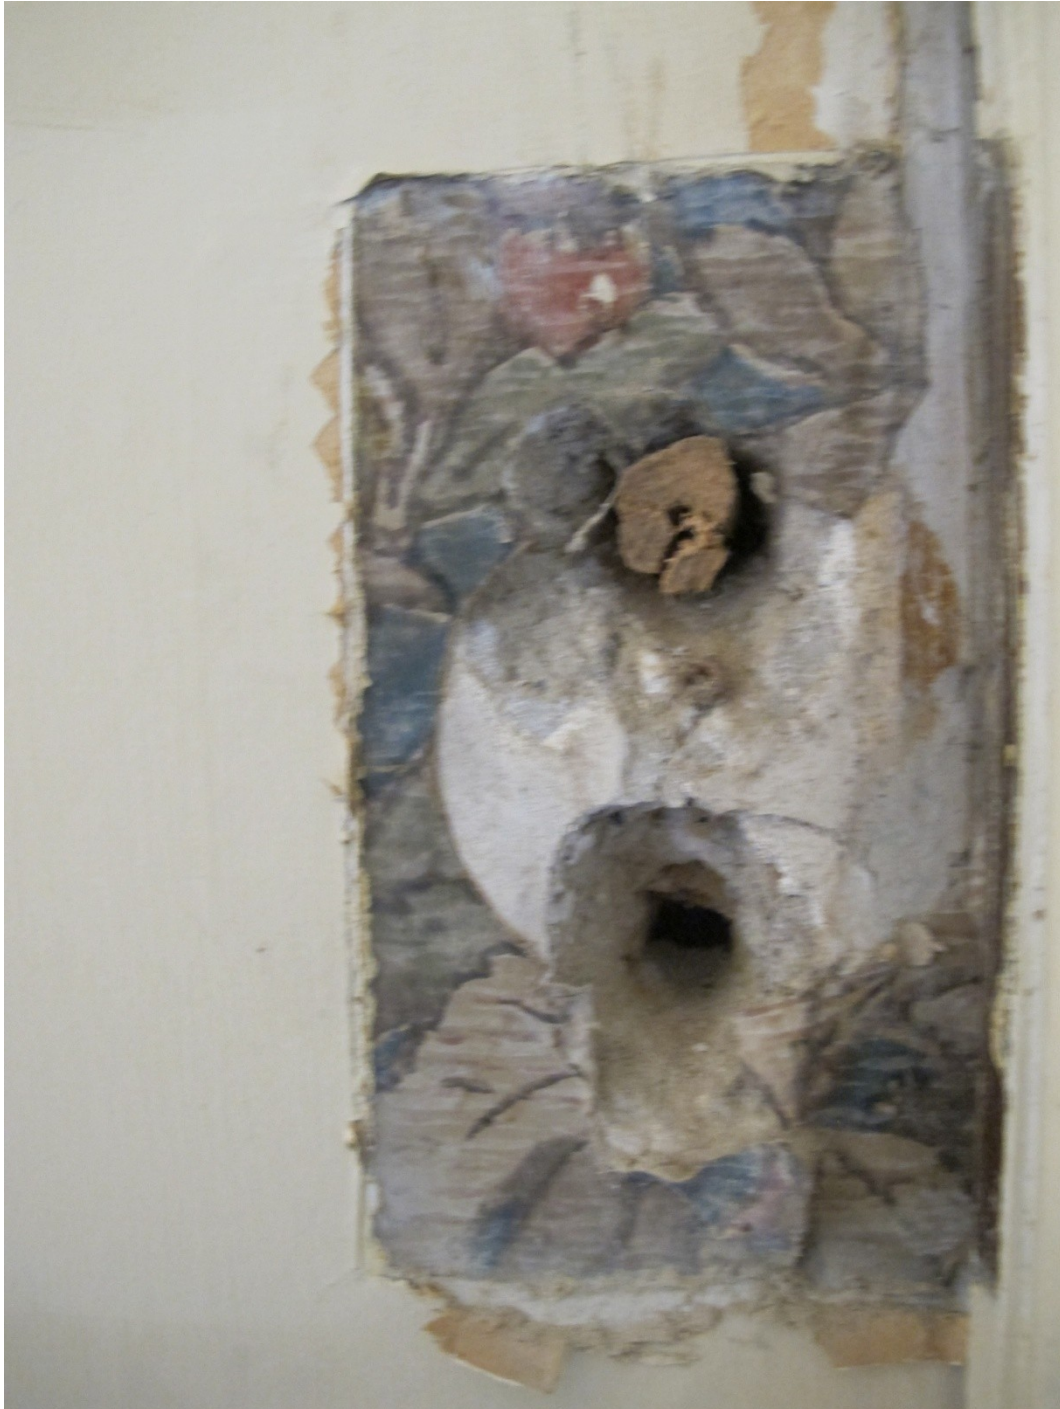
Wallpaper protected by electric switch

A section of foliate patterned paper is retained on the east wall beside the door.

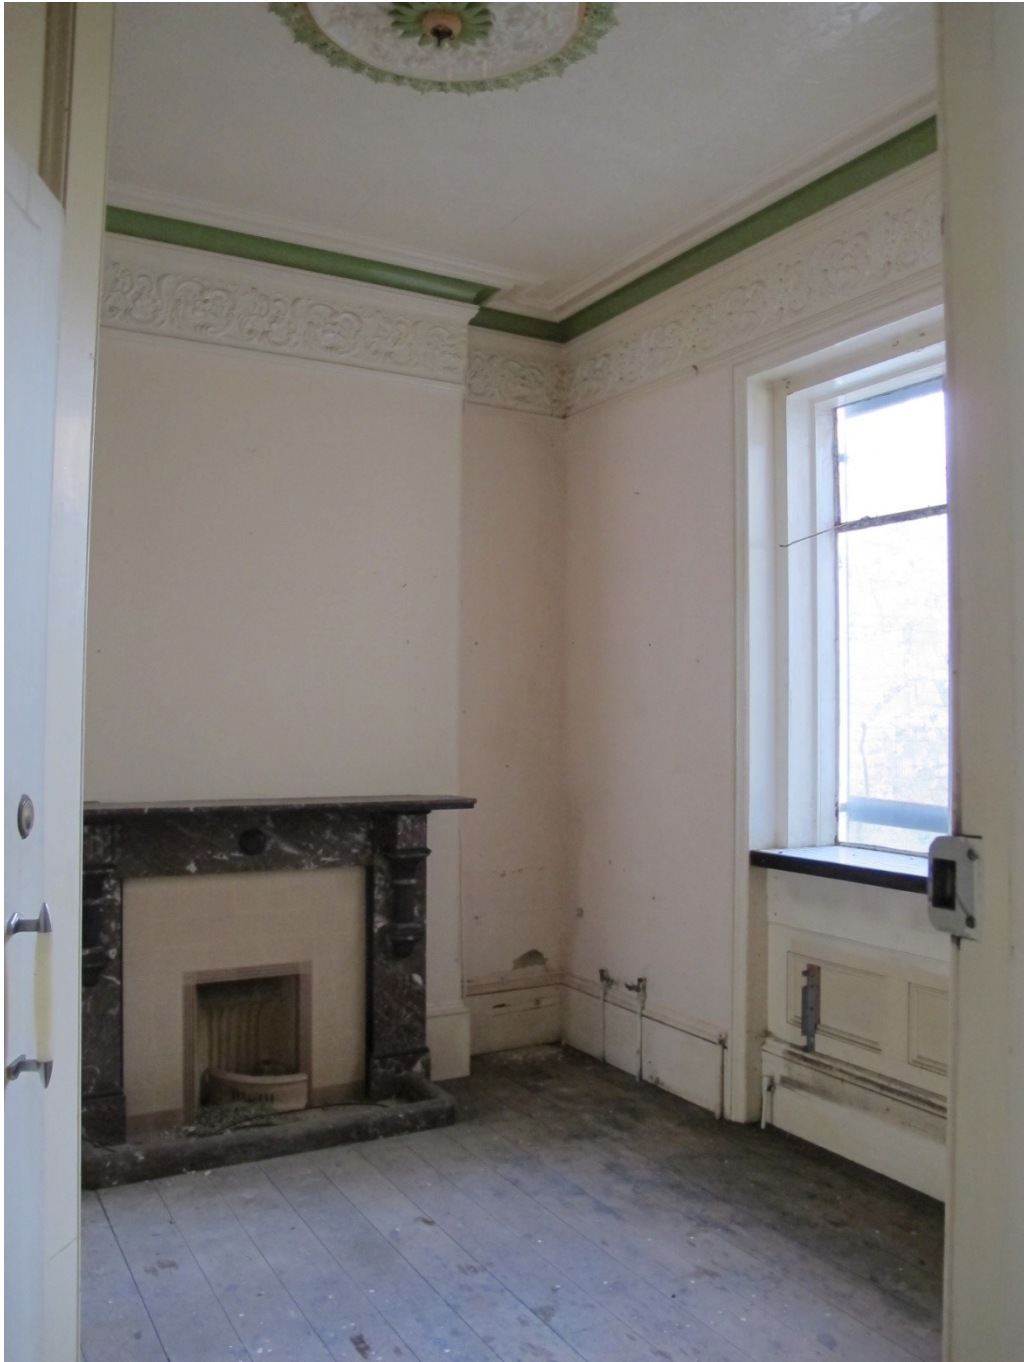
Rear Drawing Room (R0.03)

This room is of lower status and does not have an ornate plaster ceiling border. The ceiling has a central plaster rose but no other plaster embellishments. It is covered by an embossed paper. There is a simple plaster cornice.

This room was used as office by the Gregory family and was not converted into a flat with a kitchenette corner. There is evidence of fire damage on the door archtrave of the folding doors. This may date from the 1930s or 1950s as it has been overpainted in zinc-based paint.

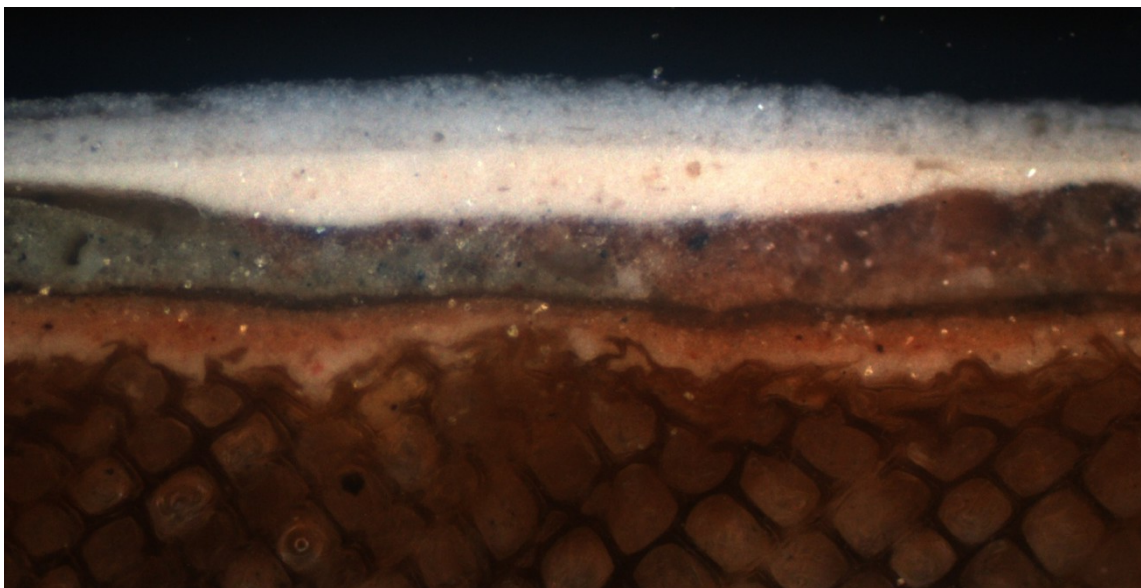
Big moulding above frieze - Sample 170 – Picked out in dull pink (surface dirt)

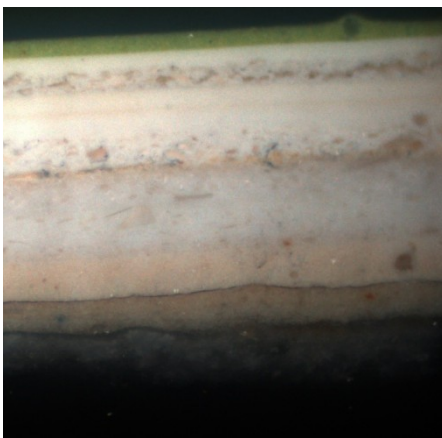
Green Concave Moulding - Sample 173

Originally Light Pink
